Bay of Plenty Regional Council

Koapeo Canal Remediation

CLG Monthly Update Report

September 2018

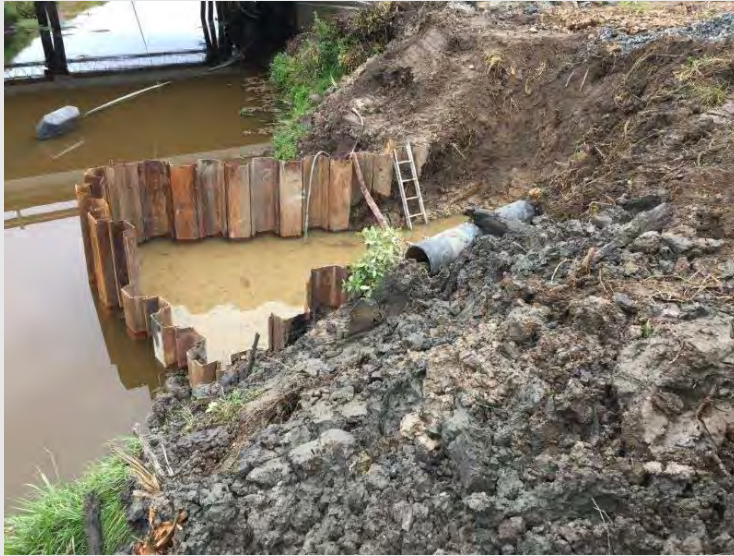
Photograph 4: Sheet pile installed for thrusting of a culvert under Shaw Road.

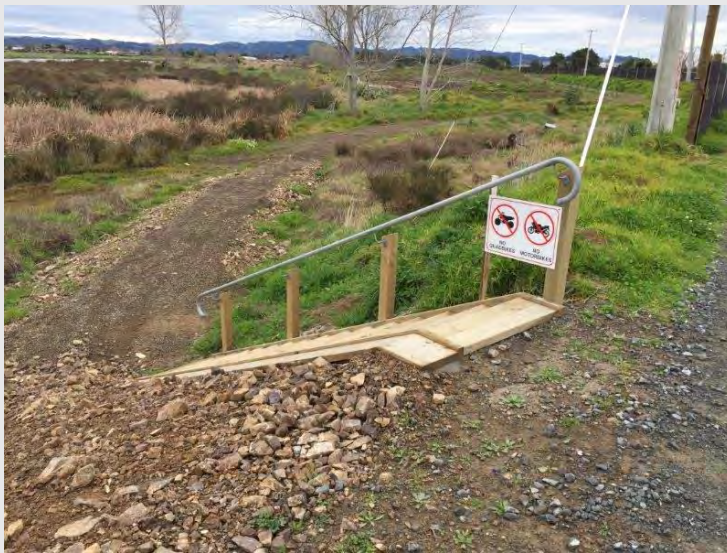
Photograph 5: Warning signs on walkway past CS3.

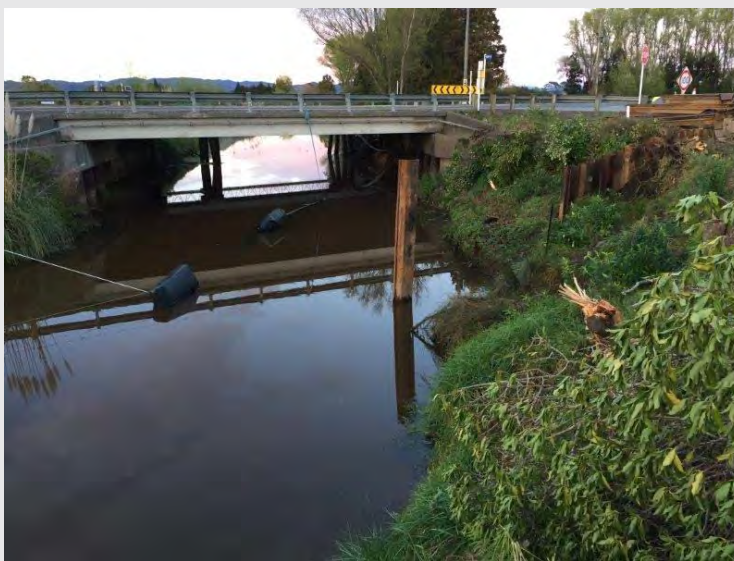
Photograph 6: Sediment transfer pipeline is floated past the newly installed temporary sheet pile.

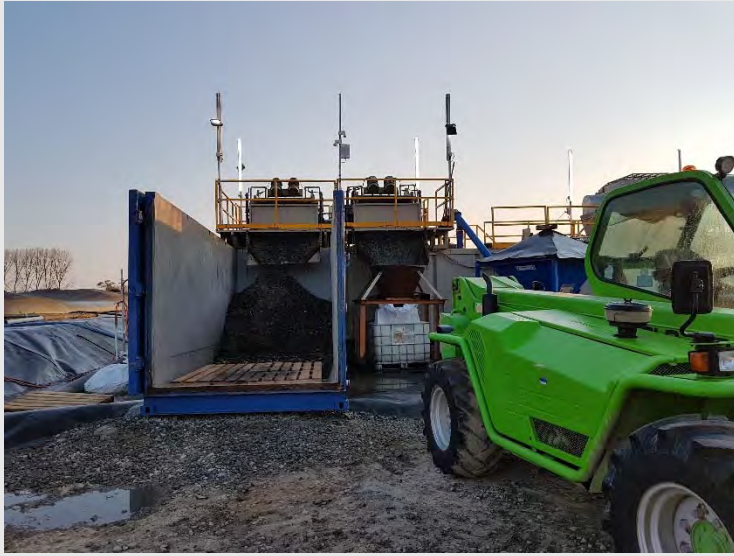
- Sediment spilled within the containment cell (Photograph 3 & 11).
- A large overflow bin for oversized material was installed at CS1 (Photograph 10). The objective of this installation was to provide relief when large slugs of oversized material arrive at the water treatment plant.

Photograph 10: New oversized material overflow bin set up.

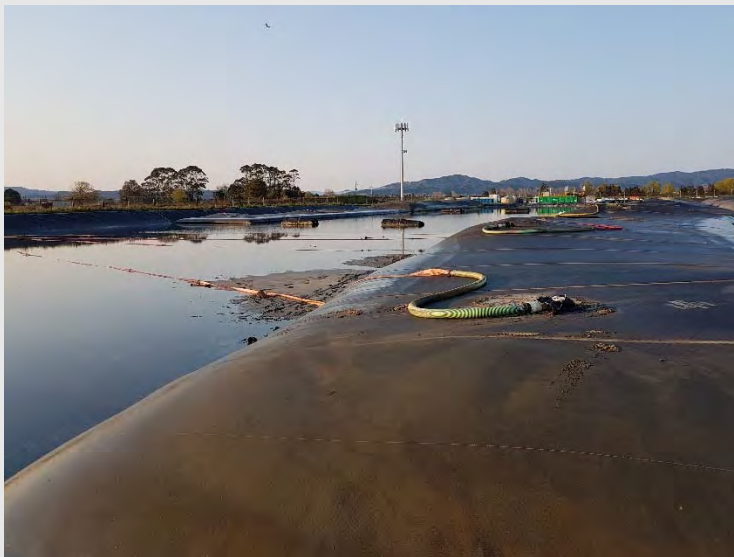
Photograph 11: Sediment spilled within the containment cell.

Sediment has been spilled in the containment cell multiple times over the last eight months and on each occasion, the IM and project team have both requested that this material be cleaned up. While it is not a dust risk due to the cell being kept flooded, there is a risk that sediment-laden water could be released from the cell into the Kopeopeo Canal. During September, a site shutdown allowed ESL and NZPGS to begin cleaning the cell and improving the general site housekeeping. The cell is being cleaned using pressure jets and brooms with the material being recirculated into the geobags and contained. This is good progress, but given the volume of sediment spilled in the cell, it will be required on an ongoing basis.

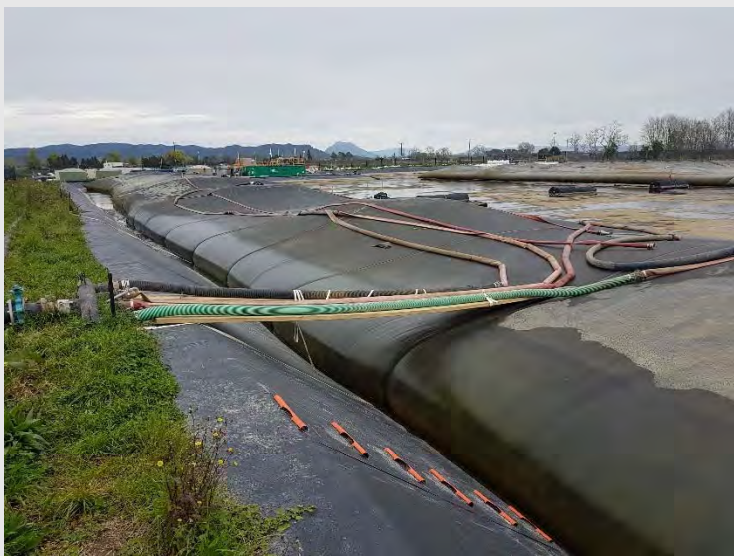
- Sediment transfer pipelines out to the geobags were placed on planks to ensure smooth flow and reduce wear and tear on the pipes (Photograph 12). This is designed to minimise leakage from the pipes and extend the operating life of equipment.

Photograph 12: Sediment transfer pipelines laid on wooden planks to reduce wear on the pipes.

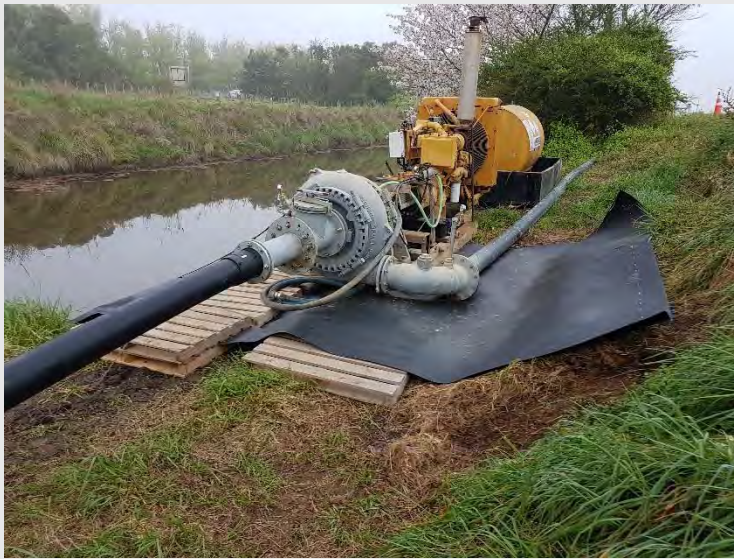
- The Gateway Drive outfall culvert was reshaped and armoured (Photograph 8 & 9).
- The two booster pumps set up along the sediment transfer pipeline were placed upon HDPE liners to ensure that any possibly leakage would drain back into the canal (Photograph 13).

Photograph 13: Boost pump set up with HDPE liner to ensure any leakages return to the canal.

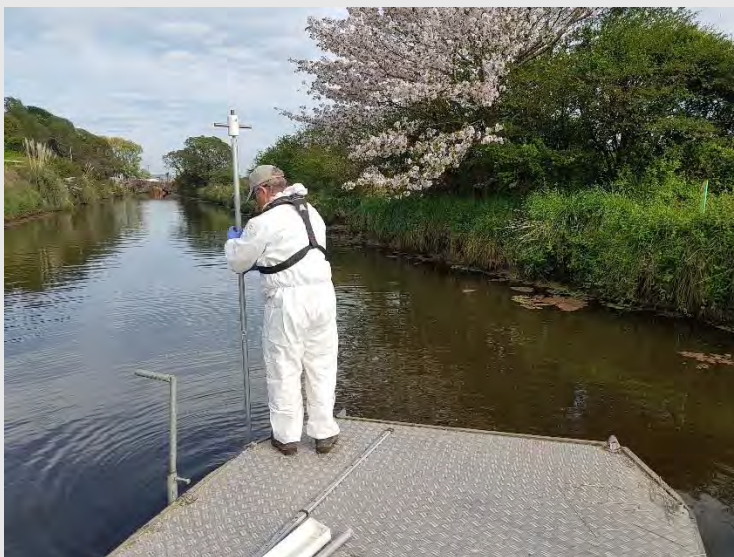
- Sediment sampling was completed by the IM to confirm the information being obtained from analytical validation (Photograph 14). The sampling results are presented in Section 5.1.

Photograph 14: Sediment sampling on the pontoon.

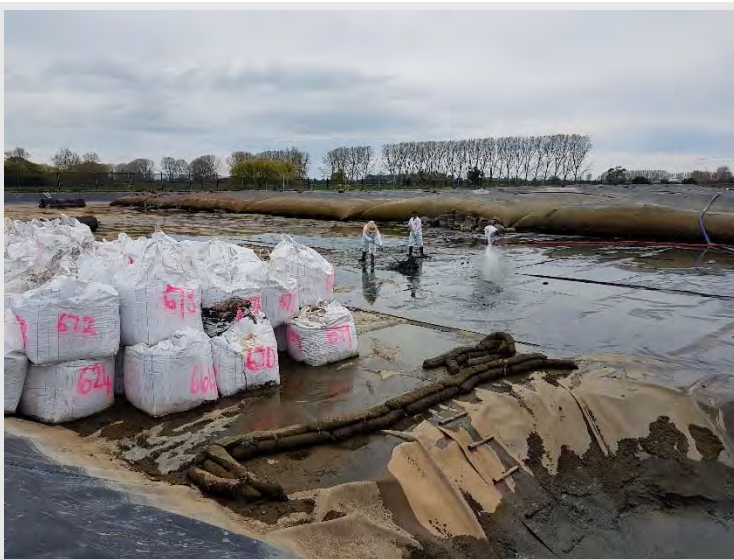
- As part of the shutdown in mid-September, cleaning of CS1 began using high pressure hoses and brooms (Photograph 15). The entire floor of the cell had been covered with 1 to 10 cm of sediment and a staged approach to cleaning the entire cell is underway.

- The floor of the CS1 cell is nearly entirely covered with 1 to 10 cm of fine sediment. This is being kept inundated with water to avoid airborne dispersal of dioxin-contaminated sediments. This material will be washed down and added to the bags upon the closure of the cell.

Photograph 15: Cleaning of the containment cell CS1 begins.

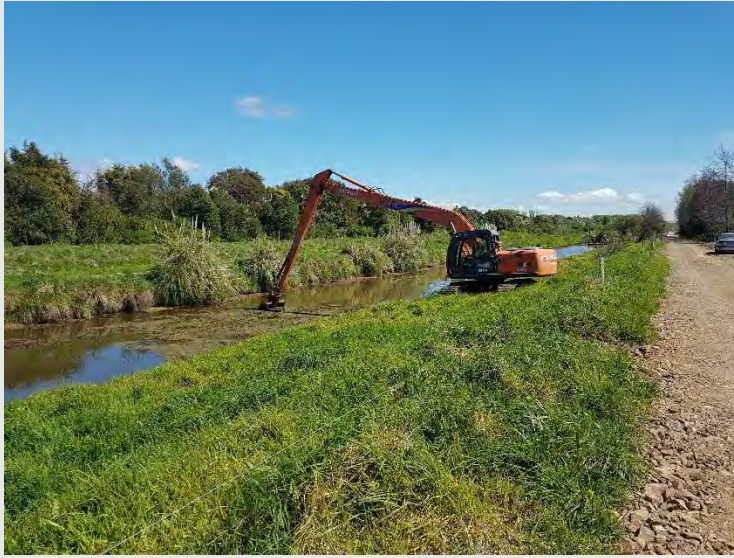
- Prior to dredging in Section 5 (Refer to the Site Plan in Appendix A), a weed cutter boat working in tandem with a long reach excavator removed weed from the canal in the lower (eastern) half of Section 5 (Photograph 22).

Photograph 22: Weed removal ahead of the barge.

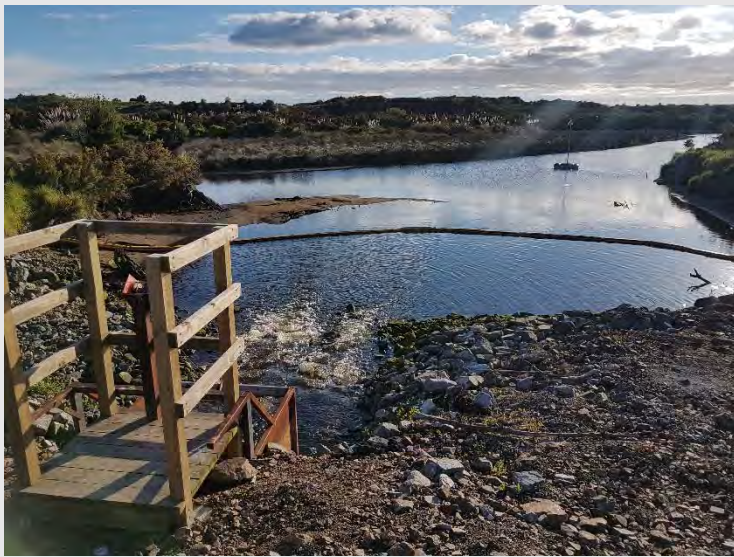
Photograph 23: FCS-East releasing water from the project area.
