Bay of Plenty Regional Council

Koapeopeo Canal Remediation

CLG Monthly Update Report

December 2018

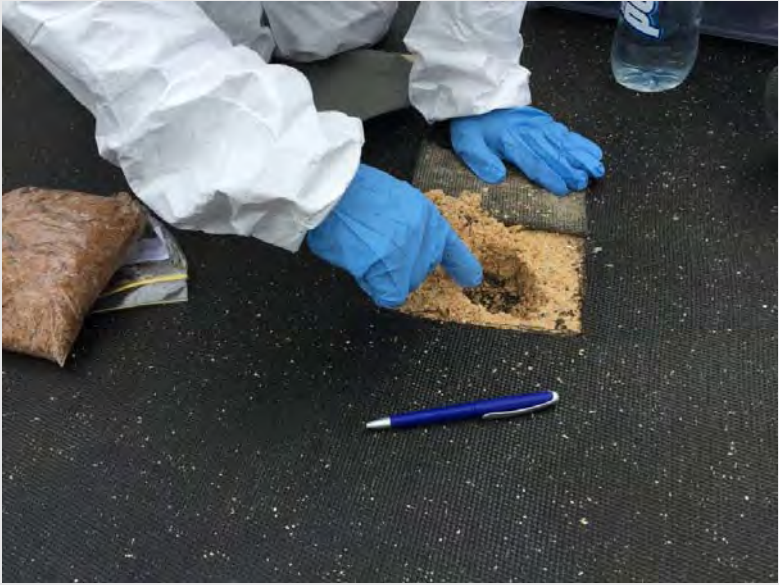
<p>Photograph 1: A hole is cut in the top of the sediment filled Geobag in CS1. The wood pulp layer that is put into the bag once the sediment is added is visible. This layer on the top of the bag provides the initial area for fungus to grow and begin the bioremediation process.</p>

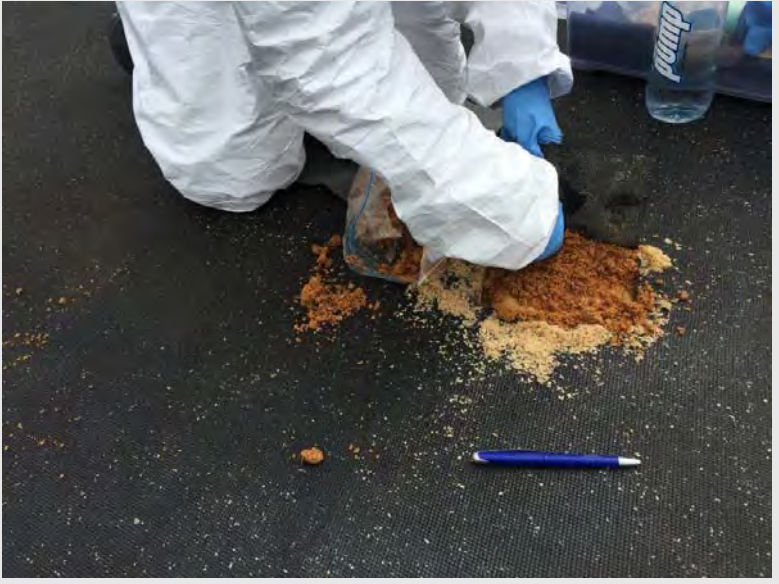
<p>Photograph 2: Fungus being added into the wood pellet layer on top of the filled Geobag.</p>

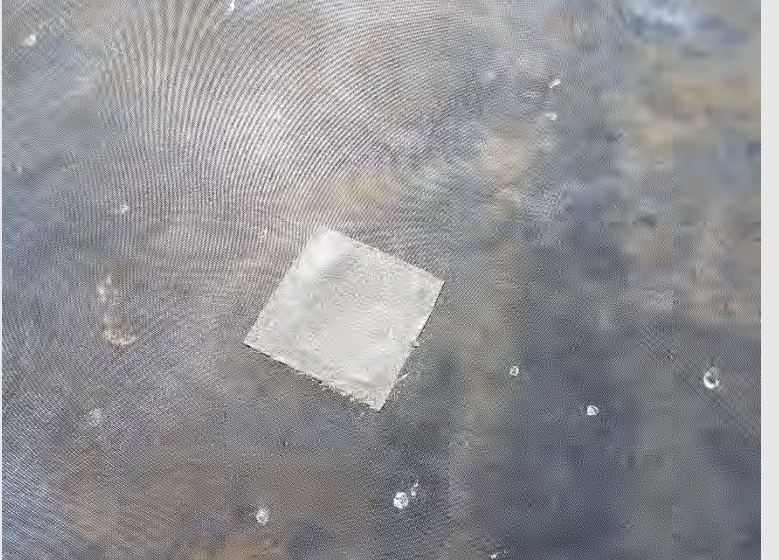
<p>Photograph 3: The hole in the Geobag is stitched up once the fungus has been added.</p>

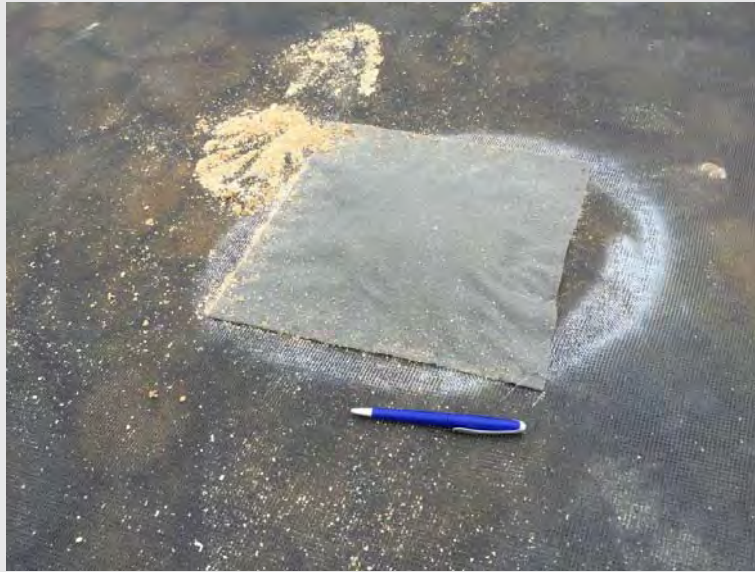
Photograph 4: Sealed up hole in the Geobag after the bioremediation team has completed the fungal addition. Bioremediation is now underway in this Geobag.

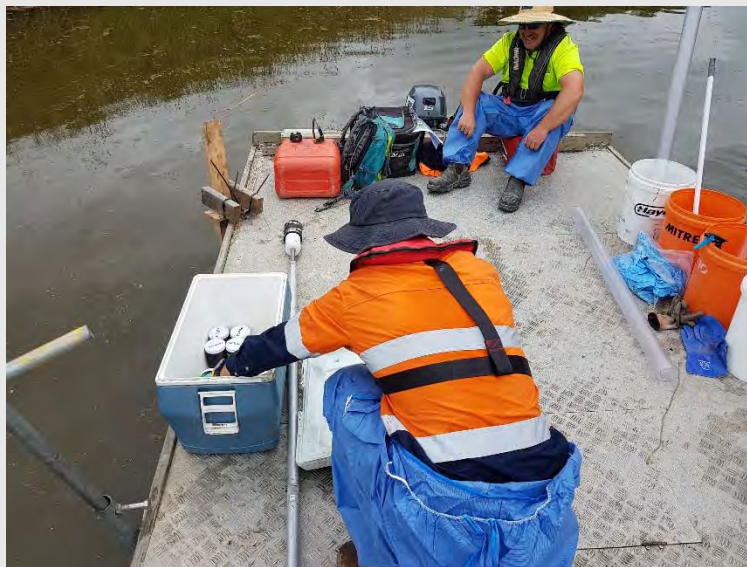
Photograph 5: Validation sampling in Section 5.

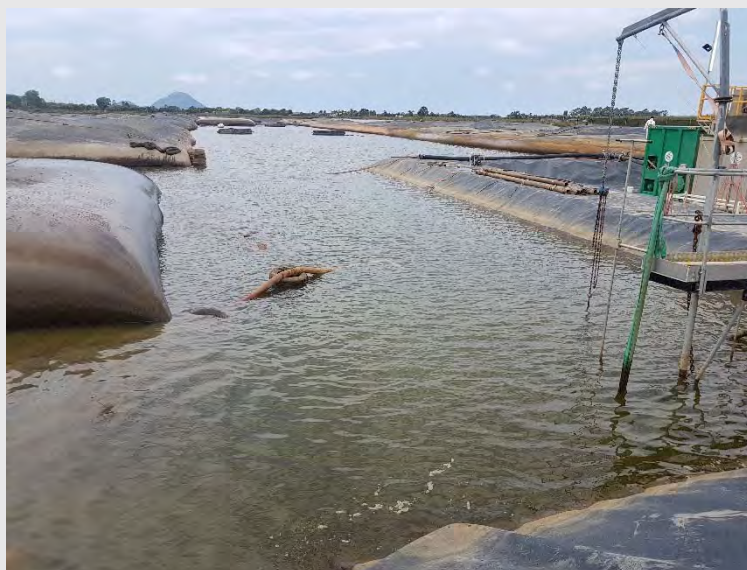
- The containment cell was left in a semi-flooded state for the Christmas shutdown (Photograph 6).

Photograph 6: CS1 left in a semi flooded state for the Christmas break.

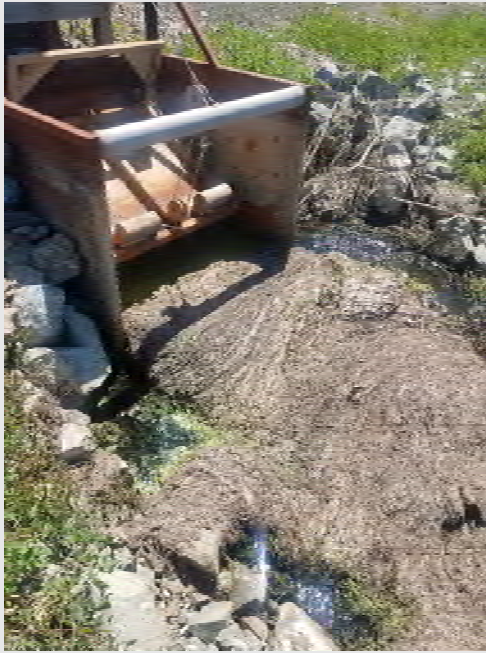
Photograph 7: Weed built up around FCS-East outfall.

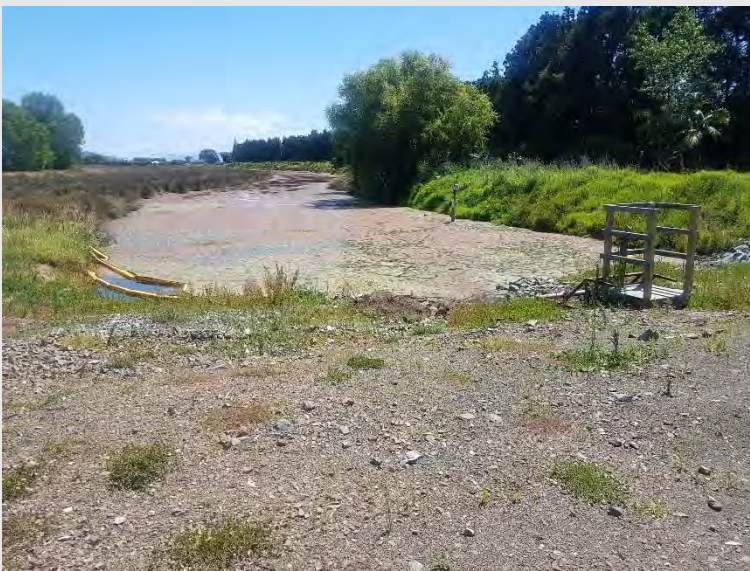
Photograph 8: Weed built up behind FCS-East.
