Bay of Plenty Regional Council

Koapeo Canal Remediation

CLG Monthly Update Report

November 2018

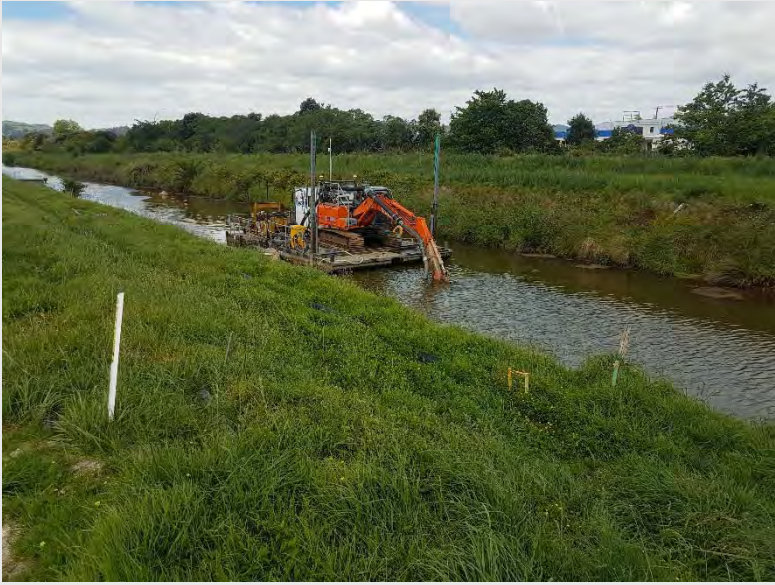
- The first pass dredging through Section 5 was completed and the dredge began redredging areas that failed chemical validation (Photograph 1).
- Geobags were rolled out in preparation for receiving sediment.
- Bulk bags of over-sized material are waiting to be lifted into the containment cell (Photograph 5).
- The entire floor of the cell had been covered with 1 to 10 cm of sediment and a staged approach to cleaning the entire cell is underway. The cell is being cleaned in the area of each new bag roll out (Photograph 2 & 6).

<p>Photograph 1: Redredging in Section 5 in early November 2018.</p>

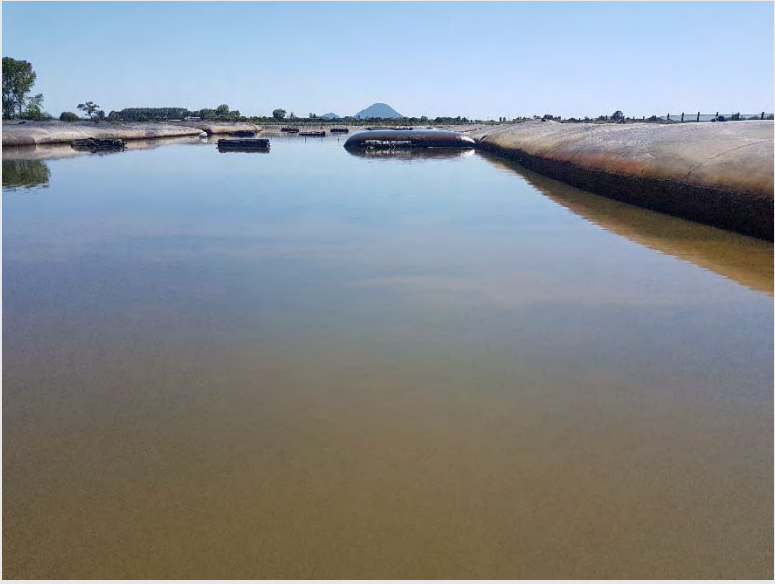
<p>Photograph 2: CS1 filled with canal water during early November 2018.</p>

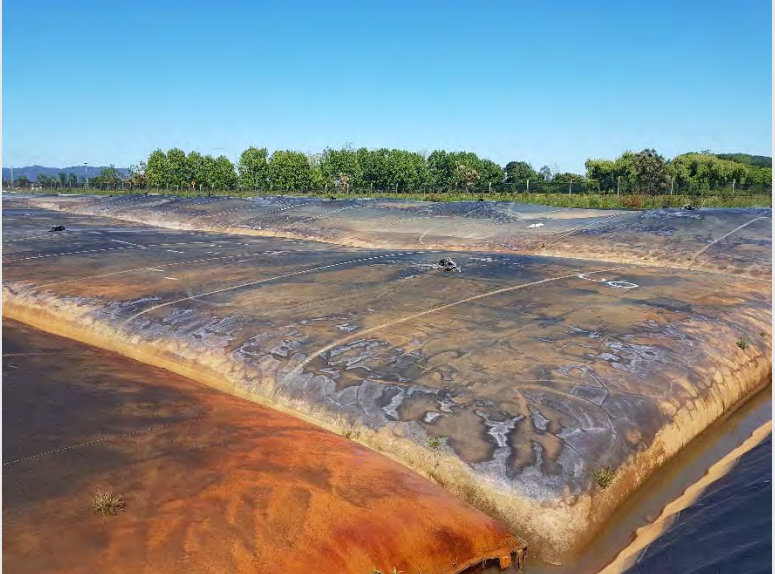
<p>Photograph 3: Filled Geobags sitting in CS1.</p>

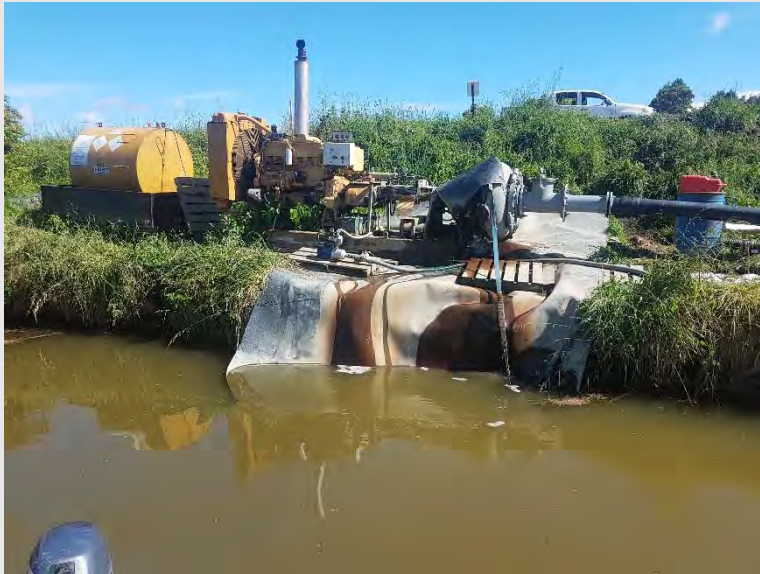
Photograph 4: Boost pump situated adjacent to Shaw Road.

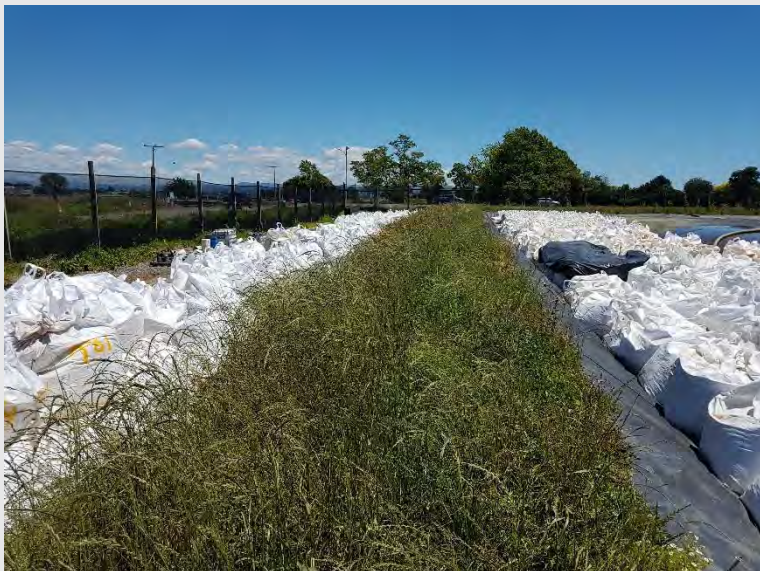
Photograph 5: Oversized material being stored before being lifted into CS1.

Oversized material coming off the water treatment plant as part of the sediment dredging process is being stored on site in one-tonne bulk bags. These bags are then crane lifted into the containment cell. Approximately 1050 bulk bags have been filled with oversized material to 31 November 2018.

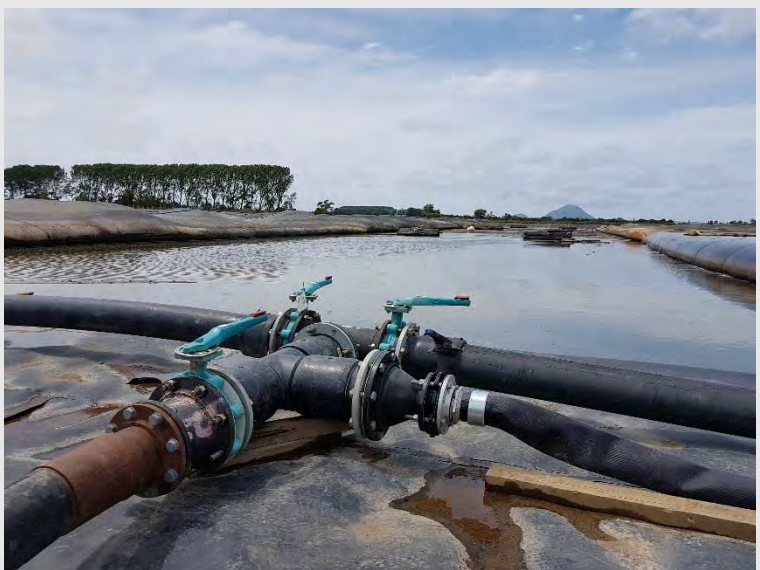
Photograph 6: CS1 during late November 2018.

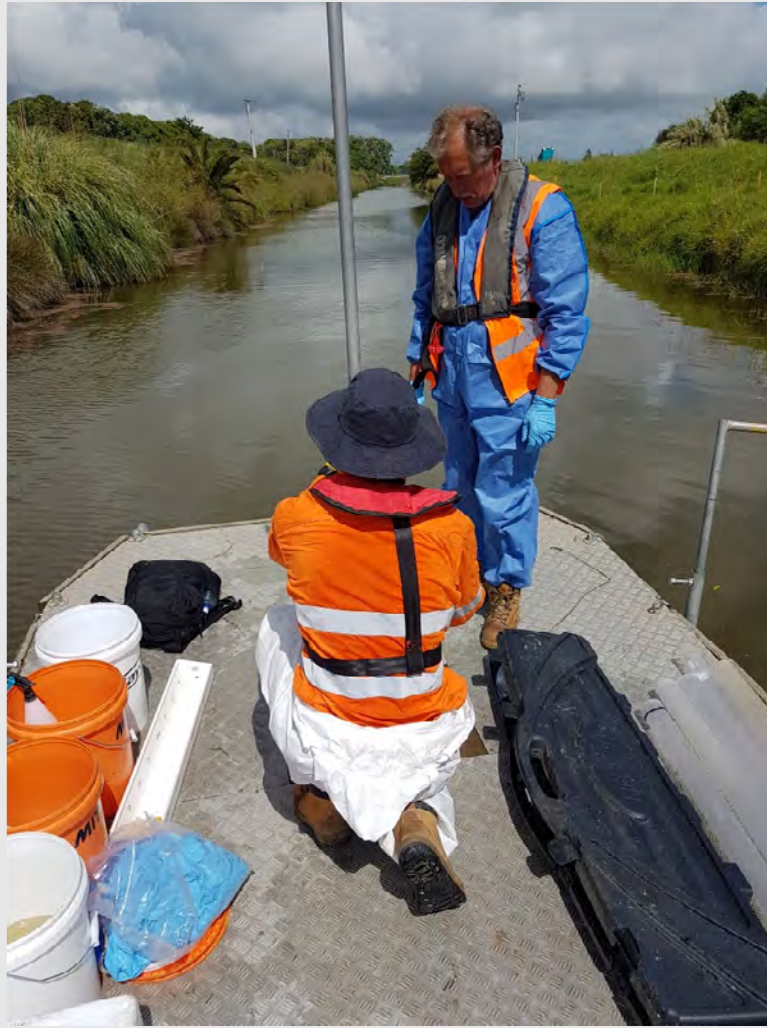
Photograph 7
Validation sampling on
the pontoon in mid
November 2018.

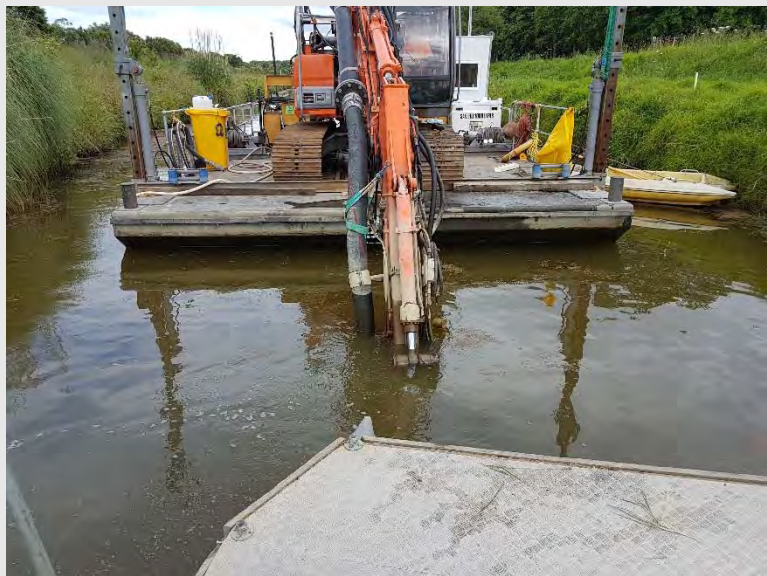
Photograph 8:
Sediment sampling
beside the dredge head
in Section 5.

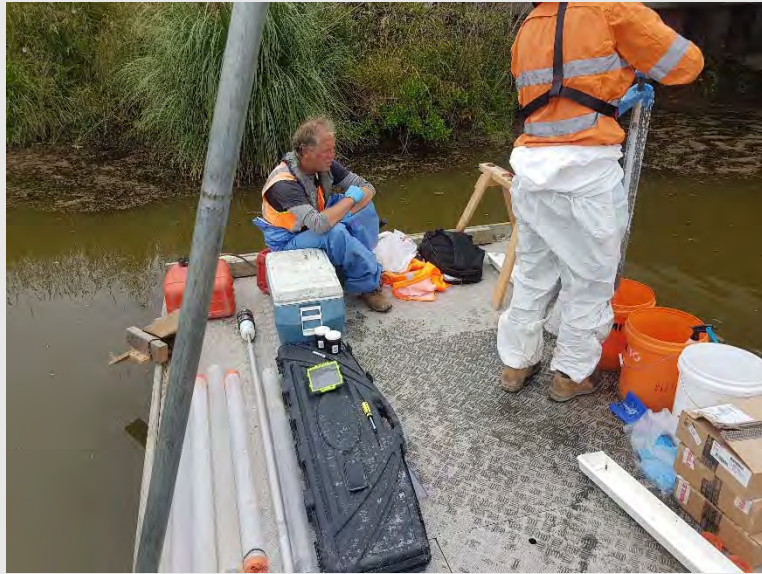
Photograph 9:
Validation sampling in
Section 5 in late
November 2018.

During November 2018, 36 validation samples were collected from behind the dredge within Section 5 (See Validation Plan in Appendix B). The Total PCDD/F (dioxin) I-TEQ Upperbound results were between 22 and 350 pg/g. Of the 36 samples analysed, nine had dioxin results between 72 and 350 pg/g, triggering the need for redredging in these areas in accordance with the EMVP. One sample had a dioxin result of 61 pg/g, which was accepted within the 95% UCL for the data set.
