Bay of Plenty Regional Council

Koapeo Canal Remediation

CLG Monthly Update Report

October 2018

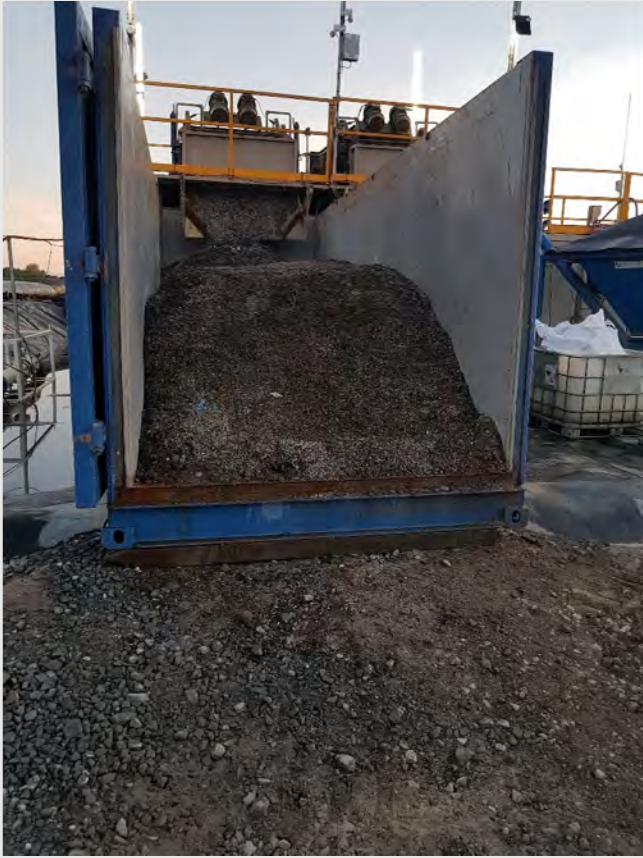
A photograph showing a large, dark, granular material overflowing from a blue metal bin. The material is piled high, reaching the top of the bin's walls. The bin is situated outdoors, and the background shows some industrial structures and a clear sky.	<p>Photograph 1: Oversized material filling up the overflow bin.</p>

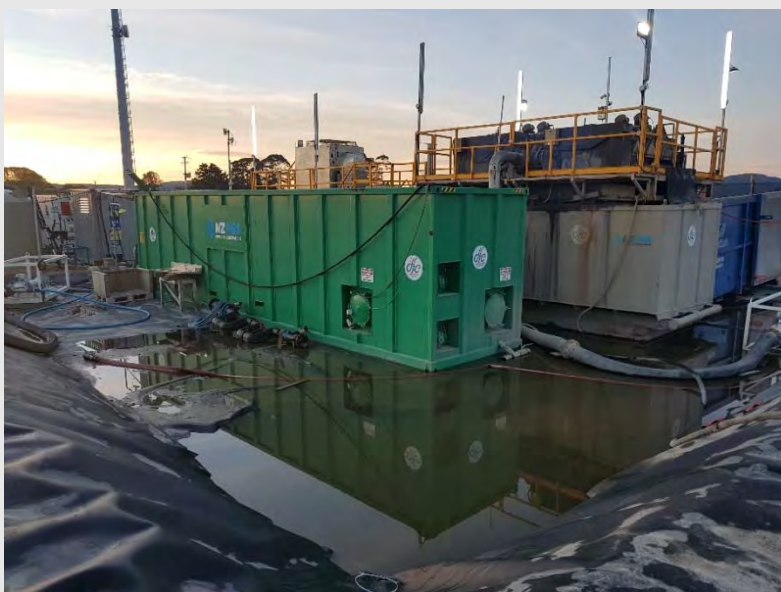
Photograph 5: Water
treatment plant with
water overflowing the
sump but kept within
the banded area.

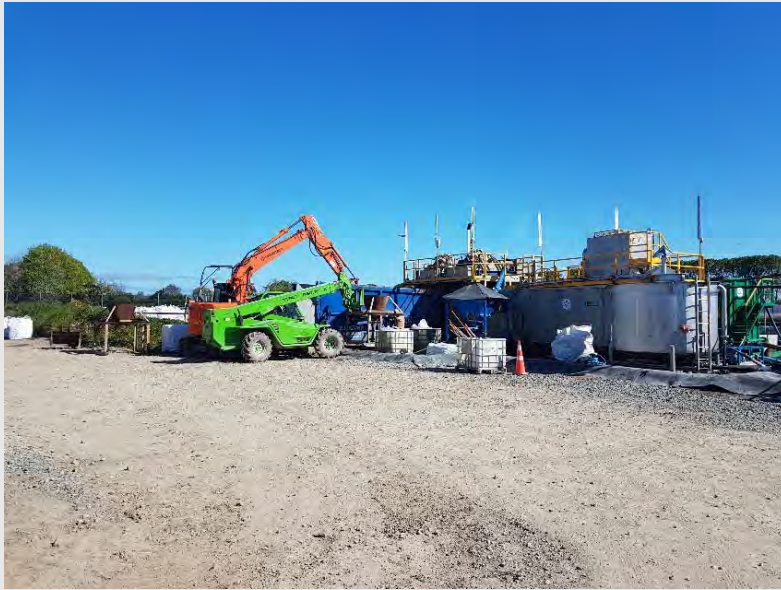
Photograph 6:
Excavator moving oversized sediment from the overflow bin into bulk bags.

A new large skip has been added to the oversized material process to better manage large inflows of material that had previously overwhelmed the smaller bulk bags. This skip bin provides a contained overflow area that is easier to clean than the bunded area surrounding the water treatment plant. During October, this bin was emptied twice using an excavator that placed the material into bulk bags (Photograph 6 in Table 1: Photograph Progress Log).

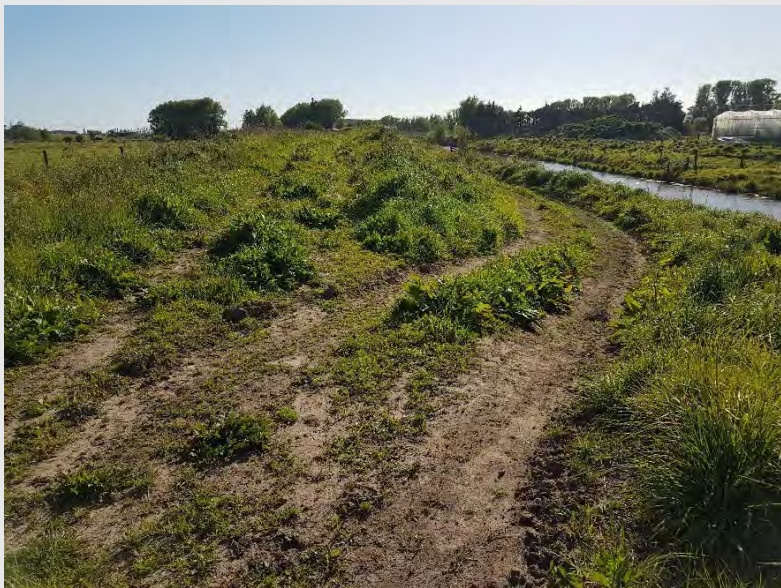
Photograph 7:
Revegetation along the canal bank between SH30 and Paroa Road.

During the winter months, topsoil had been disturbed along the true left bank of the canal between Paroa Road and SH30. This area is being monitored and vegetation appears to be growing well since the area stopped being trafficked by project vehicles. The area directly adjacent to the booster pump may need to have grass seed applied once the pump is removed in January 2019.

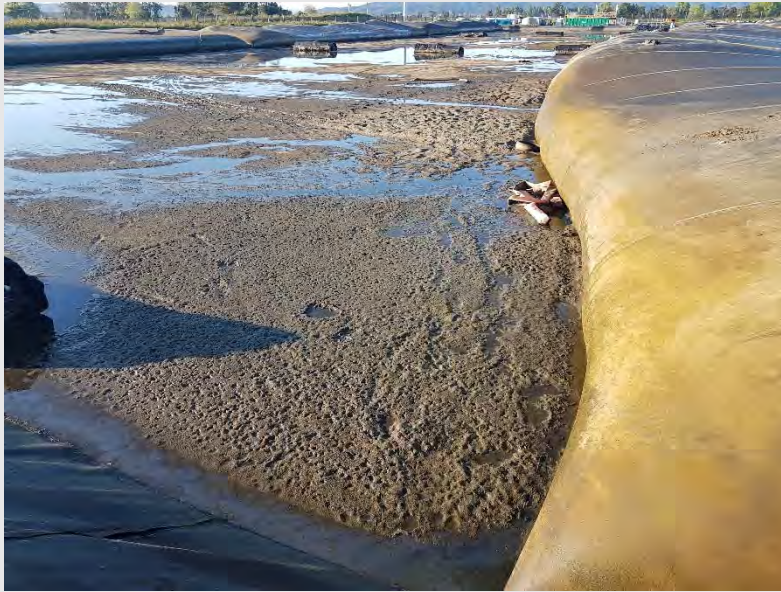
Photograph 9: Sand sitting in the containment cell is visible when the water level is dropped to allow access into the cell.

Sediment has been spilled in the containment cell multiple times over the last eight months and on each occasion, the IM and project team have both requested that this material be cleaned up. While it is not a dust risk due to the cell being kept flooded, there is a risk that sediment-laden water could be released from the cell into the Kopeopeo Canal. The cell is being cleaned using pressure jets and brooms with the material being recirculated into the Geobags and contained. The cleaning is focusing on the areas beneath each new Geobag that is rolled out. This is good progress, but given the volume of sediment spilled in the cell, it will be required on an ongoing basis.

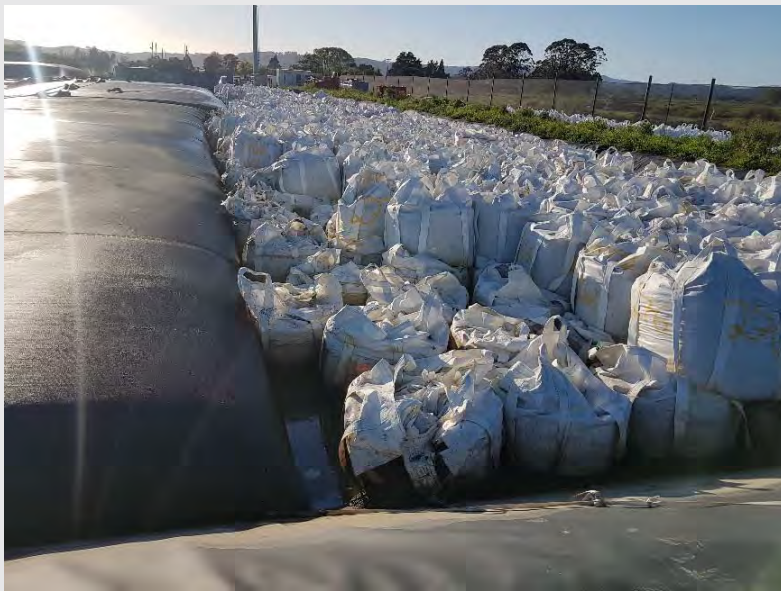
Photograph 10: Bulk bags stored within the cell. The closest one is damaged.

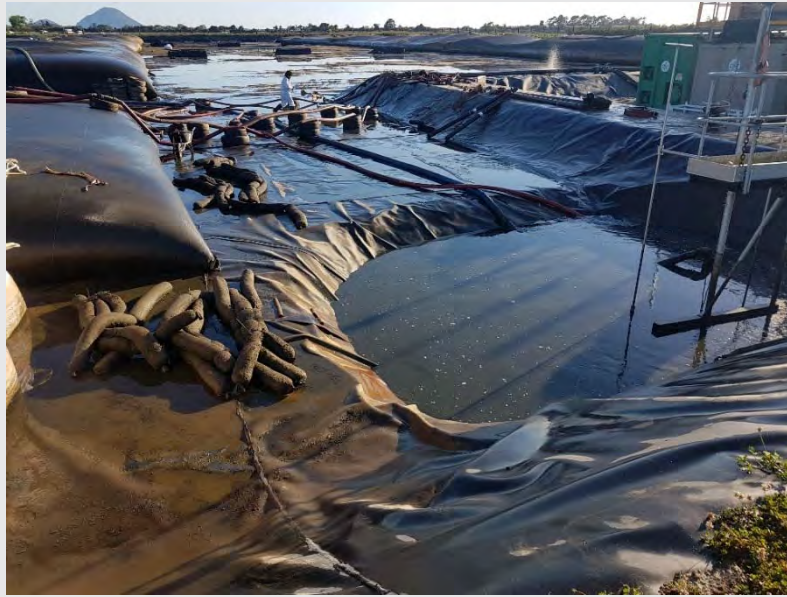
Photograph 12: The sump has had the built up sediment removed.
