Bay of Plenty Regional Council

Koapeo Canal Remediation

CLG Monthly Update Report

August 2018

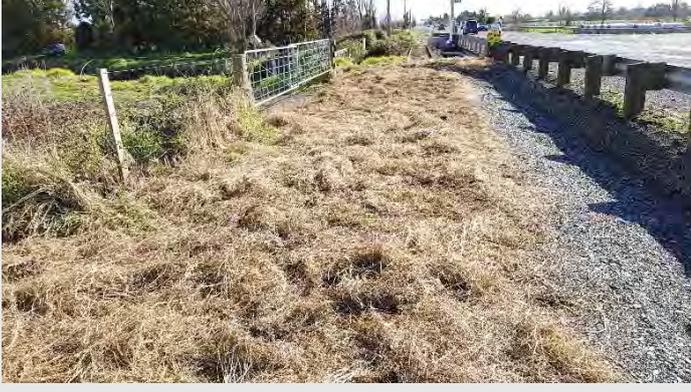
A photograph showing a long, narrow channel of water or mud. On the right side, a concrete curb is visible. A large pile of dry, brown grass or hay is laid out along the curb, intended to promote revegetation.	<p>Photograph 2: Bailage lain down beside the SH30 road bridge to promote revegetation.</p>

Topsoil was disturbed beside the SH30 road bridge by vehicles accessing the area and by works associated with another project. This area has been covered in baillage to promote revegetation and minimise dust generation risk.

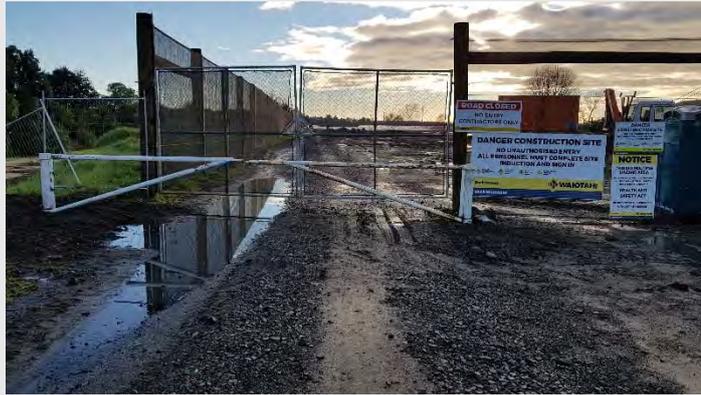
- New shade cloth and fencing was installed at CS3 (Photograph 1).
- A new forestry gate was installed across the main entrance gates to CS3 in response to a vehicle ramming the existing wire mesh gate. Following the installation of the new gate, the area of the stopbank that had been disturbed was covered with clean soil (Photograph 5 & 6).
- The CS3 cell is to be kept flooded with rainwater to minimise risk of wind damage to the HDPE liner.

Photograph 5: New forestry gates installed at CS3 after a vehicle rammed the original gate.

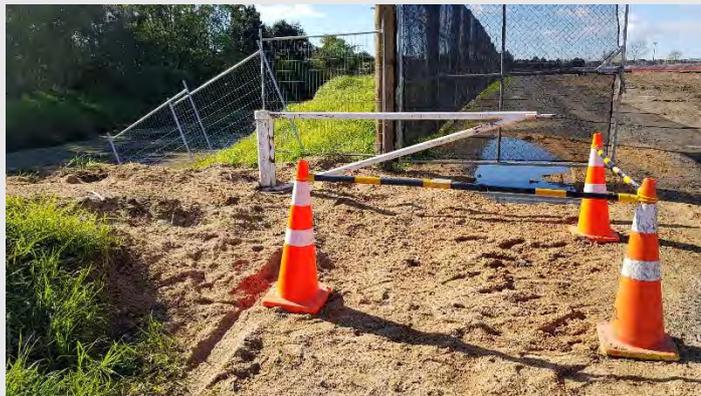
Photograph 6: Clean soil placed over the top of the potentially contaminated stopbank material disturbed during the gate installation.

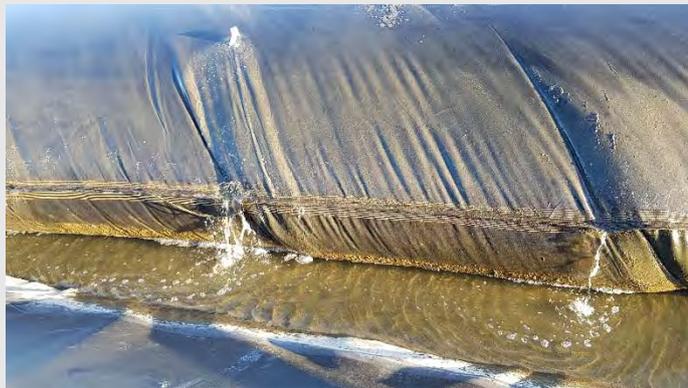
- A small (<10 cm) hole was discovered in one of the geobags. Geofabrics Limited were contacted to provide a methodology for undertaking the repair (Photograph 11 & 12).

Photograph 11: A hole discovered in one of the geobags in CS1.

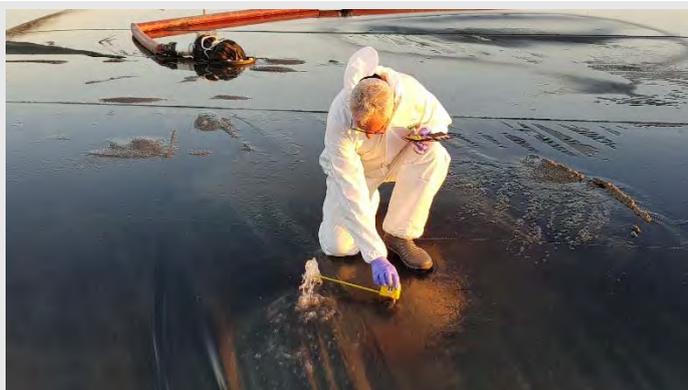
Photograph 12: Checks of the geobag damage and coordination with Geofabrics Limited as to the best methodology for repair.

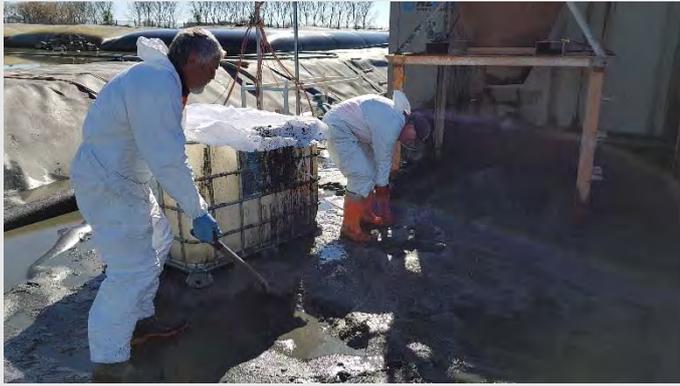
- Due to heavy sands being picked up by the dredge, the oversized screens on the shakers have sometimes become overwhelmed with material and overflowed into the bunded area around the water treatment plant. This material then has to be manually removed and the area cleaned (Photograph 13).

Photograph 13: Clean-up of sediment from within the CS1 water treatment area bund after an overflow due to dredging into heavy sands.

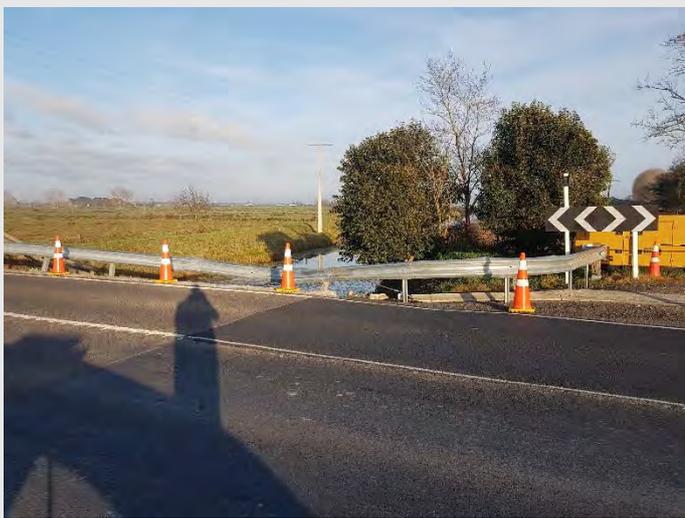
- The road bridge barrier on SH30 opposite CS1 was extensively damaged when a member of the public crashed into it. This was observed by the project team; however, the driver drove off as they were calling emergency services (Photograph 18).

Photograph 18: Traffic barrier on SH30 was damaged after a member of the public crashed into it.

A member of the public crashed into the SH30 road bridge barrier outside of CS1 after crossing the centre line and narrowly missing an oncoming car. A member of the project team was on site and went to assist the woman who crashed, but as the team member moved away from the vehicle to call for help, the driver drove away.

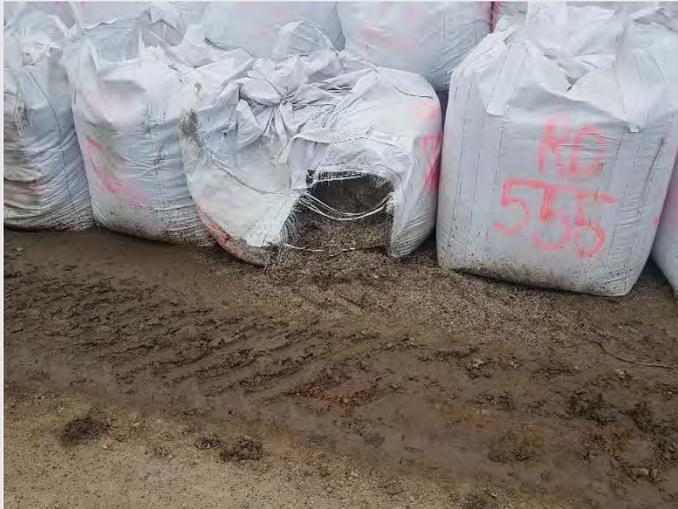
- A bulk bag was damaged while it was being stored in CS1 and it spilled oversized sediment (Photograph 20). The material was picked up and placed into a new bulk bag.

Photograph 20: Damaged bulk bag spilling oversized sediment.

One bulk bag was damaged as it sat awaiting the crane lift into the containment cell (Photograph 20 in Table 1: Photograph Progress Log). The material that spilled from the bag was collected, placed into a new bulk bag, and crane lifted into the containment cell.

27.1 – 27.2	Complaints Register	Yes	Complaints register reviewed (Section 4.10).
28.1 – 28.5	Spill Prevention & Response	Yes	One bulk bag was damaged as it sat outside the containment site awaiting a crane lift. The material that spilt was scraped up and placed into a new bulk bag. Photograph 20 in Table 1: Photograph Progress Log shows the spill.

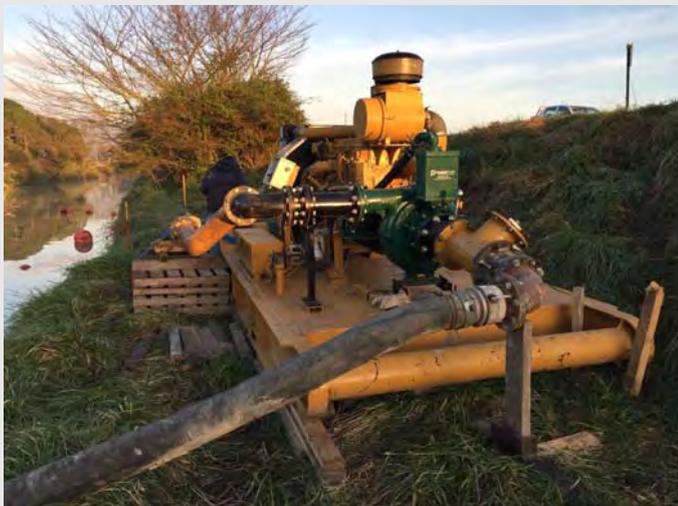
- Dredge began removing sediment from Section 5 (Photograph 19).
- A new boost pump was installed at Shaw Road and then broke a few days later (Photograph 21). This required parts are to be flown in from Australia.

Photograph 21: New booster pump installed adjacent to Shaw Road.
