The Mt Maunganui terminal site³

Incident

Cause of the discharge

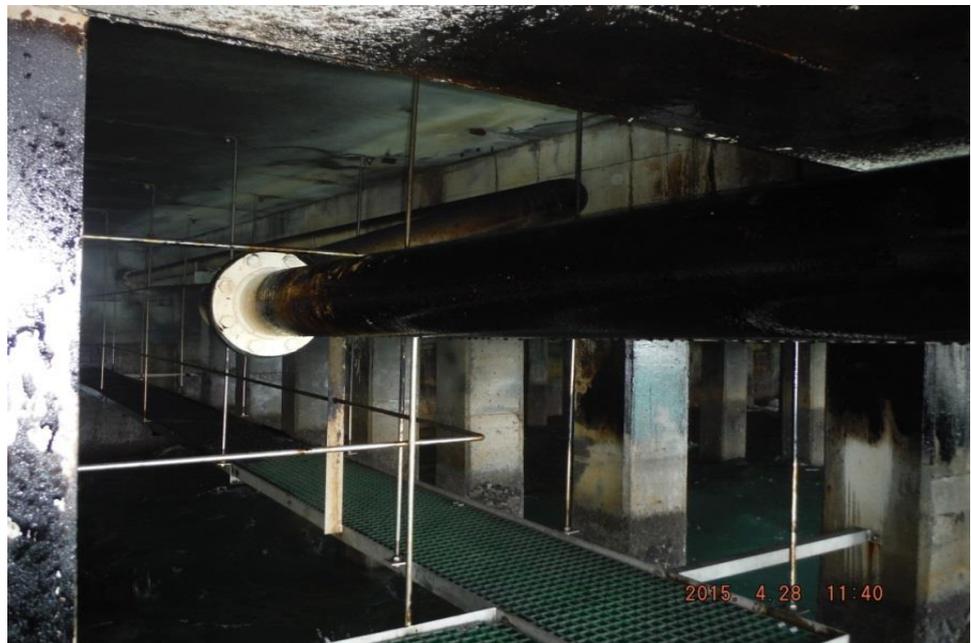
32. After his discussion with the Terminal Manager and contractors about custody of the lateral pipe following its removal, Mr Holst took the following photograph of the damaged section of lateral 1340 in situ, beneath berth 8.

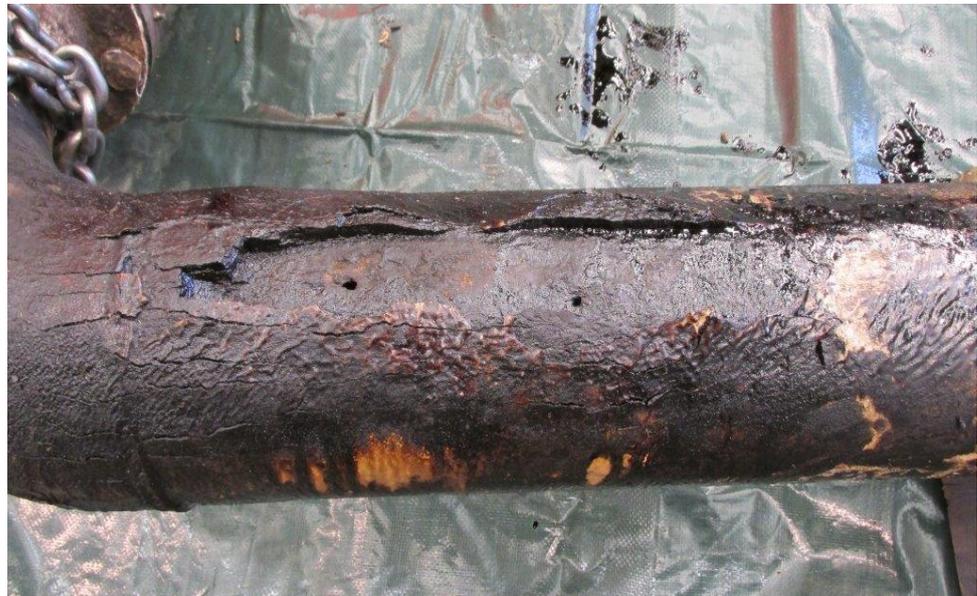
35. The HFO escaped from two holes in lateral 1340, one of which was measured to be 4mm in diameter and the other which was measured to be a 8.5mm x 5.8mm elongated hole (as shown in the following photograph).⁸

36. The holes were caused by corrosion initiating and progressing under the pipe coating on the external pipe surface.
37. Council's corrosion expert, Les Boulton of Les Boulton & Associates Limited, and Mobil's corrosion expert from Aurecon Limited, inspected the failed lateral.

38. Mr Boulton concluded:

- (a) As the lateral pipe was located just above the high tide level, it is likely that contaminants (e.g. sea salts and grime) may have gained ingress under the coating after the external paint cracking had initiated.

- (b) The corrosion mechanism occurring under the paint coating was mainly surface corrosion but as differential aeration conditions prevailed, crevice corrosion occurred. Crevice corrosion is insidious and it is also more rapid than general corrosion on steel.

- (c) The appearance of the corrosion perforations indicated that both the pipe wall holes resulted from thinning of the pipe wall before failure (perforation) of the pipe wall.

- (d) The external pipe coating (three paint layers) had delaminated from the steel pipe wall due to underfilm corrosion occurring after the coating had become weakened due to cracks in the paint slowly developing.

- (e) Crevice corrosion initiated on the external surface of the lateral pipe and the dense black corrosion product (magnetite) was trapped under the external coating adhering to the external steel pipe wall.

- (f) The volume expansion of the corrosion product (magnetite) formed under the coating resulted in the paint becoming weaker, thereby extending the cracking in the coating. Eventually, the paint cracking became severe, underfilm corrosion was exacerbated, and the corrosion on the steel pipe surface accelerated until the pipe wall strength was compromised at two localised areas where the holes subsequently formed. It appears that pressurised oil sprayed out of the two lateral pipe perforations onto the concrete beam above the lateral pipe and onto surrounding structures and then the HFO escaped into the harbour.

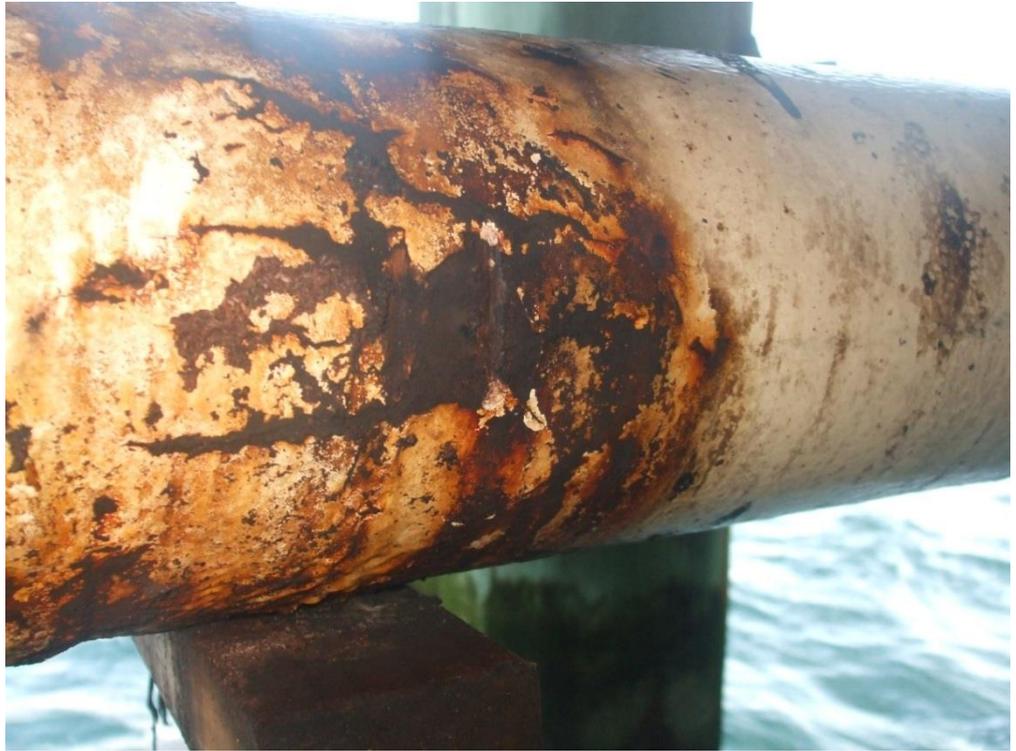
56. The Council engaged a pipe expert Roy Askham of Inspec Limited, to inspect and assess the condition of Mobil's lateral line pipe work at the Port in May 2015. On 26 May, Mr Askham inspected four randomly selected lateral pipes and found visible external corrosion in all four (ie 975, 998, 1060 and 1244). The following photograph of the 1244 lateral and was taken by Mr Askham on 26 May 2015.¹¹

57. Following Mr Askham's inspection, he reported to Council that:
- (a) These pipes were all in the splash zone of the incoming tide.
 - (b) The rusted piping in all four areas he inspected should be replaced.
 - (c) The remainder of the lateral pipes should be subjected to a thorough visual inspection by a qualified inspector and then replaced or subjected to additional testing on a case by case basis.
 - (d) Wherever scale corrosion was present it had to be removed as it will cause a more aggressive degradation to the pipe material.

58. Mobil's experts, Aurecon, responded to Mr Askham's report, stating:
- (a) They agreed with Mr Askham's factual observations of the lateral pipes, namely, that the pipeline has suffered from corrosion of a particular nature under a coating that has reached the point where maintenance is required.
 - (b) They disagreed with Mr Askham's view that the condition of the pipeline laterals justified their entire replacement.
 - (c) Mobil should assess the need to retain each lateral and maintain or replace sections of the pipe only where this is justified.

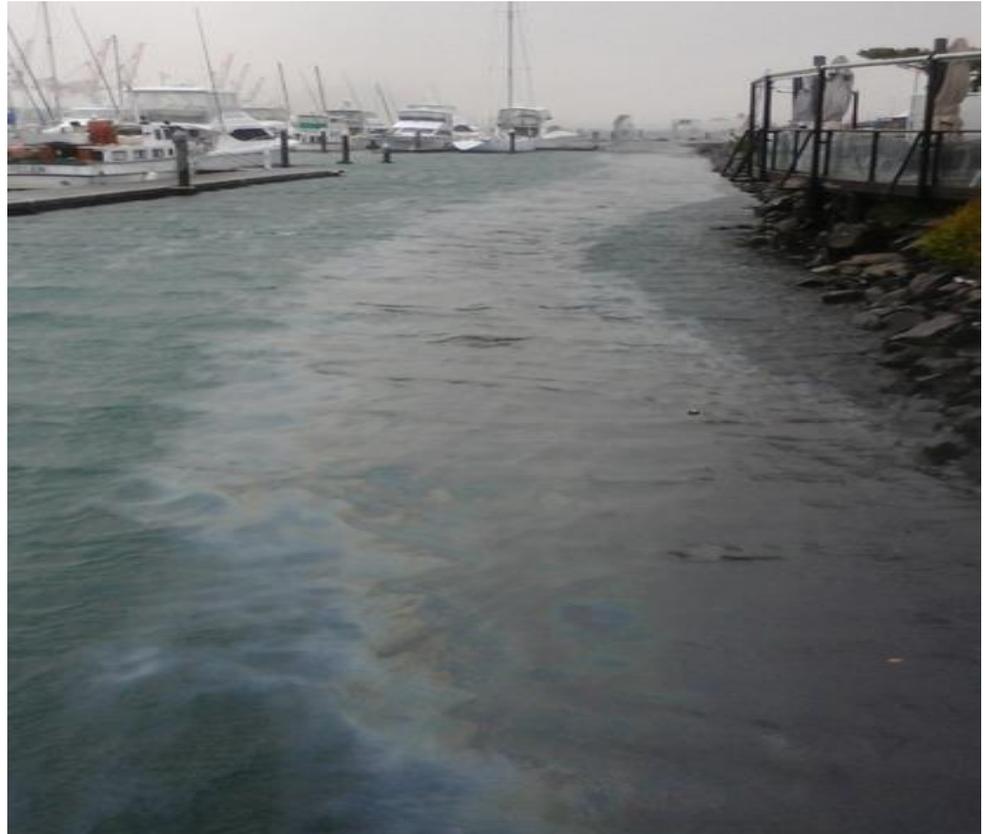
64. The oil initially affected Tauranga Bridge Marina, as shown in the following photograph taken on 27 April.

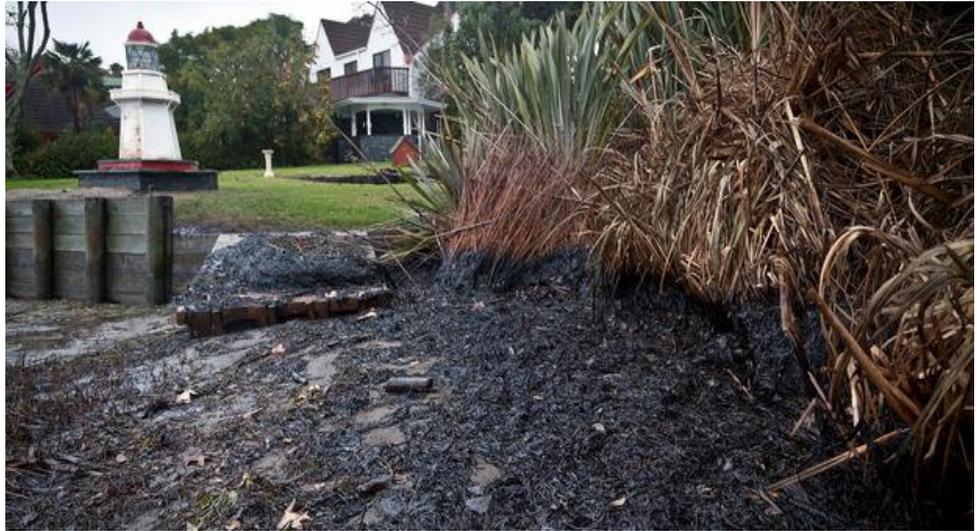
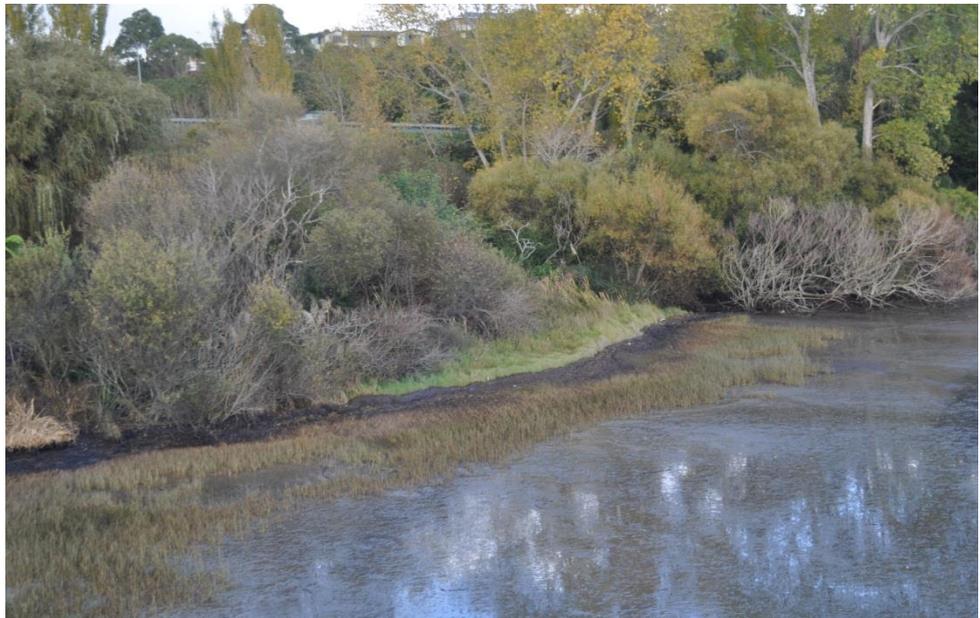
67. The following photographs show oil on the shore at Maungatapu, approximately 8 kms south of lateral 1340, on 28 April.
