Bay of Plenty Regional Council
Kopeopeo Canal Remediation
CLG Monthly Update Report

January 2019

Executive summary

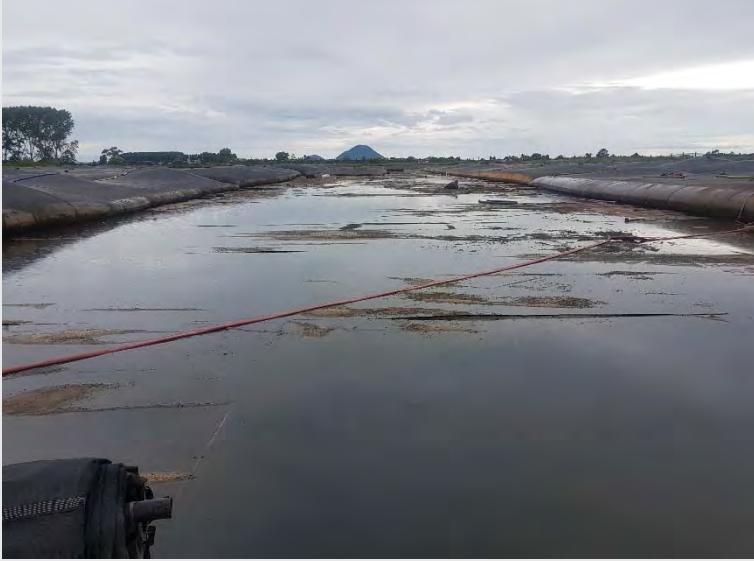
A wide-angle photograph showing a large, rectangular containment cell filled with water. The cell is bounded by black plastic sheeting. A red hose lies across the water surface. In the background, there are trees and a small hill under a cloudy sky.	Photograph 3: CS1 containment cell in mid-January awaiting clean up.

Small volumes of sediment have been spilled in the containment cell multiple times over the last 12 months and on each occasion; the IM and project team have both requested that this material be cleaned up. As the cell floor has been covered with water during the filling of the Geobags in CS1, the generation of dust was not likely. However, as January had very low

rainfall, the layer of water that was in the base of the containment cell has evaporated. Beneath this layer of water is a layer of contaminated sediment approximately 1 to 20 cm thick that has accumulated over the previous 12 months. While this material constitutes a minor portion of the total sediment volume safely deposited within the Geobags, it has dried out and as such, this may breach Bay of Plenty Regional Council Resource Consent 67173-AP Condition 40.1 which states that sediment must be kept wet until the time it is covered and stabilised. It is acknowledged that this consent condition was created to manage the dust generation risk under the originally consented excavate and truck method, and as the material is wet pumped directly into the Geobags it has largely been superseded. The condition is beneficial however in that it provides a control to mitigate potential risks of dry sediment in the containment cell being released to the environment in windy conditions. Recent inspections of the material in the base of the cell by the IM field observer did note that it has a hard crust that made it unlikely to generate dust, even in windy conditions. There has been no observed dust released as a result of wind action and there has been no regular site work at CS1.

The IM has issued a request to the project team and the principal contractor asking for the material to be cleaned up or covered with water again. The IM also raised the dust generation risk for any workers involved in the clean up. The material should be disturbed only once it has been damped. The cell is being cleaned using water and brooms with the material being recirculated into the Geobags and contained.

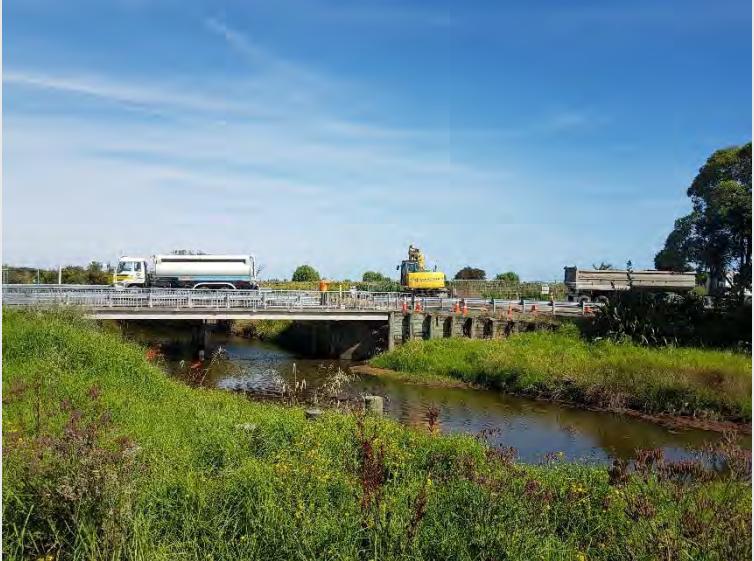
A photograph of a road bridge crossing a river. The riverbank is covered in green grass and some yellow flowers. A white truck is driving on the bridge. In the background, there are trees and a clear blue sky.	Photograph 4: Keepa Road closure. Closure was not due to KCRP.

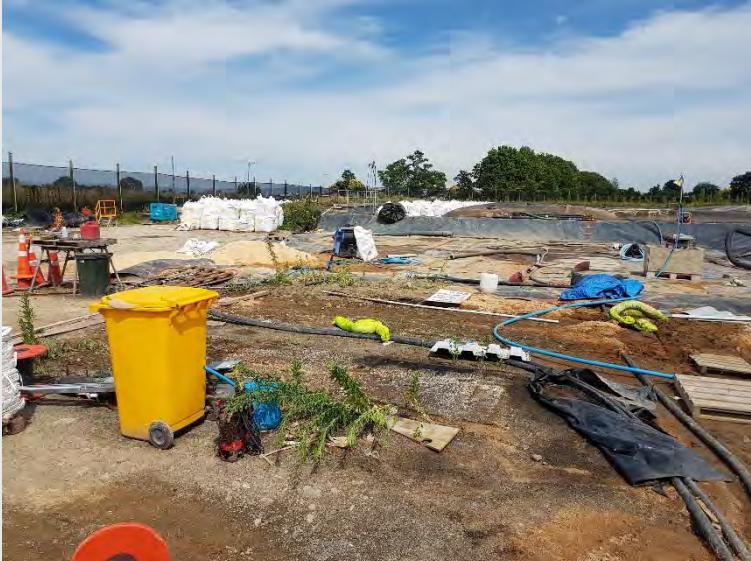
<p>Photograph 8: CS1 during equipment move.</p>

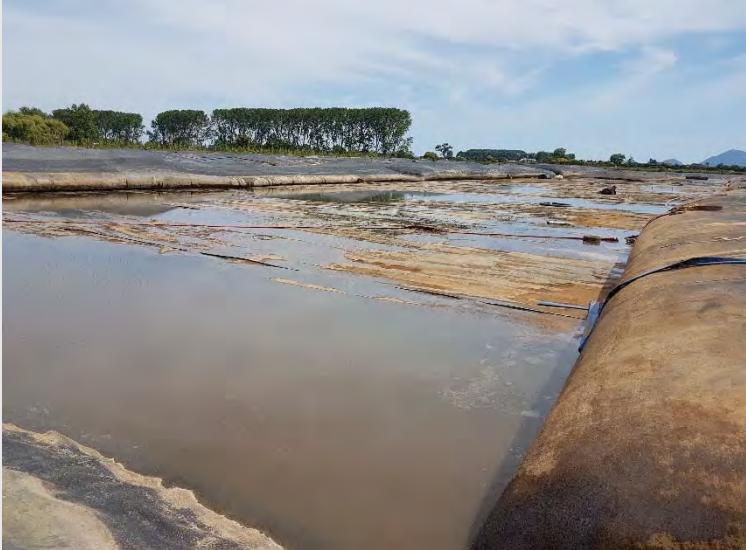
<p>Photograph 9: CS1 containment cell.</p>

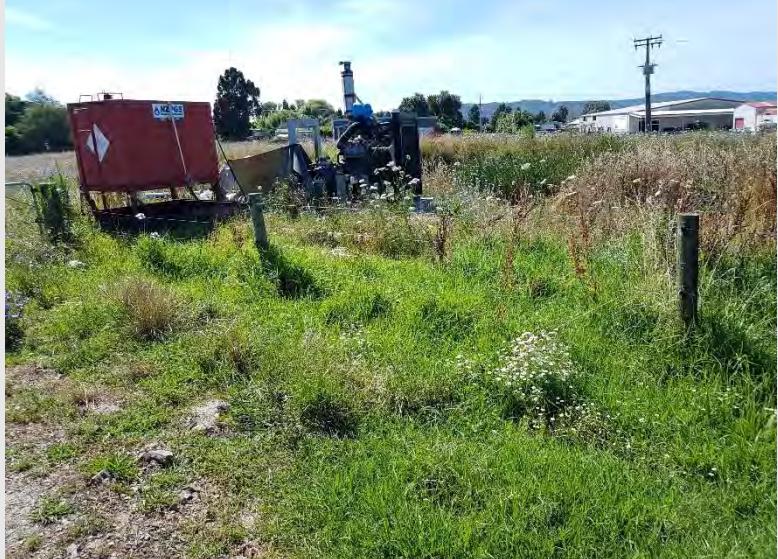
<p>Photograph 12: Boost pump at Paroa Road awaiting removal.</p>

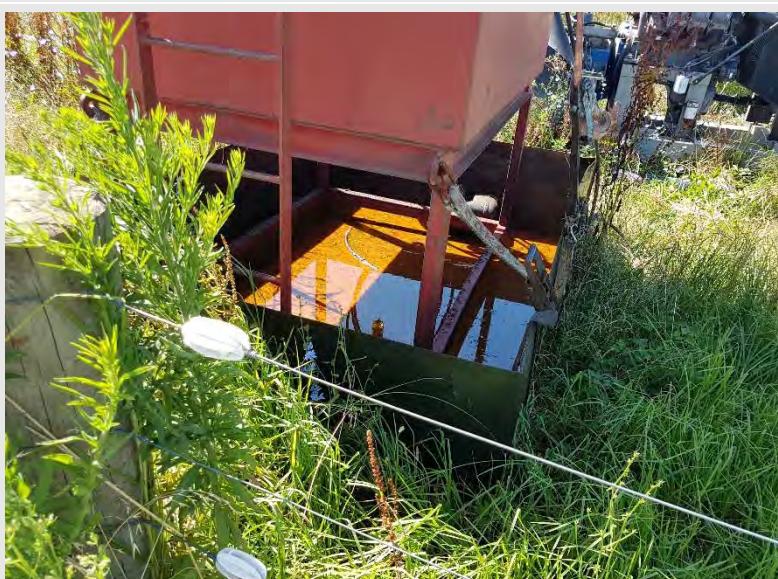
- A crane removed the Shaw Road boost pump (Photograph 10).
- The Paroa Road boost pump remains in place. The liquid in the bund beneath the fuel tank will require sucker truck removal before it can be moved (Photograph 12 & 13).

<p>Photograph 13: Water in the bund beneath the fuel tank of the Paroa Road boost pump requiring sucker truck removal.</p>

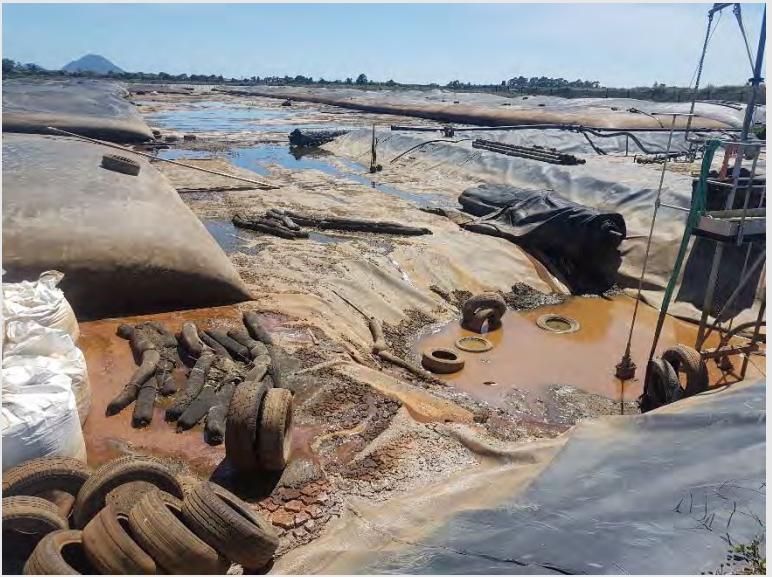
<p>Photograph 17: CS1 sump awaiting clean up. Note the dry sediment within the containment cell as water levels are very low.</p>

40.1 – 40.7	Dust Management	No	The containment cell at CS1 is currently dry and contains sediment that has been spilt over the last 12 months. While there is a hard crust to the sediment that makes dust generation unlikely, it is not being kept wet and as such, it may breach Consent Condition 40.1.

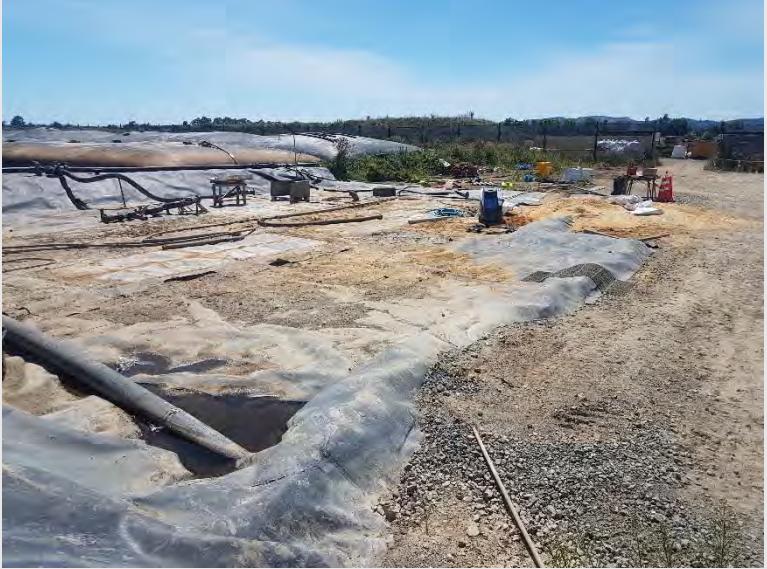
<p>Photograph 18: CS1 water treatment area awaiting clean up.</p>

CS1 requires tidy up and cleaning ahead of closure. The Principal Contractor (ESL) has stated that this clean up will be completed by the end of February 2019.

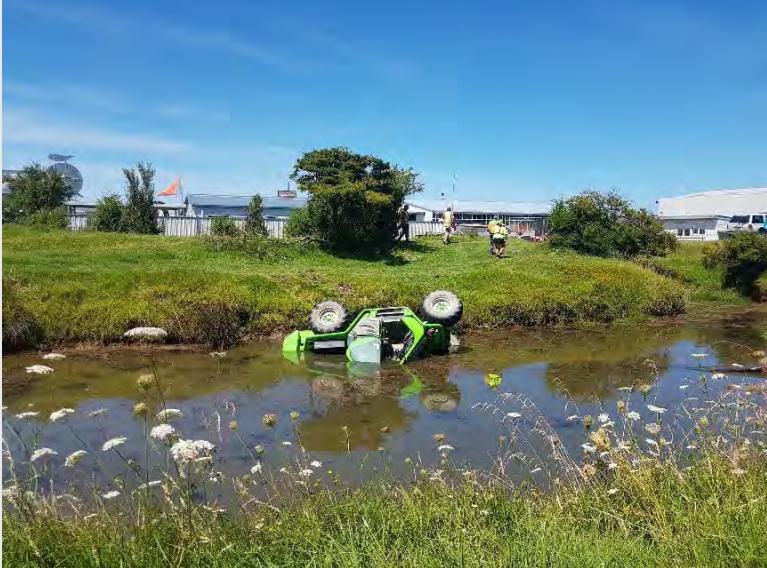
- An articulated forklift (Merlo) overturned into the Kopeopeo Canal on 22 January 2019. (Photographs 19 – 25). Two cranes were used to remove the vehicle and no one was injured. An investigation is ongoing and will be reported on once it is provided to the IM.

<p>Photograph 19: Merlo overturned in the canal near Keepa Road on 22 January 2019.</p>

An articulated forklift (Merlo) overturned into the Kopeopeo Canal on 22 January 2019. No one was injured and the incident has been reported to WorkSafe New Zealand. Two cranes were used to remove the vehicle. An investigation is ongoing and will be reported on once it is provided to the IM.

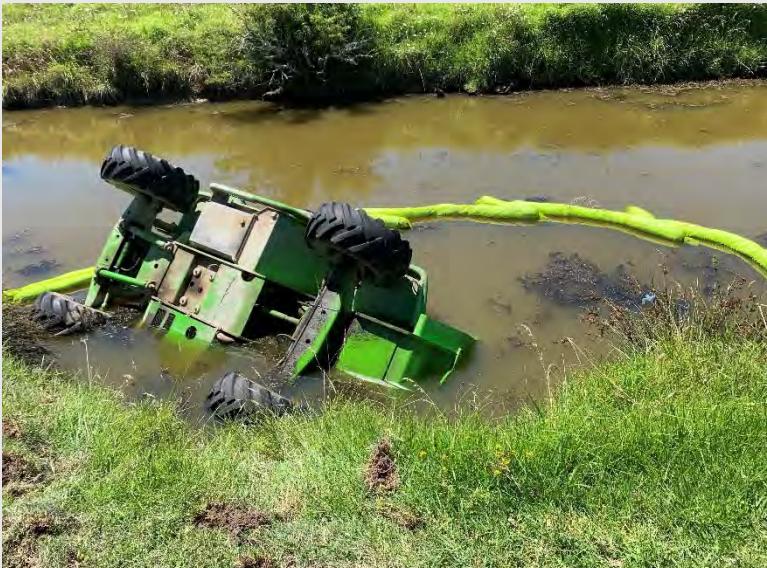
<p>Photograph 20: Merlo overturned in the canal near Keepa Road on 22 January 2019.</p>
