Bay of Plenty Regional Council

Koapeopeo Canal Remediation

CLG Monthly Update Report

February 2019

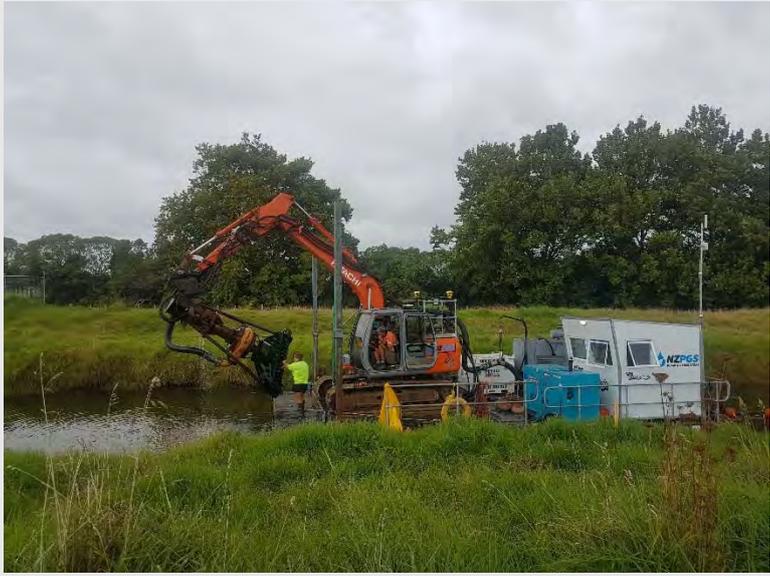
<p>Photograph 1: Dredge operating in Section 6. The dredge head is being checked for blockages in this photo.</p>

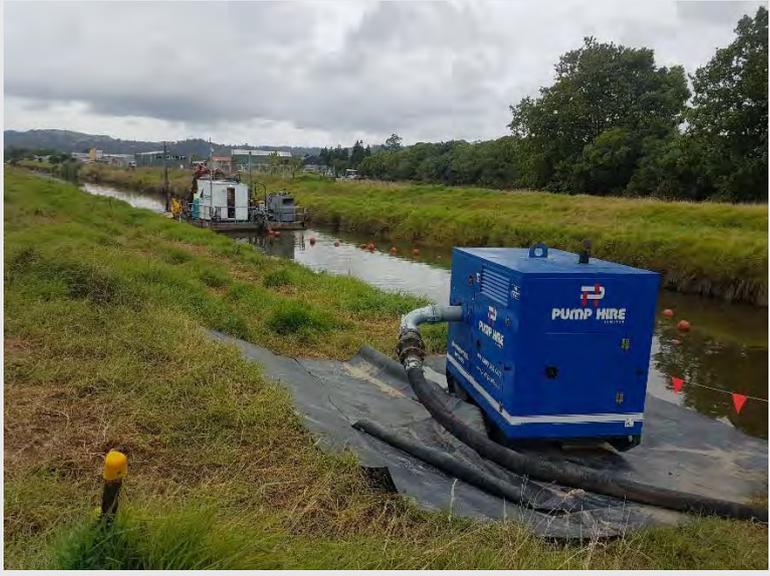
- Two boost pumps are operating along Kope Canal Road to move sediment to CS3 (Photographs 2, 4 and 5).

<p>Photograph 2: One of the boost pumps in the foreground with the dredge working along Section 6 in the background.</p>

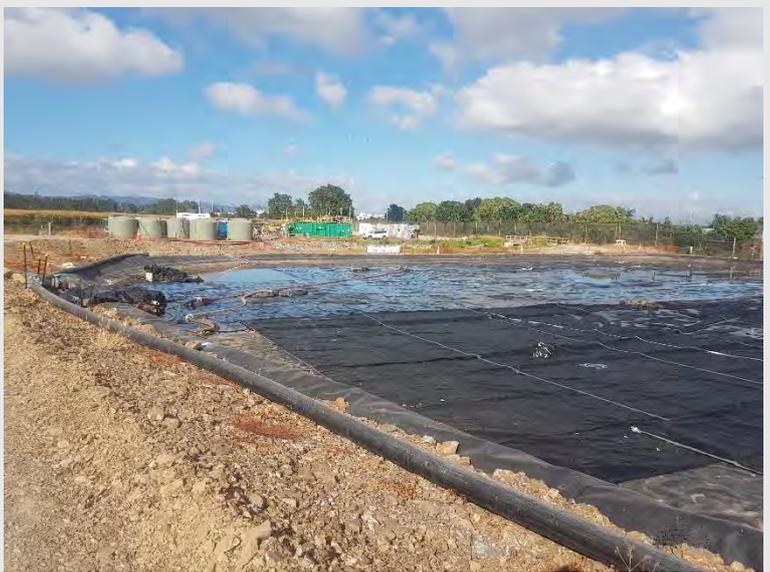
<p>Photograph 3: Sediment being pumped to the first Geobag in CS3. The water treatment plant is visible in the background.</p>

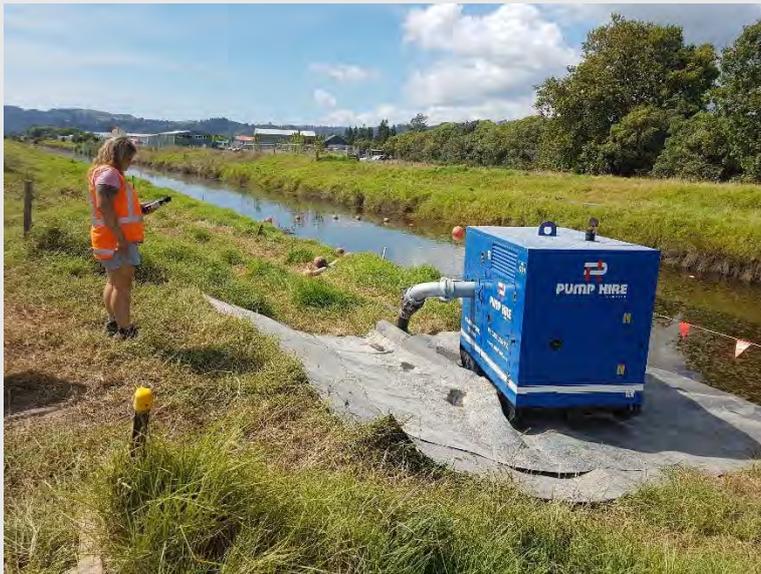
Photograph 4: Noise monitoring being undertaken at one of the boost pumps adjacent to Kope Canal Road.

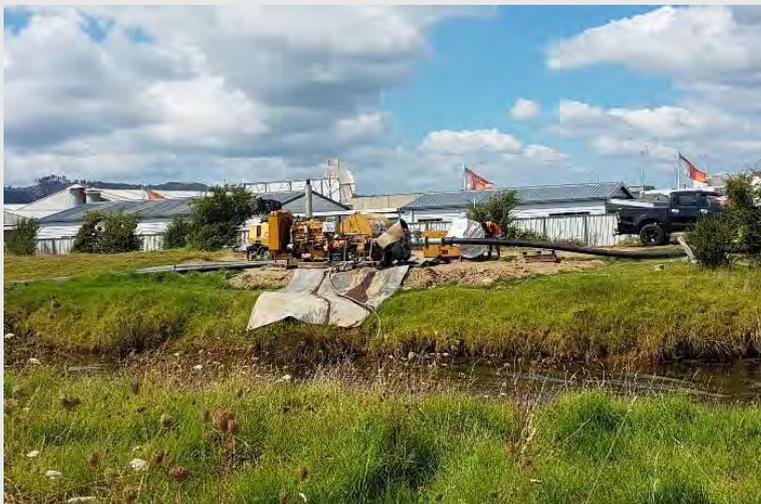
Photograph 5: Boost pump situated behind the industrial properties off Gateway Drive.

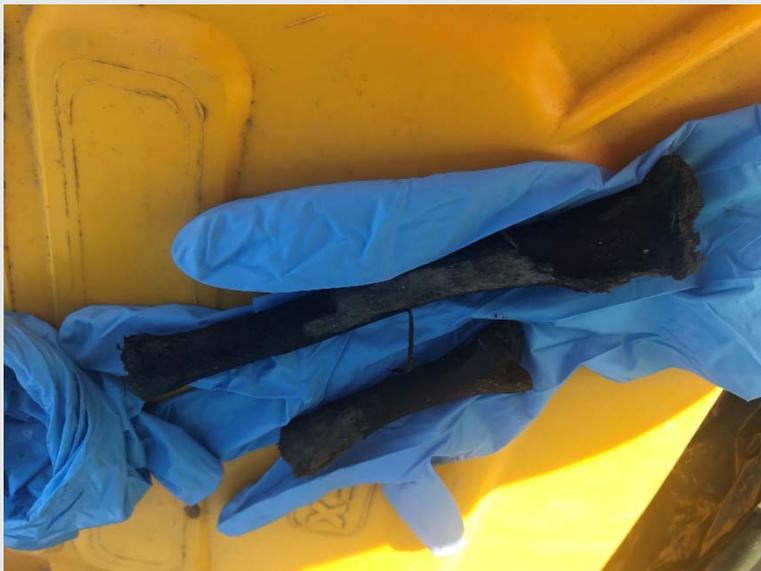
- Bird bones were found and the discovery protocol was enacted by the Cultural Monitor (Photograph 6).
- Oversized material being separated during the dredging process has consisted of predominantly bark and saw dust in the early part of Section 6 (Photograph 15). This material is likely to have entered the canal through the stormwater network from the Whakatane mill.

Photograph 6: Bird bones discovered in the water treatment plant.

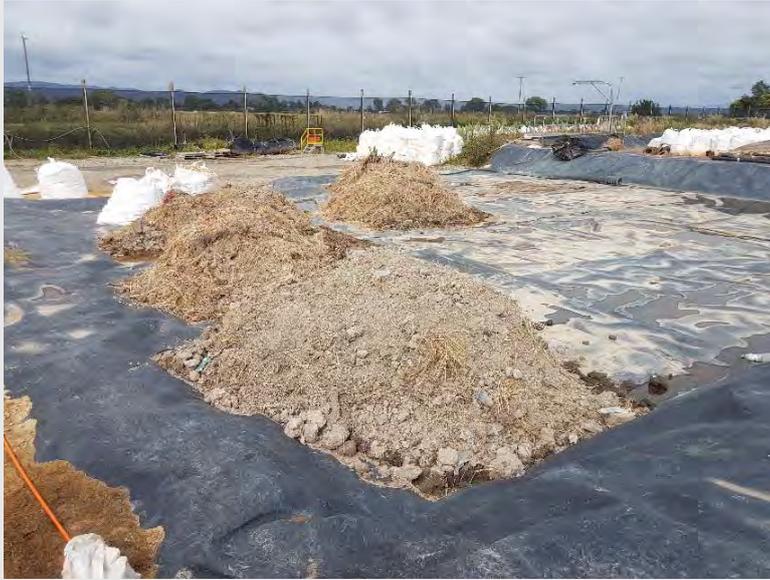
- Bioremediation is underway at CS1 with the bioremediation team continuing to add fungal inoculant to the Geobags.
- CS1 is in an untidy state as it awaits clean up following the transfer of equipment to CS3 (Photograph 10).
- Sediment has been spilled within the containment cell at CS1 and is yet to be contained within the Geobags (Photograph 11).
- Soil that was removed from a drain adjacent to the Kopeopeo Canal is being stored within the bunded area and will be added into the containment cell (Photograph 7). This material is not from the Kopeopeo Canal.

Photograph 7: Material removed from drains adjacent to Kopeopeo Canal is stockpiled within the bund at CS1. This material is not from the Kopeopeo Canal.

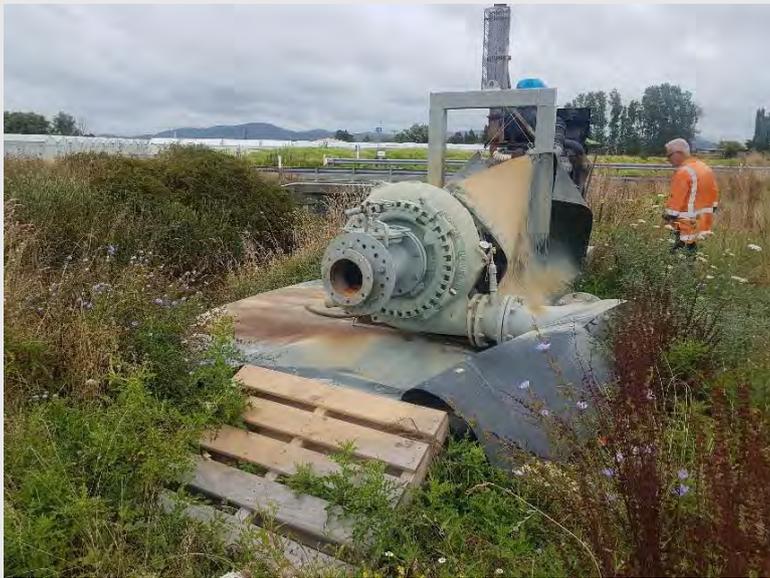
Photograph 8: Inspecting the inactive boost pump at Paroa Road.

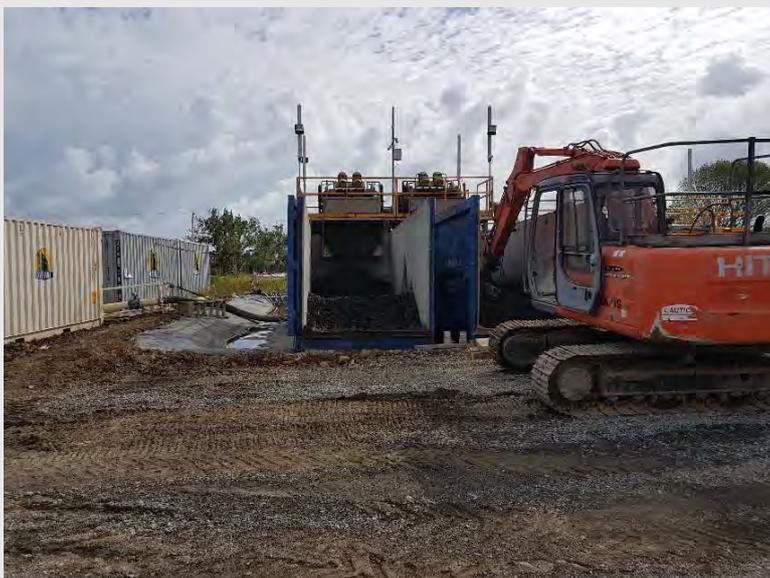
- Two releases of canal water containing sediment occurred outside of the water treatment area bund (Photograph 9). One was caused by one of the shakers turning off and the other was caused by a valve vibrating closed during pumping. All of the areas where water and sediment spilt were scraped using an excavator and placed into oversized bulk bags for placement into a containment cell (Photograph 13).

Photograph 9: Area where contaminated water spilled outside the bunded water treatment area.

On two occasions during February 2019, water containing contaminated sediment spilled outside the water treatment plant bunded area. These spills were caused by one of the oversized material shaker screens turning off, and by a valve vibrating closed. The areas of the spills were marked immediately using paint and then an excavator was used to scrape down the contaminated areas and place the material into bulk bags. These bags are then stored within the containment cell.

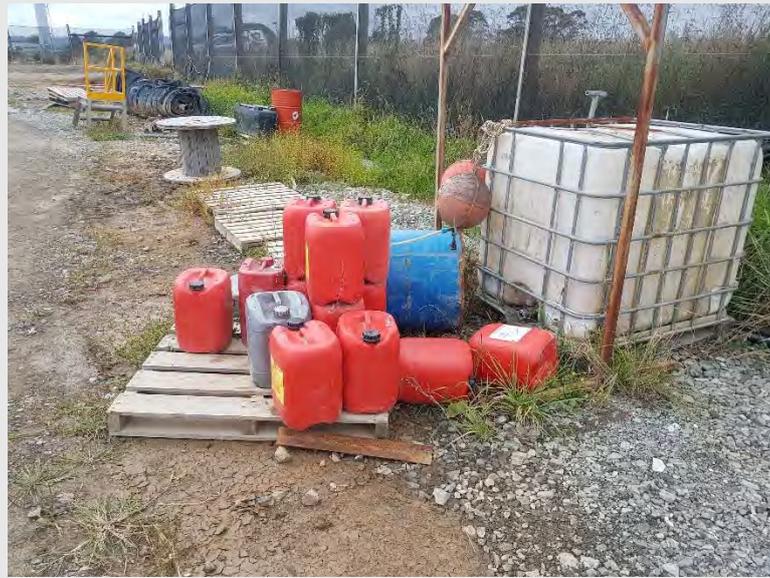
Photograph 10: Used oil containers at CS1 awaiting disposal.

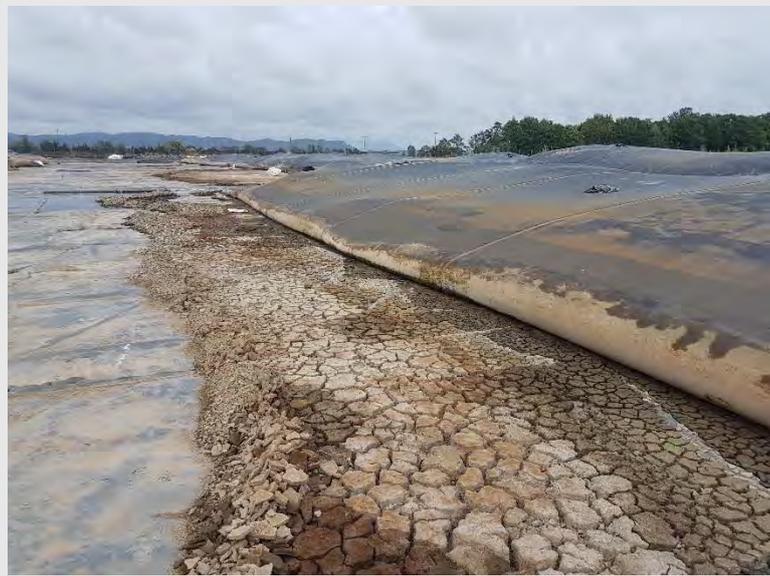
Photograph 11: Sediment dried hard within CS1 awaiting clean up.

Small volumes of sediment have been spilled in the containment cell multiple times over the last 12 months and on each occasion; both the IM and project team have requested that this material be cleaned up. As the cell floor has been covered with water during the filling of the Geobags in CS1, the generation of dust was not likely. However, as January and February had very low rainfall, the layer of water that was in the base of the containment cell has evaporated. Beneath this layer of water is a layer of contaminated sediment approximately 1 to 20 cm thick that has accumulated over the previous 12 months. While this material constitutes a minor portion of the total sediment volume safely deposited within the Geobags, it has dried out and as such, this may breach Bay of Plenty Regional Council Resource Consent 67173-AP Condition 40.1 which states that sediment must be kept wet until the time it is covered and stabilised.

It is acknowledged that consent Condition 40.1 was created to manage the dust generation risk under the originally consented excavate and truck method, and as the material is wet pumped directly into the Geobags it has largely been superseded. The condition is beneficial however in that it provides a control to mitigate potential risks of dry sediment in the containment cell being released to the environment in windy conditions. Recent inspections of the material in the base of the cell by the IM field observer did note that it has a hard crust that made it unlikely to generate dust, even in windy conditions. There has been no observed dust released as a result of wind action and there has been no regular site work at CS1.

The IM has issued a request to the project team and the principal contractor asking that the material to be cleaned up or covered with water again. The IM also raised the dust generation risk for any workers involved in the clean up. The clean up has begun and the methodology involves using water and brooms to recirculate the material into the Geobags where it is securely contained.

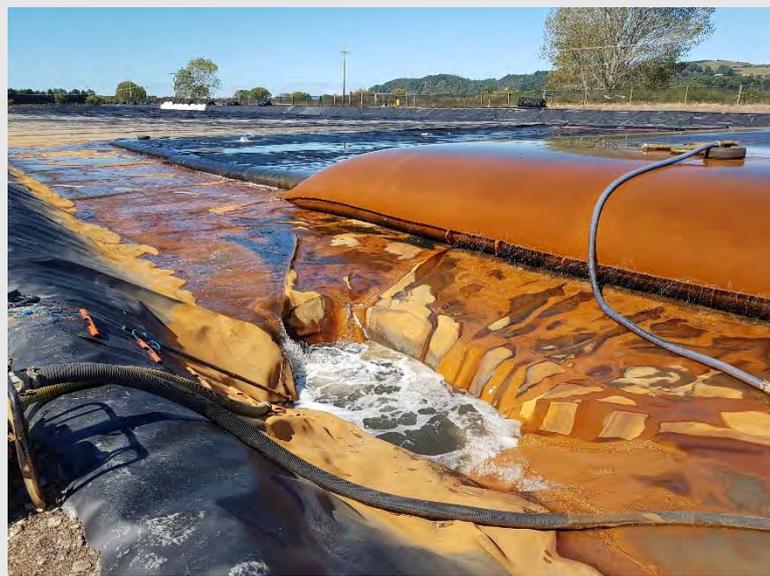
- Dredging and pumping of contaminated sediment to Geobags began (Photographs 1 and 3). What appears to be iron precipitate is forming on the surfaces of the containment cell and on the Geobags (Photograph 12). This is likely due to temperature, pH, or salinity changes during warm weather that was also experienced at CS1 in 2018.

Photograph 12: Iron precipitate forming on the Geobags and CS3 liner. The water flowing into the sump is clear.

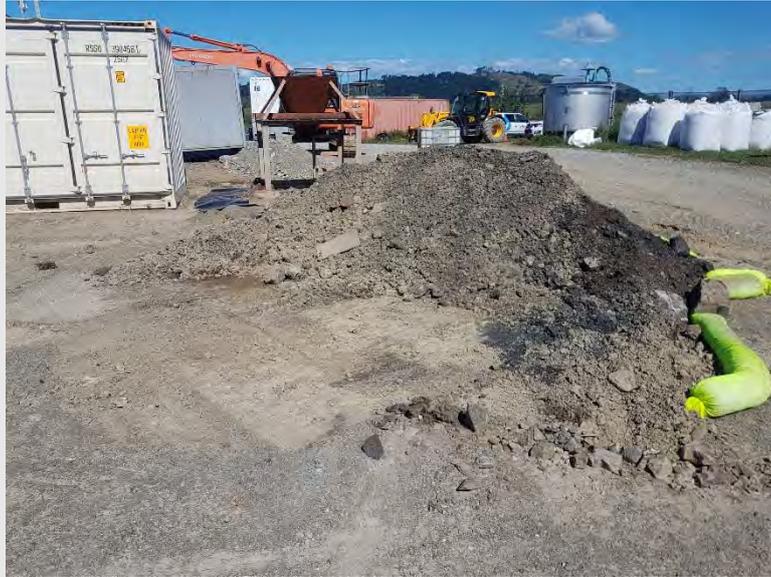
Photograph 13: Material stockpiled after a spill of sediment from the water treatment plant. This material is to be placed into bulk bags, which will then be transferred to the containment cell.

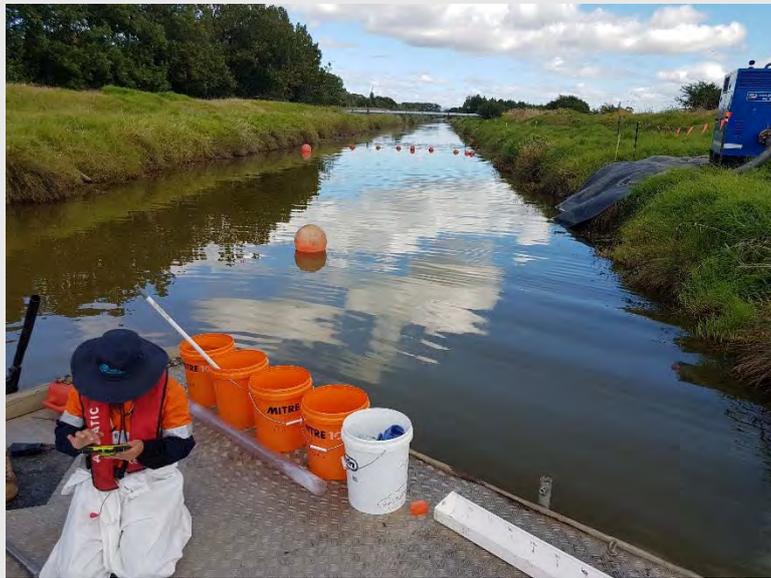
Photograph 14: Golder Associates Limited (GAL) undertaking the first round of validation in Section 6.

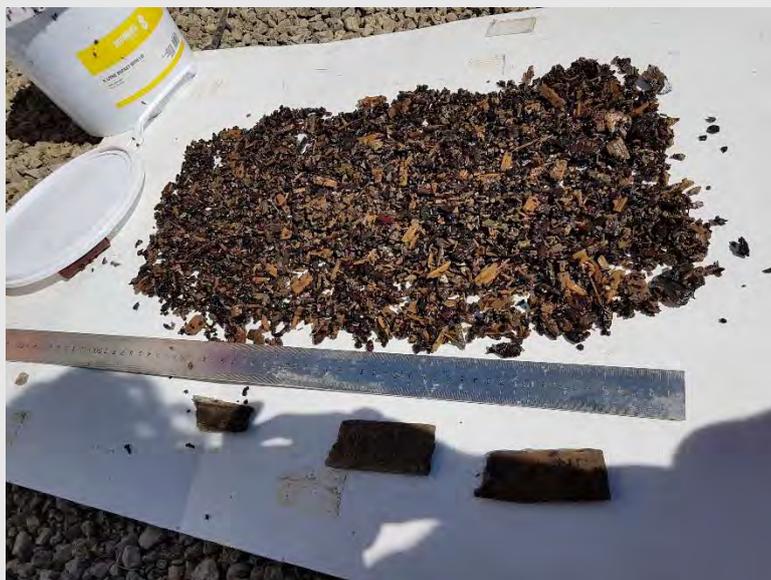
Photograph 15: Bark and saw dust coming out of the water treatment plant as oversized material. This is likely to have come from the Whakatane mill through the stormwater system.
