# Bay of Plenty Regional Council

## Koapeopeo Canal Remediation

### CLG Monthly Update Report

March 2019

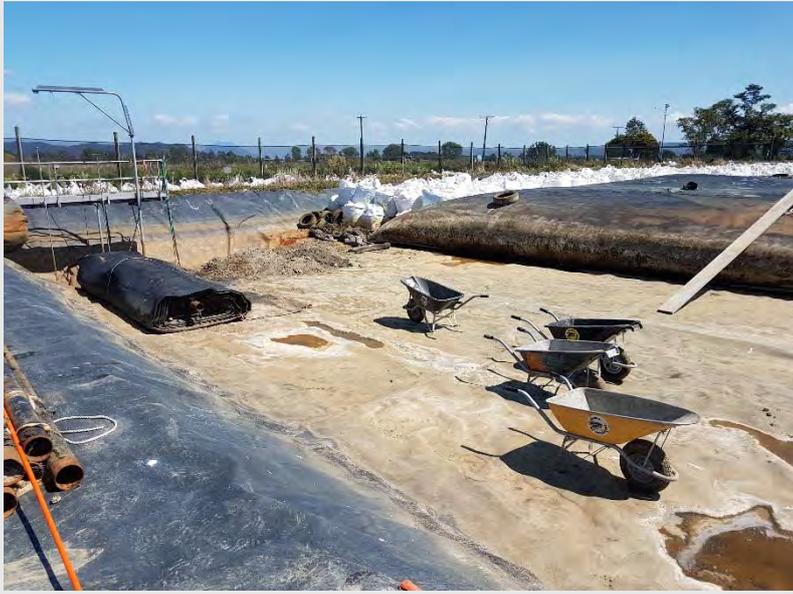
<p>Photograph 1: Clean up at CS1 with wheelbarrows being used to transport sediment to the sump where it can be pumped into the Geobags.</p>

Sediment has been spilled in the containment cell multiple times over the last eight months and on each occasion; the IM and project team have both requested that this material be cleaned up. At the beginning of March 2019, rain filled up the containment cell and covered the sediment with water. This has ensured that the sediment is wet and as such complies with relevant conditions of Bay of Plenty Regional Council Resource Consent 67173-AP. The clean-up process is ongoing. However, with the sediment being kept wet, the dust generation risk is mitigated.

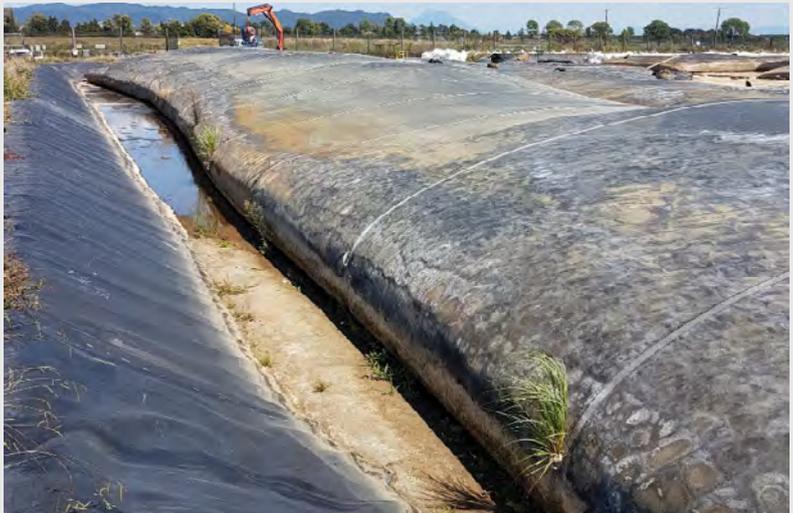
<p>Photograph 2: Sediment in the base of the containment cell at CS1.</p>

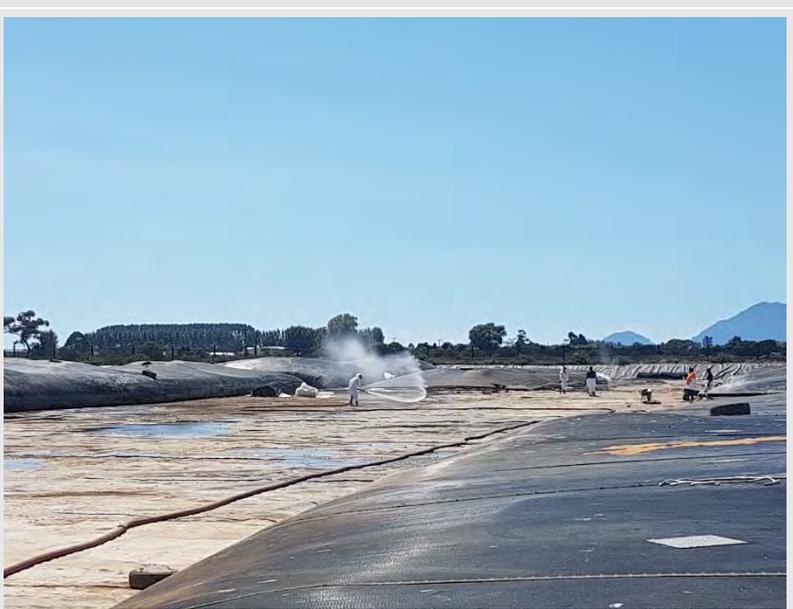
<p>Photograph 3: Waiotahi Contractors cleaning up the sediment in the base of CS1. Water is being used to ensure dust is not generated as the sediment is disturbed.</p>

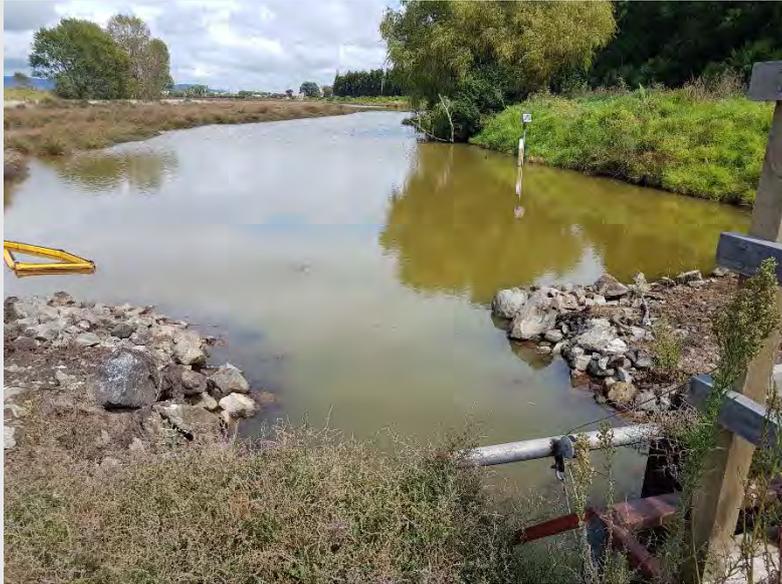
Photograph 4: FCS-East closed to maintain optimal water levels.

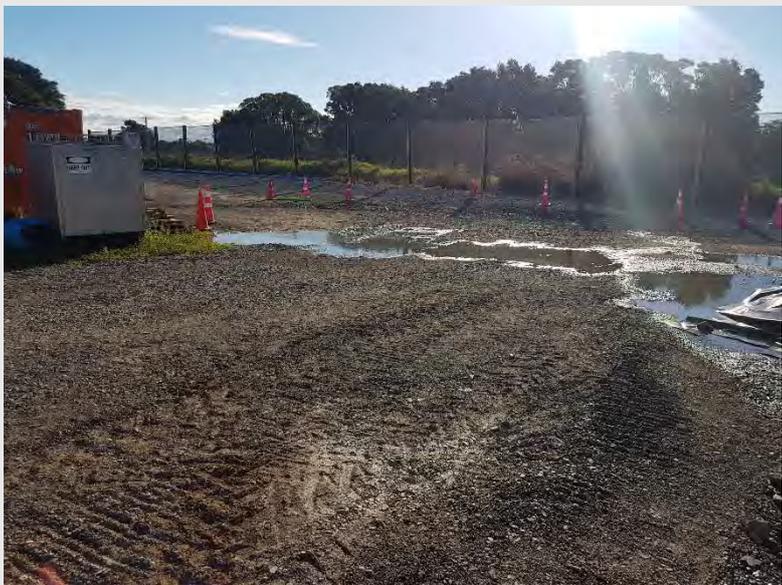
Photograph 5: A spill of potentially contaminated water outside the bunded water treatment area.

On two occasions during March 2019, water containing contaminated sediment spilled outside the bunded, water treatment plant area. These spills were caused by pipes disconnecting. The areas of the spills were marked and then an excavator was used to scrape down the material that accumulated in the area(s) of the spill and place it into bulk bags. These bags are then stored within the containment cell.

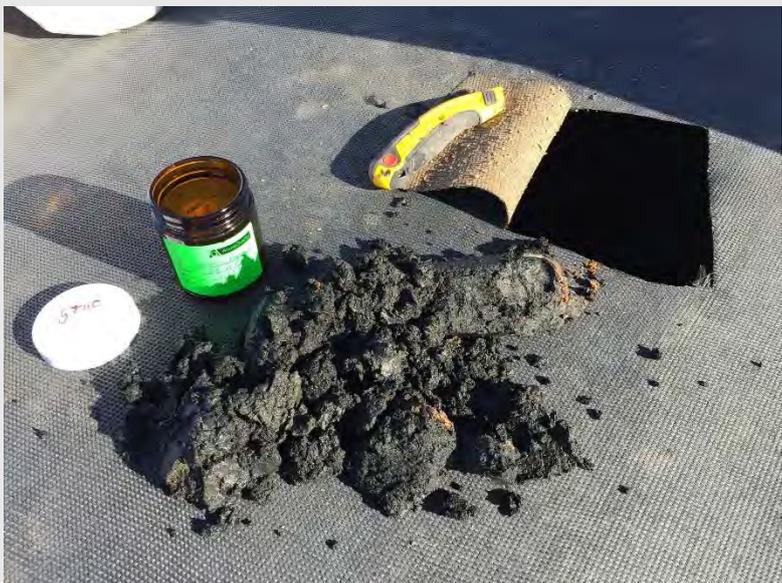
Photograph 6: Bioremediation team sampling within the Geobags at CS1. This core shows exclusively target material in the Geobag at this location.

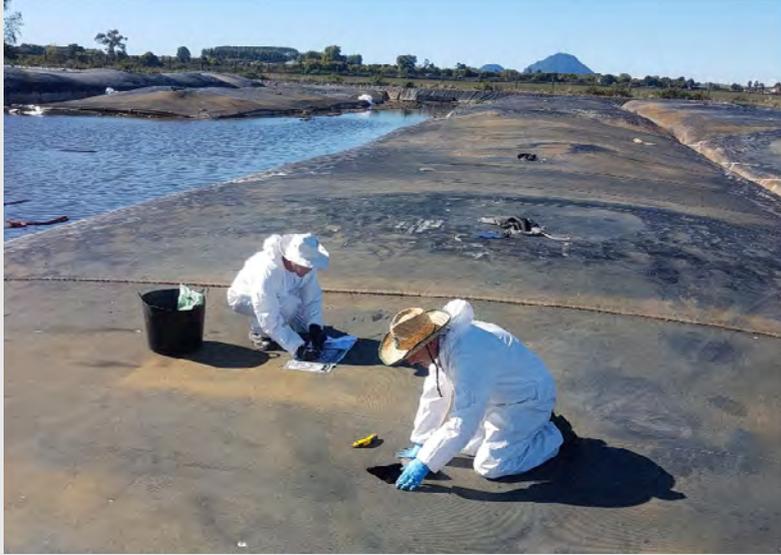
Photograph 7: Bioremediation team sampling within the Geobags at CS1.

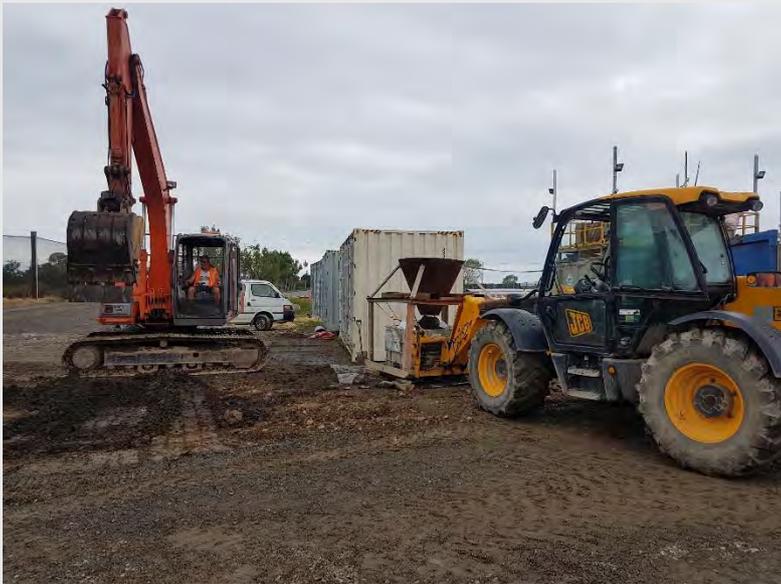
Photograph 8: Excavator scraping down the area of the spill within CS3. This material is then placed into oversized bulk bags and stored within the containment cell.

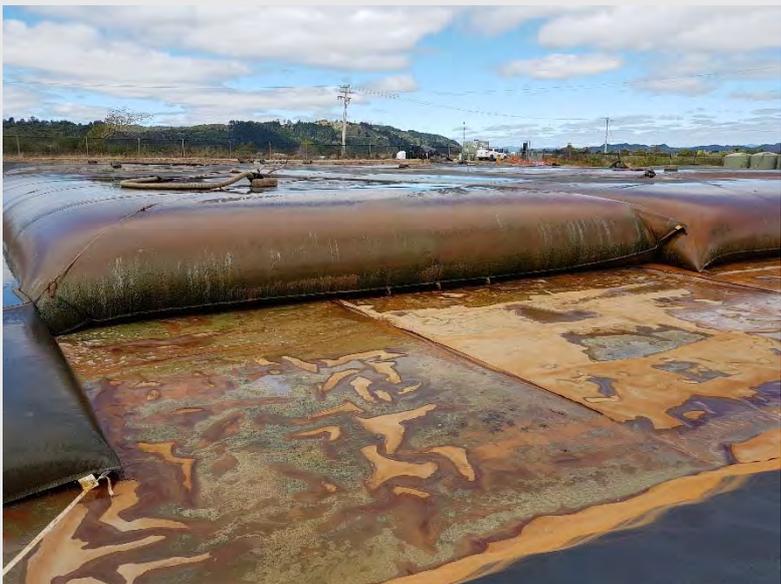
Photograph 9: Geobags within CS3 dewatering. The water coming out of the Geobags has very low turbidity and is released back into the canal.

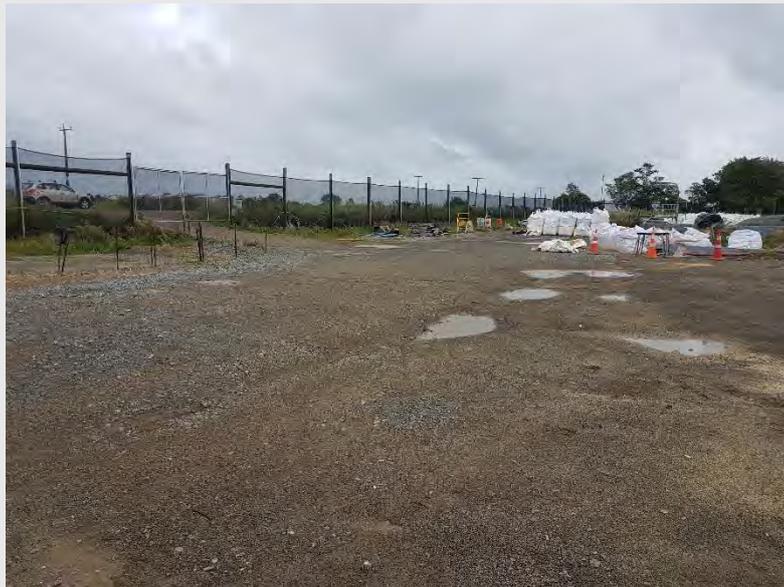
Photograph 10: CS1 awaiting further tidying before closure.

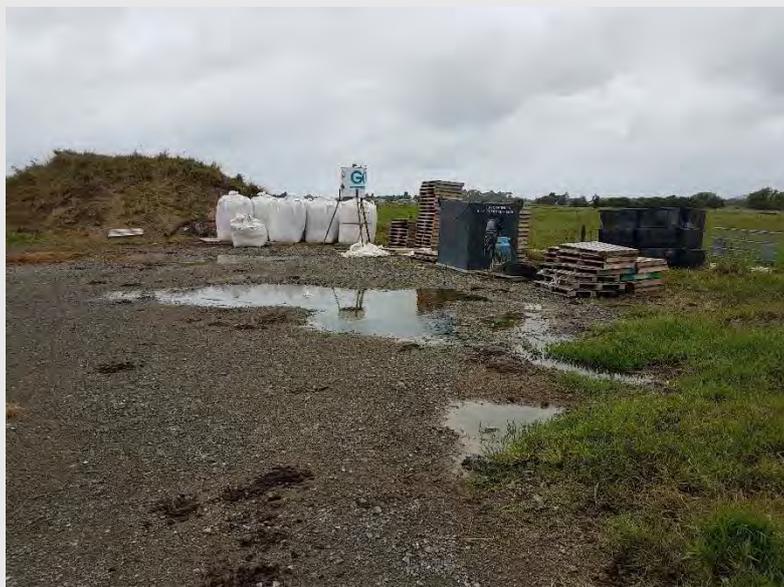
Photograph 11: Equipment in the carpark adjacent to CS1 awaiting removal.

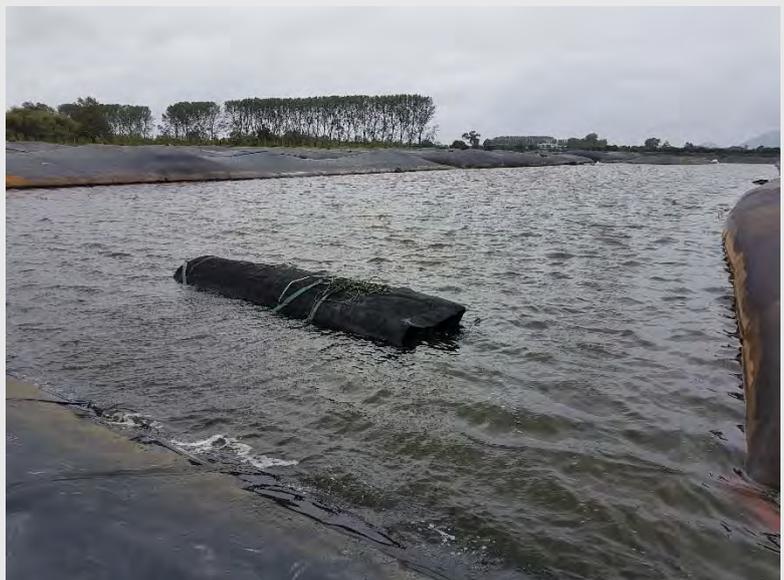
Photograph 12: CS1 flooded with rainwater.

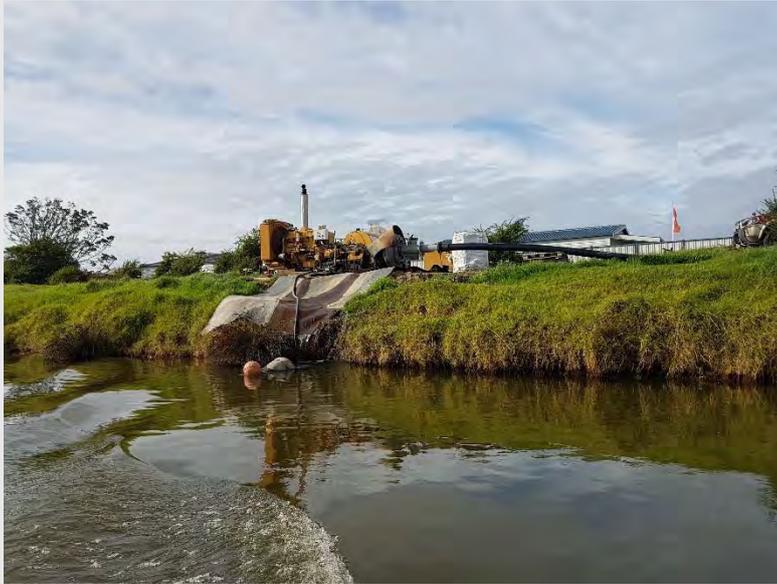
Photograph 13: Boost pump operating adjacent to Gateway Drive properties. This pump is the source of the noise complaint.

Noise complaints have been received from a member of the public in relation to the boost pump operating near Gateway Drive. The complaint is outlined in Section 4.11 and an investigation is underway. If the noise is found to be in excess of construction noise levels, noise reduction will be required.

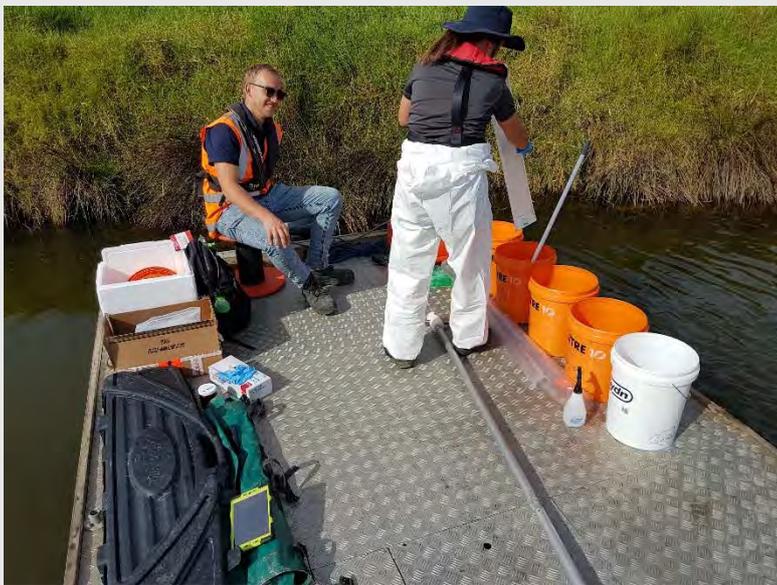
Photograph 14: GAL undertaking validation sampling in Section 6.

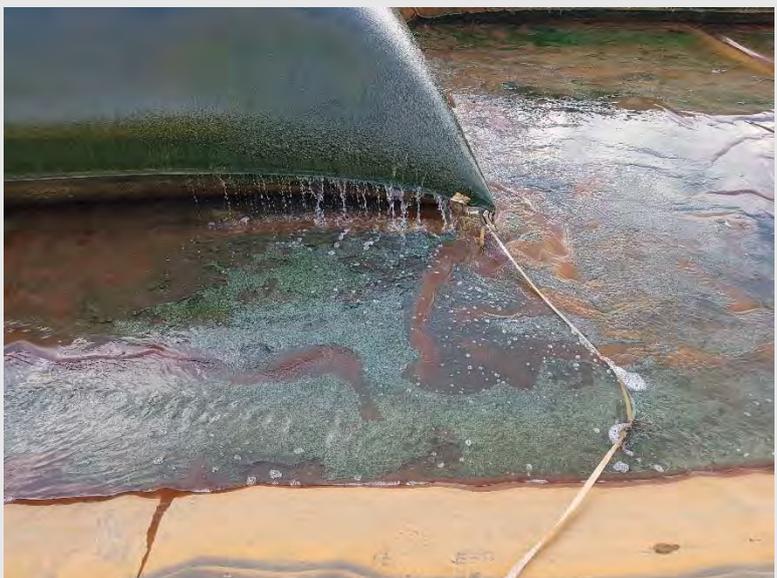
Photograph 15: Geobags dewatering at CS3. The water is clear with very low turbidity as the sediment remains trapped in the Geobags.
