Monitoring impacts of on-site wastewater treatment systems - Bay of Plenty

Bay of Plenty Regional Council
Environmental Publication 2011/05
May 2011

Monitoring the impacts of on-site wastewater treatment systems, Bay of Plenty

Environmental Publication 2011/05

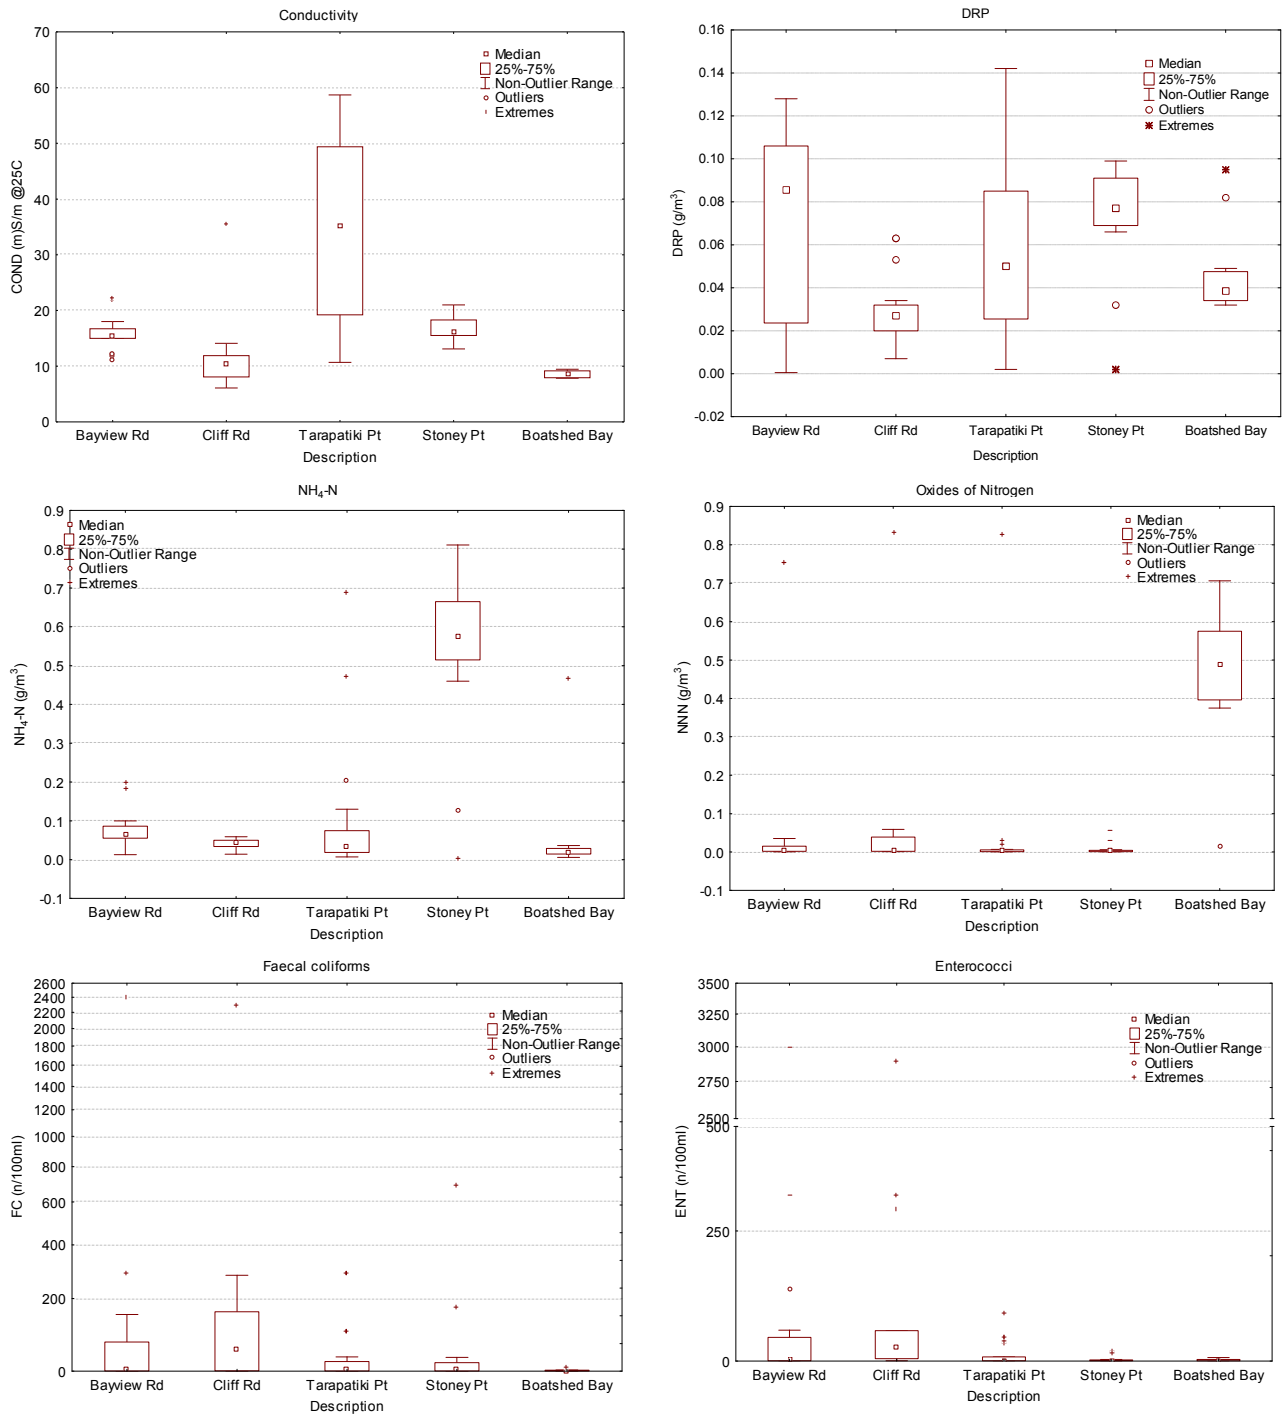
Figure 3.2 Box whisker plots of several water quality parameters from shallow groundwater sites around the Lake Tarawera community.

Conductivity measured in groundwater samples at Tarapatiki Point is on average much higher than for other groundwater sample locations (Figure 3.2). The sulphurous odour of the samples may indicate geothermal influences, although the Bayview Road site also has this feature with a much lower conductivity. Tarapatiki Point also has had some elevated ammonium concentrations with conductivity and ammonium correlating well (Pearson $r = -0.630$, $p=0.05$). The negative correlation could indicate that ammonium is flushed out with rain diluted groundwater, and this may occur for dissolved reactive phosphorous (DRP) also.

Ammonium-nitrogen (NH₄-N) levels are for the most part reasonably low with only the Stoney Point Reserve sample point displaying elevated levels (Figure 3.2). Elevated ammonium-nitrogen levels can be a result of contamination from poorly treated effluent, however there is no correlation of ammonium-nitrogen with faecal coliform data. If groundwater at Stoney Point is contaminated from a septic source, effluent is achieving microbiological decontamination in the ground. The level of ammonium-nitrogen found at this site is consistent with concentrations found in a similar study at Lake Okareka where it was thought that groundwater flows were not sufficient to dilute ammonium-nitrogen concentrations (NIWA, 2000).

Boatshed Bay sample point had median nitrate-nitrogen levels elevated compared to the other sample points. Other parameters are at low levels at this site. Comparison of nitrate-nitrogen levels monitored in this monitoring programme to a similar sampling programme on the shores of Lake Okareka shows levels observed to be much lower at Tarawera and as such may be a result of only low level contamination from septage and/or nitrate-nitrogen (NNN) from other catchment sources.

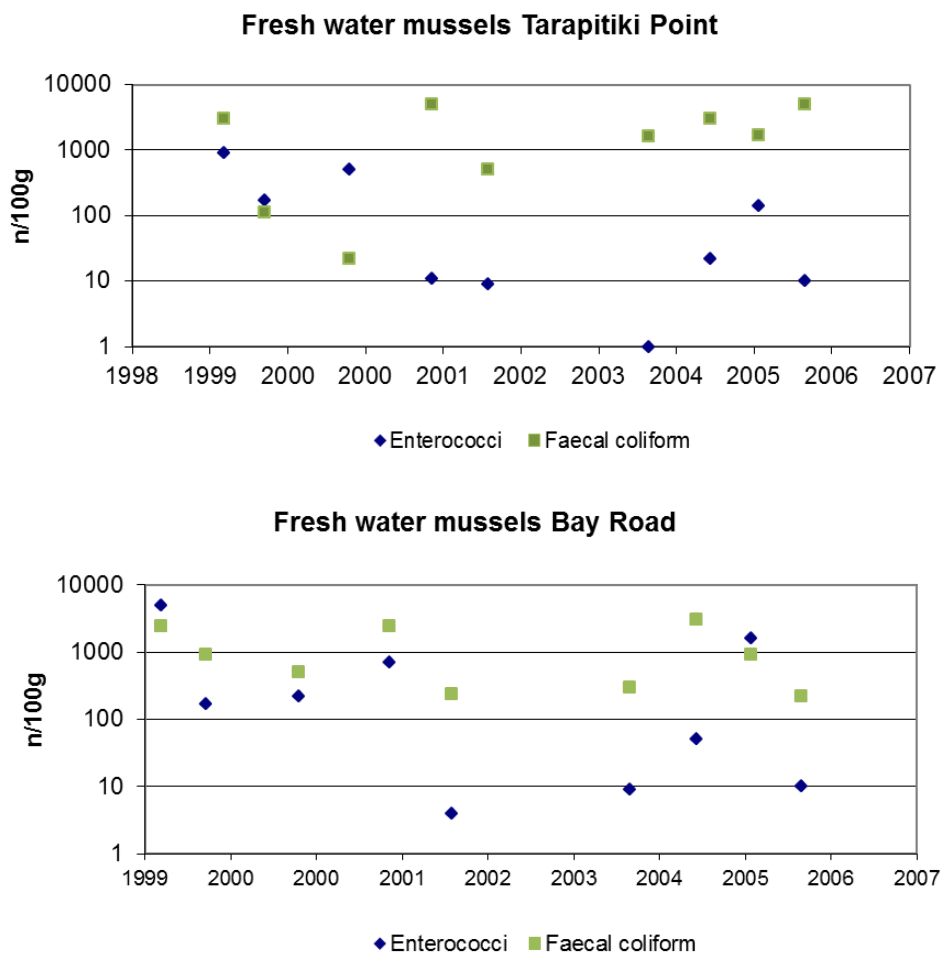
Figure 3.4 Freshwater mussel monitoring results, 1999 to 2007, Lake Tarawera.

The enterococci to faecal coliform ratio of shellfish monitored at Bay Road shows much less variance than shellfish monitored at Tarapatiki Point (Figure 3.4). This variance could indicate the difference between a constant source of bacteria from water fowl, and stream inflows, versus bacteria from a variable source such as septage. There are no obvious long term trends in the shellfish monitoring data apart from a general decrease in enterococci levels at Tarapatiki Point over the past few years. Salmonella was analysed for in one month and not detected but low levels of *Clostridium perfringes* were detected. This may suggest septage rather than water fowl.

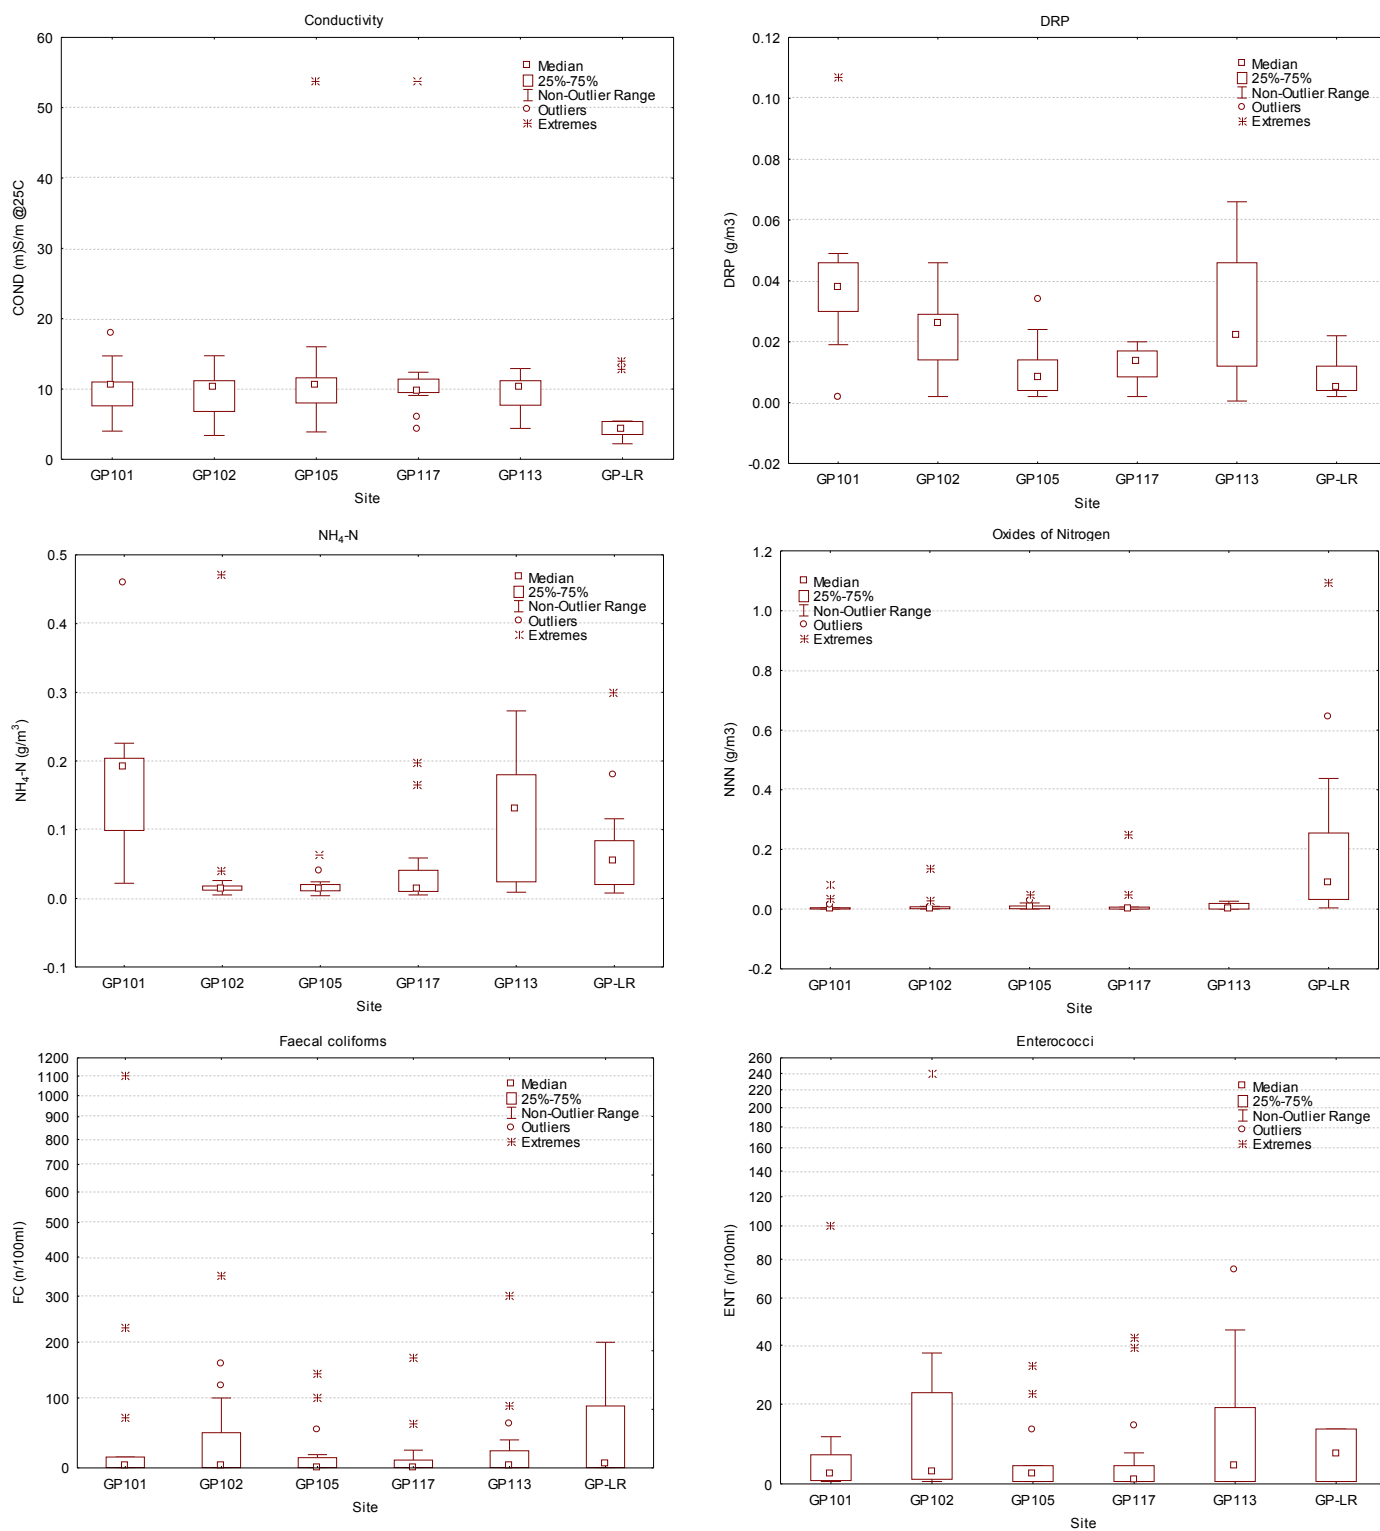
Figure 3.6 Box whisker plots of several water quality parameters from shallow groundwater sites around the Gisborne Point community, Lake Rotoiti.

Oxides of nitrogen (NNN) levels were relatively low in all wells. Only well GP101 displayed a correlation between NNN concentrations and faecal coliform concentrations (also for E.coli) (Spearman $r=0.779$, $p<0.05$, $n=18$), indicating a preferential septage path was found. This well also displayed the highest median ammonium-nitrogen and dissolved reactive phosphorus concentrations (Table 4.1, Figure 4.7). DRP also had a correlation with conductivity (Spearman $r=0.475$, $p=0.05$, $n=19$) potentially indicating contamination of groundwater with phosphate.

Faecal indicator species have been elevated at times for all wells but at levels below contact recreational guidelines.

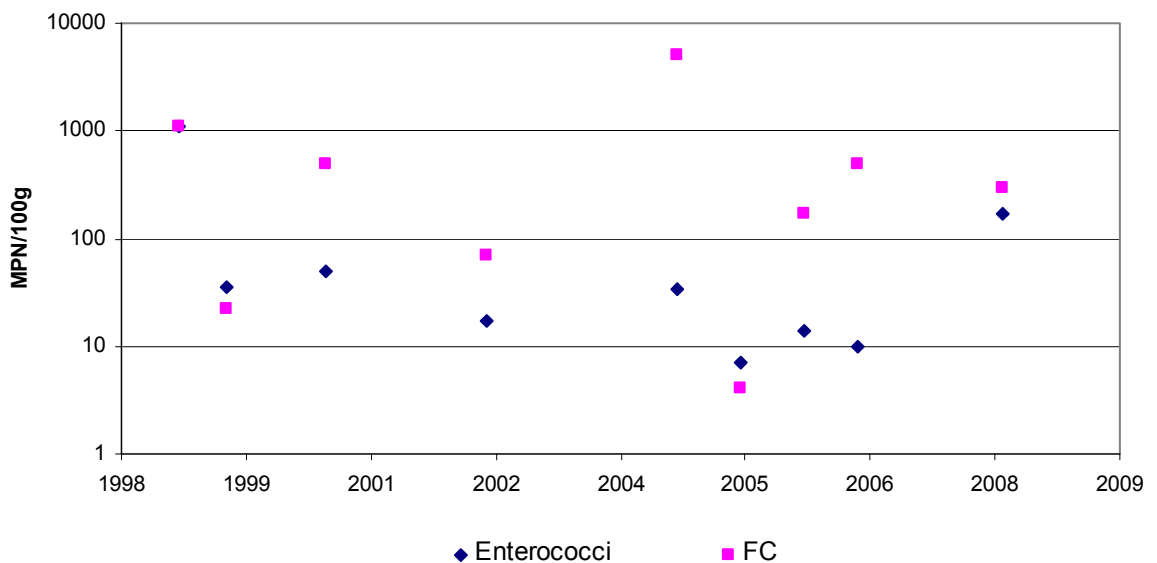
Figure 3.11 Freshwater mussel monitoring results, 1999 to 2009. Hinehopu, Lake Rotoiti.

Faecal coliform levels in freshwater mussels have on occasion been at levels not considered safe for human consumption (Figure 3.11). Enterococci levels are at a low level in the shellfish which may indicate a terrestrial source rather than water fowl.

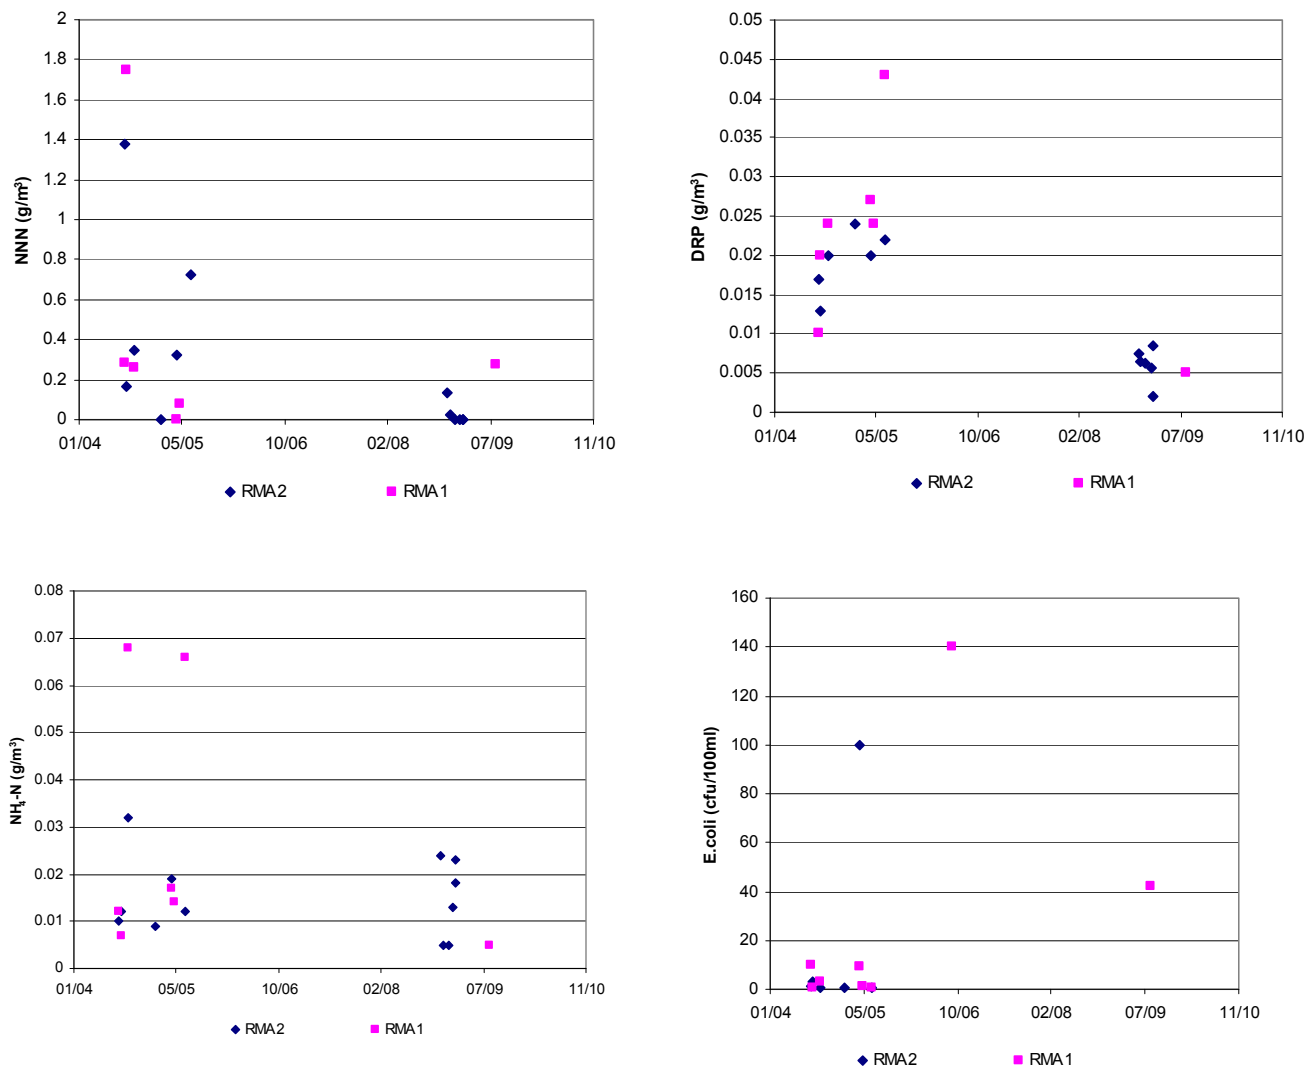
Figure 3.13 Nutrient and *E.coli* concentrations in shallow wells, Lake Rotomā.

Due to the pervious nature of the soils around Lake Rotomā shallow groundwater is potentially the best indicator of any trace of contamination by septic tanks. Figure 3.13 displays nutrient indicators and *E.coli* concentrations in two shallow monitoring wells located around the most densely built up part of the Rotomā community, the Whangaroa settlement.

Nutrient levels decreased between 2004/2005 and 2008/2009. This is probably climatically driven with lower rainfall reducing flushing and dilution of nutrients in some years. NNN levels are elevated compared to shallow groundwater monitoring at other lakes but are generally similar to those found in the Rere Stream (average NNN = 0.238 g/m³). Concentrations above this surface water average have occurred on three occasions (Figure 3.13). Both DRP and NH₄-N concentrations tell a similar story with only one or two samples above background concentrations.

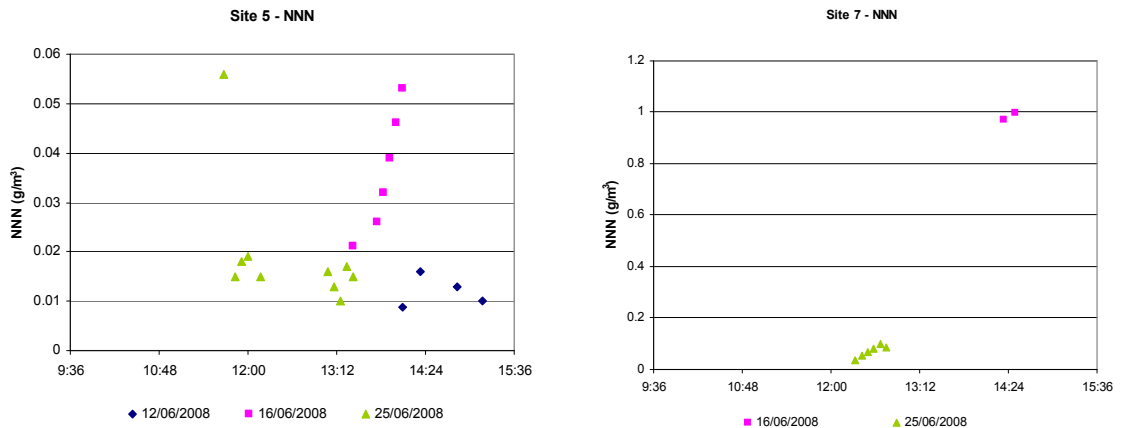
Figure 3.14 NNN concentrations in shallow water wells, Anaputu Bay, Lake Rotomā.

Sampling of two shallow wells around Anaputu Bay on several occasions has also yielded some interesting results. Figure 3.14 shows NNN concentrations taken on different days but with multiple samples being taken within a short time of each other. Site 5 (Figure 3.14) has low NNN levels compared to other shallow wells sampled, but on one occasion an increasing plume is detected. For Site 7 NNN levels are at quite different concentrations on two different sampling days, potentially indicating the arrival of a plume on one of the days due to a contamination source.

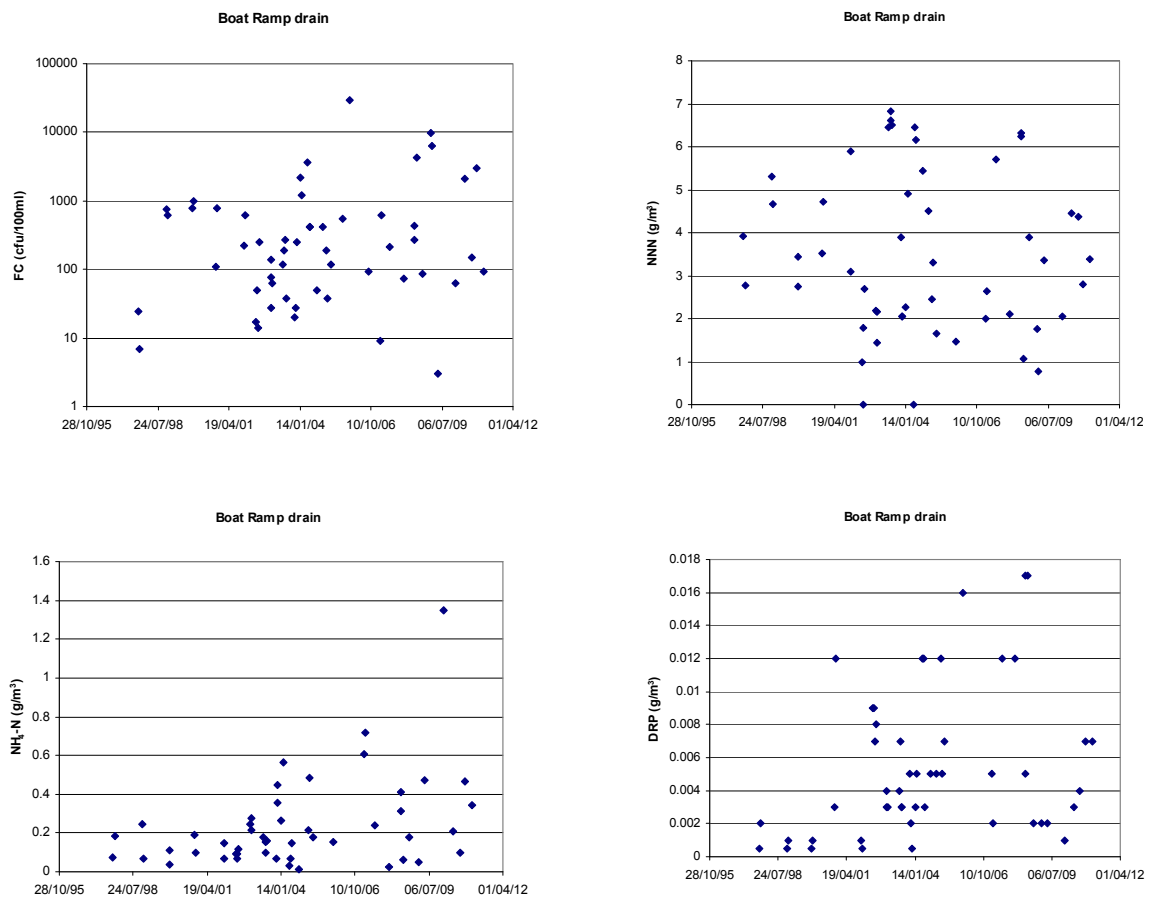
Figure 3.17 Faecal coliform and nutrient concentrations, Boat Ramp drain, Tanners Point.

NNN results are also high, indicating that septic tank contamination is likely to be occurring. High NNN results have also been found in the waters emanating from the sub-surface drains. Ammonium-nitrogen and dissolved reactive phosphorous concentrations also have at times been at levels that suggest a contamination source.

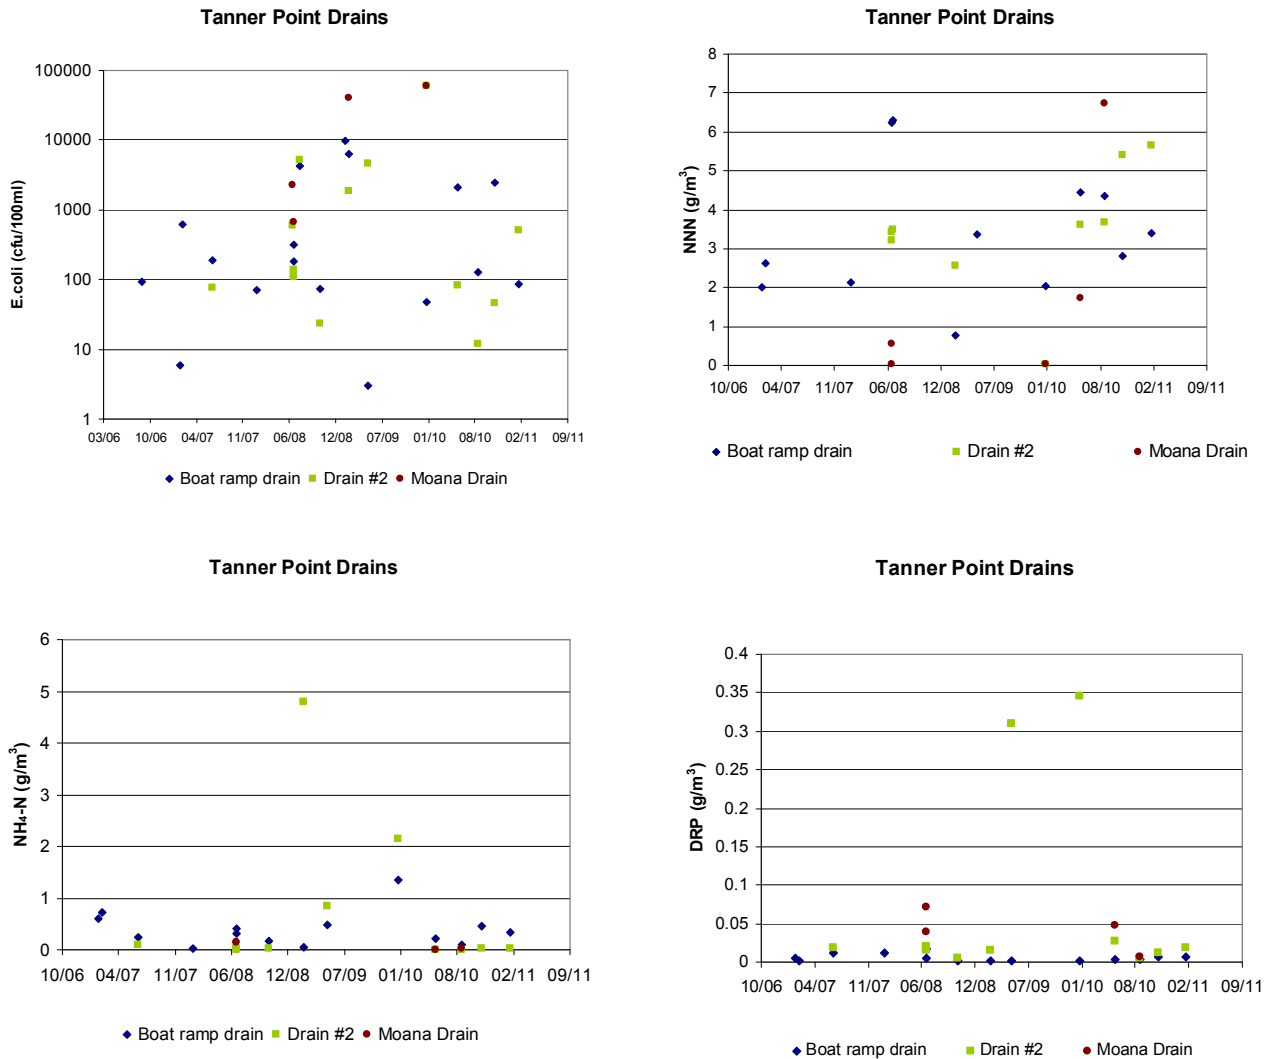
Figure 3.18 Faecal coliform and nutrient concentrations, Boat Ramp drain, Tanners Point.

Monitoring of Tanners Point drains in June 2008 over three days after intensive rainfall occurred showed elevated concentrations of *E.coli* and oxides of nitrogen with the highest levels emanating from the sub-surface drains at the bottom of the small boat ramp sub-catchment. Waterlogged soakage fields and increased rainfall is likely to have contributed to leaching of septage into the lower drains and to the foreshore.

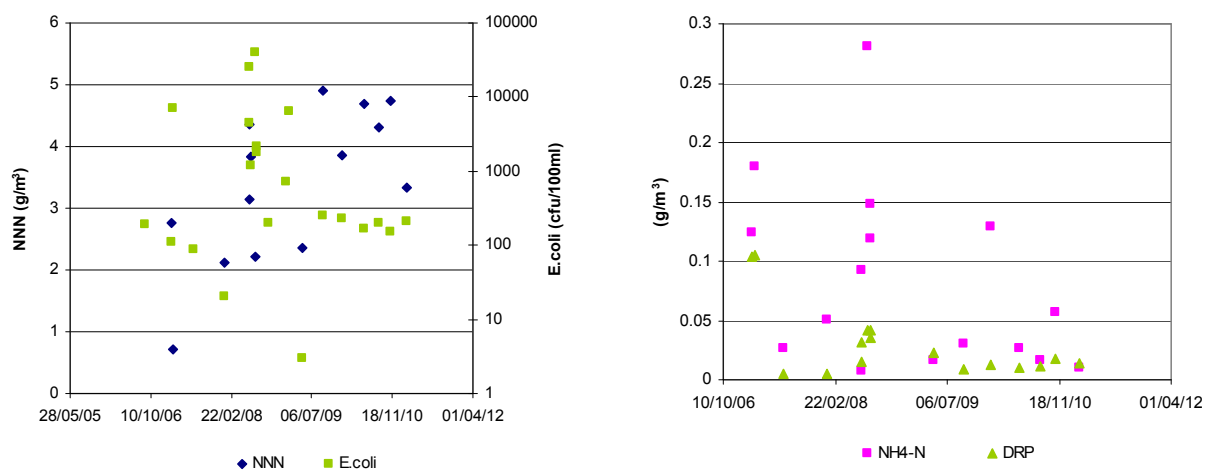
Figure 3.21 *E.coli* and nutrient concentrations, drain near toilet block, Ongare Point.

Oxides of nitrogen (NNN) show an increasing trend with recent concentrations above 3 g/m^3 . Nitrate-nitrogen is the more mobile nitrogen species through groundwater and at such high levels it is likely that part of this loading is from septic tanks. NNN concentrations in the drain near the toilet block are similar to concentrations in the spring south of the boat ramp (Figure 3.22). Other drains monitored have lower NNN concentrations on average but higher NNN to $\text{NH}_4\text{-N}$ ratio. There may be an influence of rural groundwater in the spring waters of the drain near the toilet block and the spring south of the boat ramp.

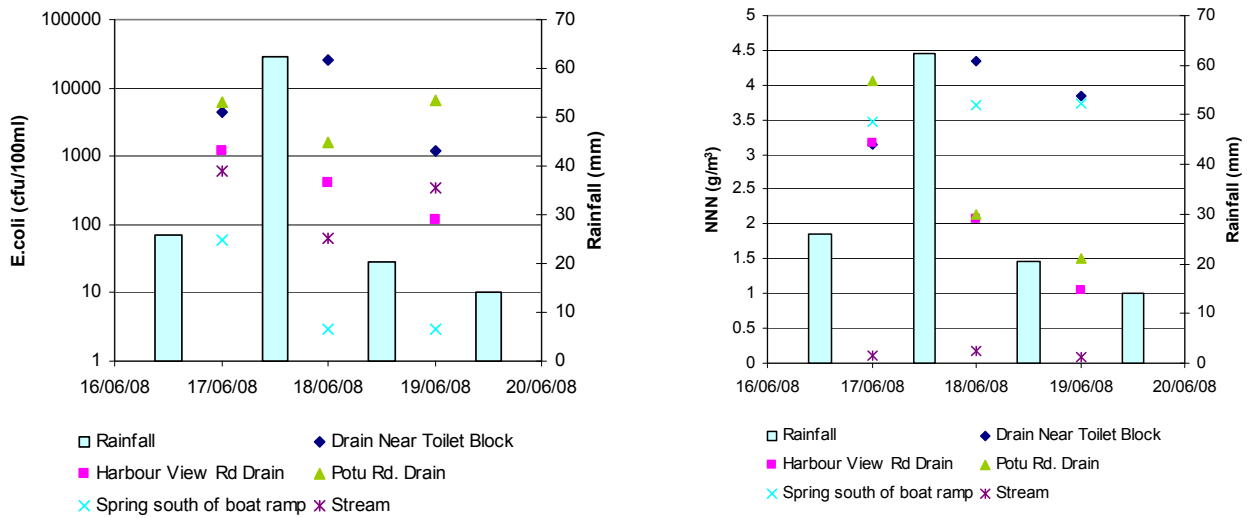
Figure 3.22 Daily total rainfall, *E.coli* and NNN concentrations, June 2008, Ongare Point.

A rainfall event was monitored over consecutive days in June 2008 (Figure 3.22). A rise in indicator bacteria levels occurred in all drains except for the spring south of the boat ramp. Nutrient species also displayed a similar increase, most probably as a result of the high groundwater and the consequent impact on drainage fields.

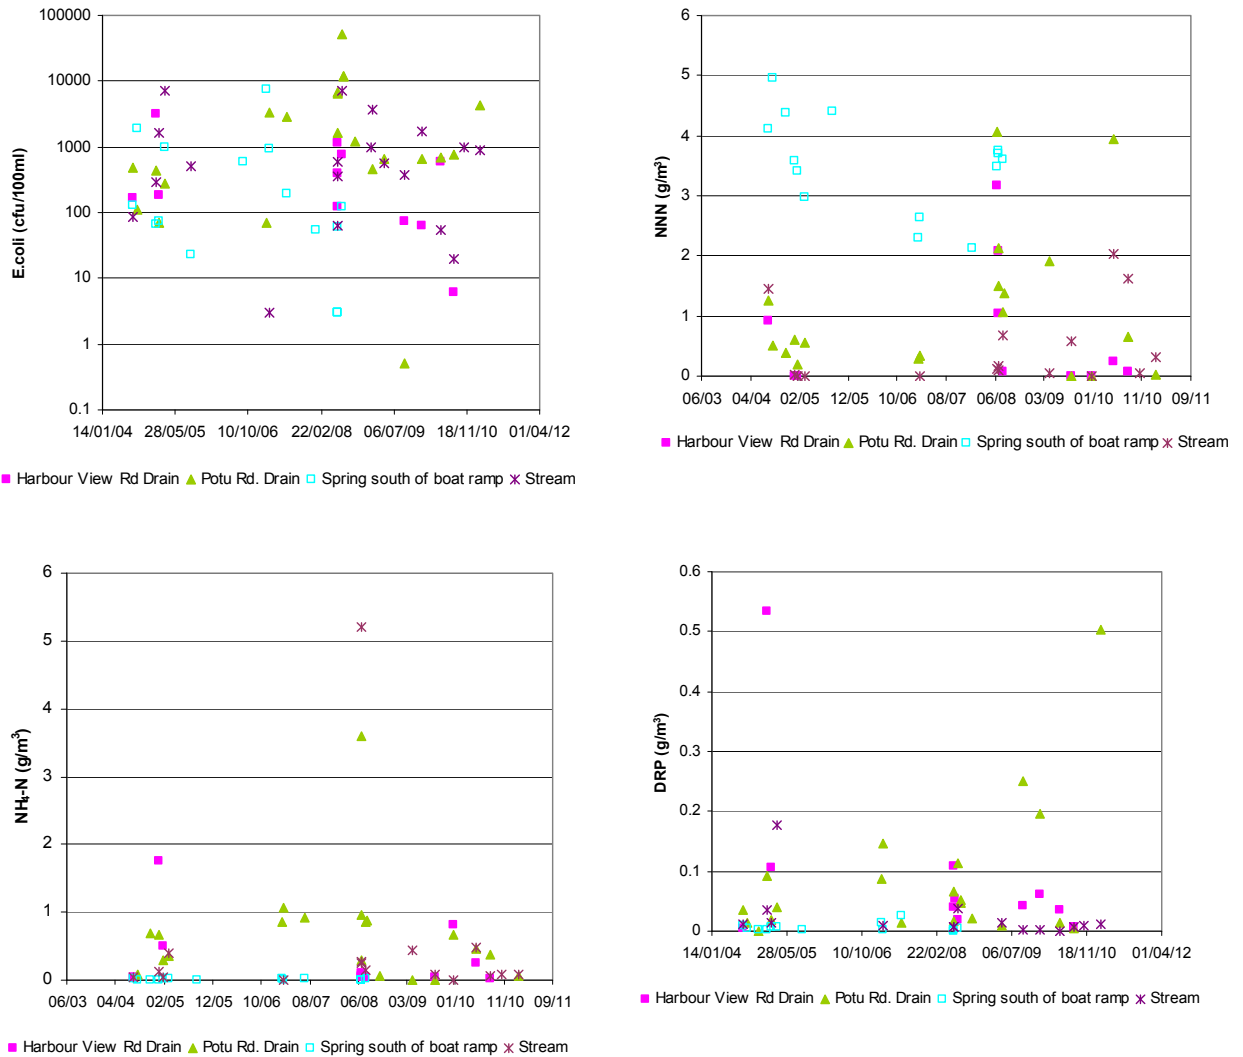
Figure 3.23 *E. coli* and nutrient concentrations, Ongare Point.

The Potu Road drain at times shows elevated *E.coli*, DRP and $\text{NH}_4\text{-N}$ concentrations (Figure 3.23). These elevated levels indicate some contamination from septic tanks. Harbour View drain has to a lesser extent also been found to have occasional higher levels of indicator bacteria and nutrients that would be expected in an uncontaminated stormwater seep. Flow from the Potu Road drain is almost year round while the Harbour View drain experiences only intermittent flow and is therefore influenced by rainfall and water table levels.

Figure 3.23 also shows *E.coli* and nutrient data from the local stream. Some monitoring has been undertaken above and below a subsurface drain that enters the stream from the Potu Road residences. This drain has shown very little flow and no marked difference in the water quality of the stream has been observed due to its input. The stream does however show signs of contamination from rural sources and has predominantly cattle grazing around its lower extent. *E.coli* concentrations are often above the contact recreational guideline and elevated $\text{NH}_4\text{-N}$ concentrations have been recorded. High $\text{NH}_4\text{-N}$ concentrations may have been a result of reduced flow and stagnation caused by the build-up of sea lettuce and the configuration of the culverts. A new culvert recently installed will alleviate some of this build up.

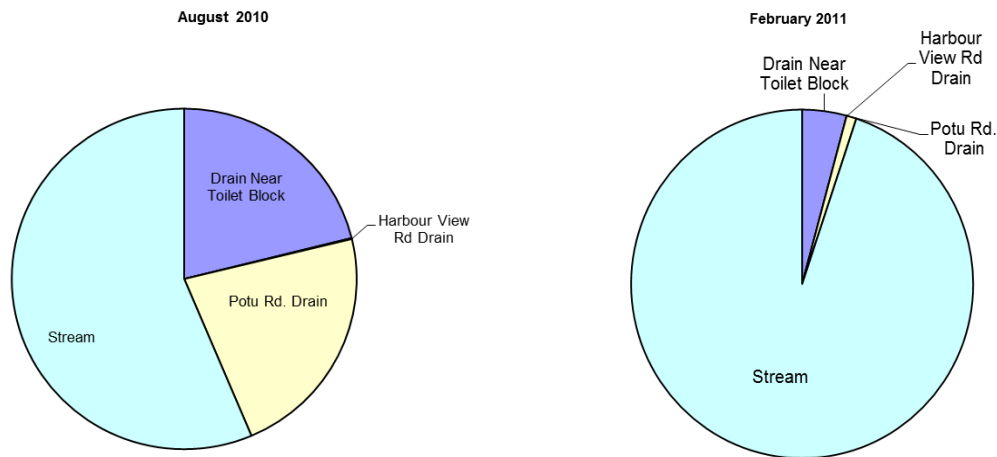
Figure 3.24 Percentage representation of *E.coli* loads to harbour (cfu/day) for Ongare Point drains and Stream.

It can be seen that in winter the drain near the toilet block can have a higher bacterial load than the higher flowing stream, but in the summer of 2011 the stream is the dominant bacteria source. *E. coli* concentrations in the winter do fluctuate and are on average likely to be higher than represented in the winter example in Figure 3.24.

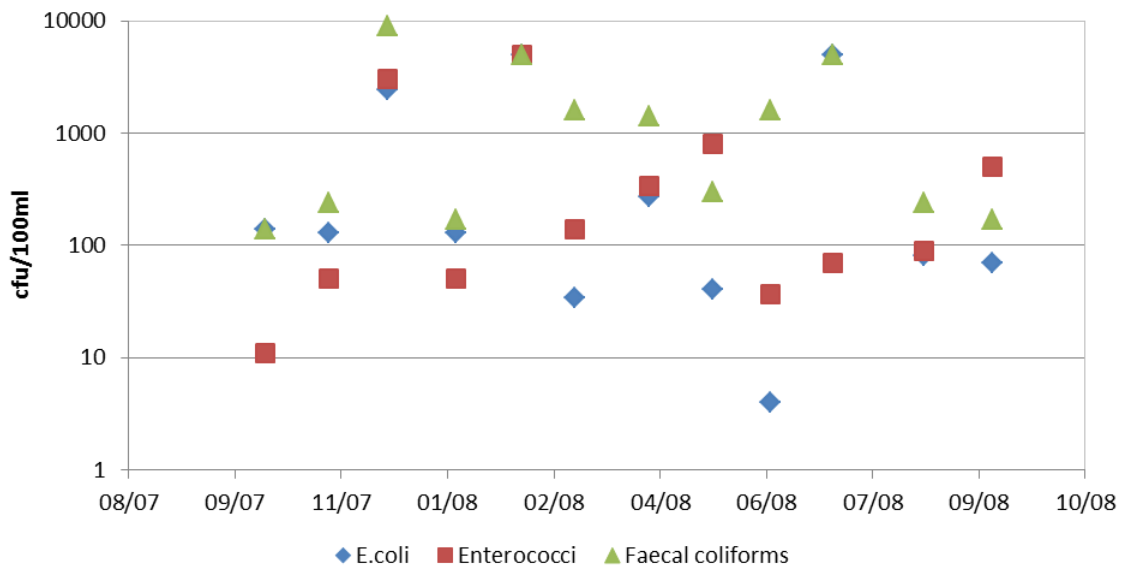
Figure 3.34 Indicator bacterial results for Te Puna estuary oysters, 2007/2008.

Indicator bacteria results are shown in Figure 3.34 over the 12 months of sampling. *E. coli* results were over the level considered safe for human consumption (what is the level?) three times over the 12 months (monthly monitoring). Two of these elevated *E. coli* concentrations occurred after rainfall. Only one positive virus detection (adenovirus) occurred in the 12 months. Human and animal F-specific RNA bacteriophage were also detected.

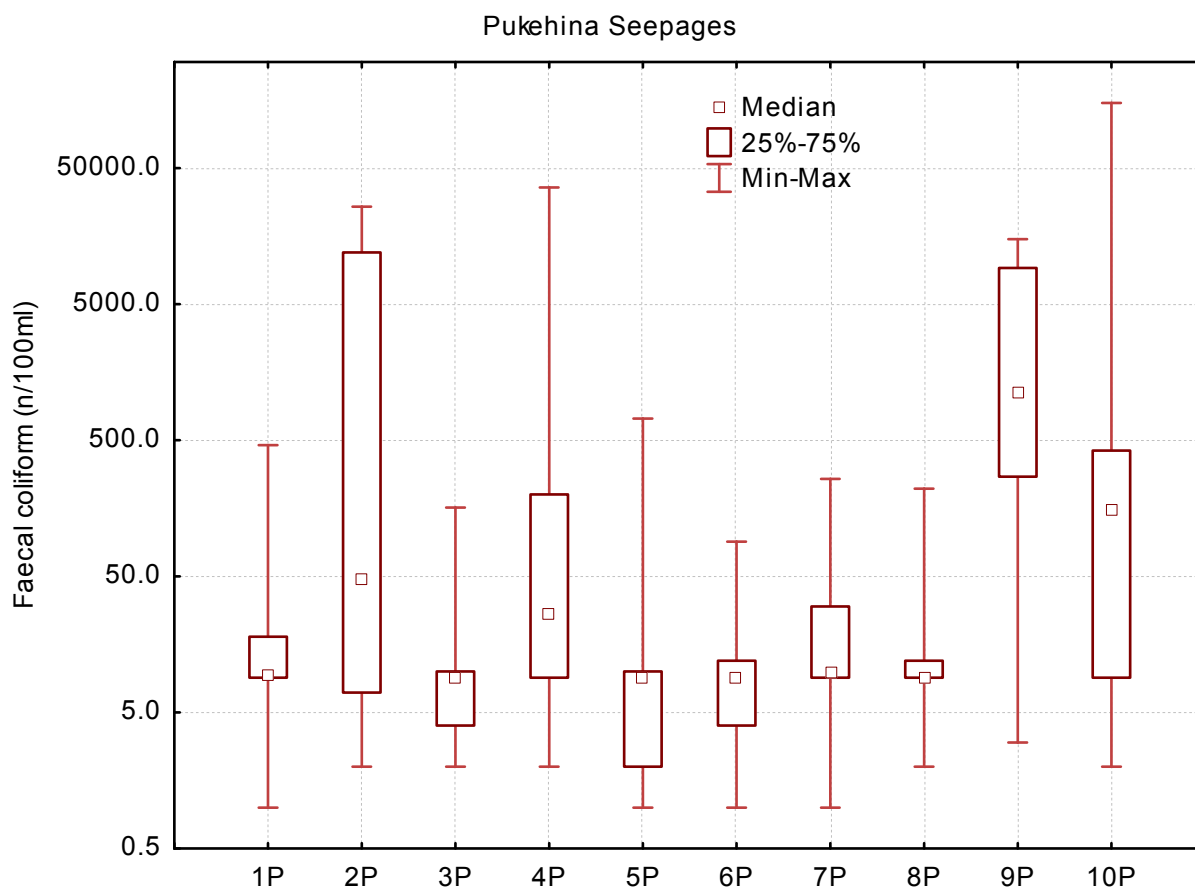
Figure 3.36 Faecal coliform concentrations (n=22-27), Pukehina seepages, 1999 to 2001.

The report also lists the results of seepage monitoring around Pukehina conducted by Western Bay of Plenty District Council (McIntosh *et al.*, 2001). Only one seep displayed consistently elevated faecal coliform results (9P) and one seep had occasionally elevated results (2P) (Figure 3.36). Both these sites are located at the south end of the community. The site 10P (eastern drain) and 4P (Midpark drain) also had some elevated results. These results indicated some local scale contamination and/or contamination hotspots, but at locations that are of low risk to public health.

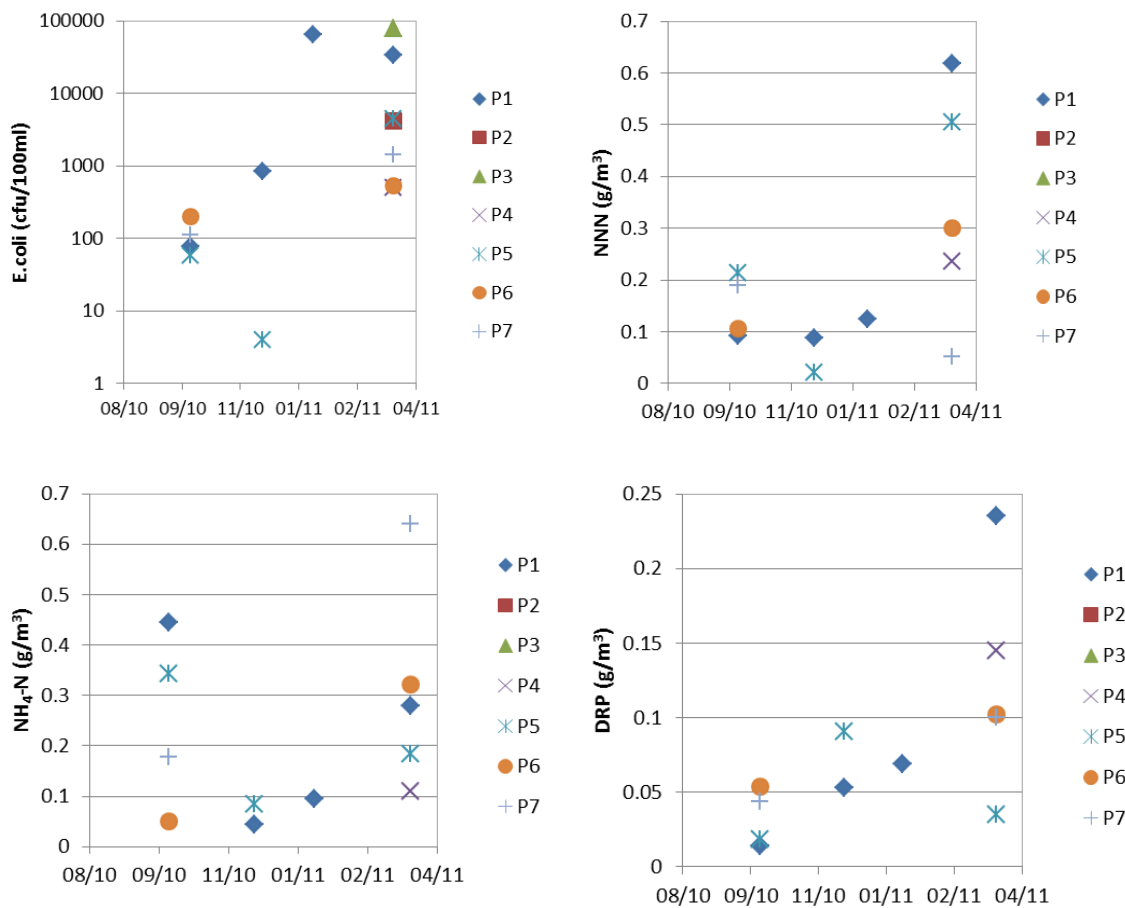
Figure 3.37 Nutrient and E.coli concentrations from seeps and drains, Pukehina.

The initial survey in spring found very low flows and low *E.coli* levels. Two drains had slightly elevated ammonium-nitrogen ($\text{NH}_4\text{-N}$) levels but these levels did not increase with subsequent sampling. However, *E.coli* levels did increase for most drains over the summer with high contamination levels found in two drains (P1 and P3). Dissolved reactive phosphorous (DRP) and $\text{NH}_4\text{-N}$ levels increased over the summer in P1 and also in P6, the eastern main drain. However, nutrient levels have not reached levels as high as other beachside communities showing contamination from septic tanks.

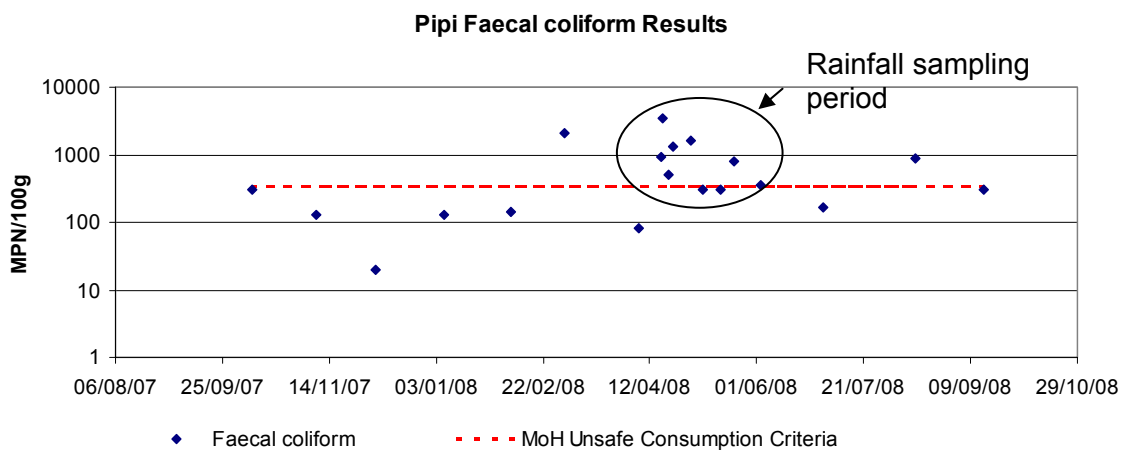
Figure 3.39 Faecal coliform concentrations, Pipi, Waihi Estuary.

Indicator bacteria results for shellfish in the Waihi Estuary have been variable, with some very high faecal coliform results found in cockles adjacent to the Little Waihi community in 2003. Faecal coliform results for main channel Pipi are generally of lower concentrations and are often at levels safe for human consumption. A monthly survey undertaken of Pipi in the estuary over a year in 2007/2008 showed elevated indicator bacteria results with moderate rainfall events (Figure 3.39), indicating some contamination is brought into the estuary during rainfall.

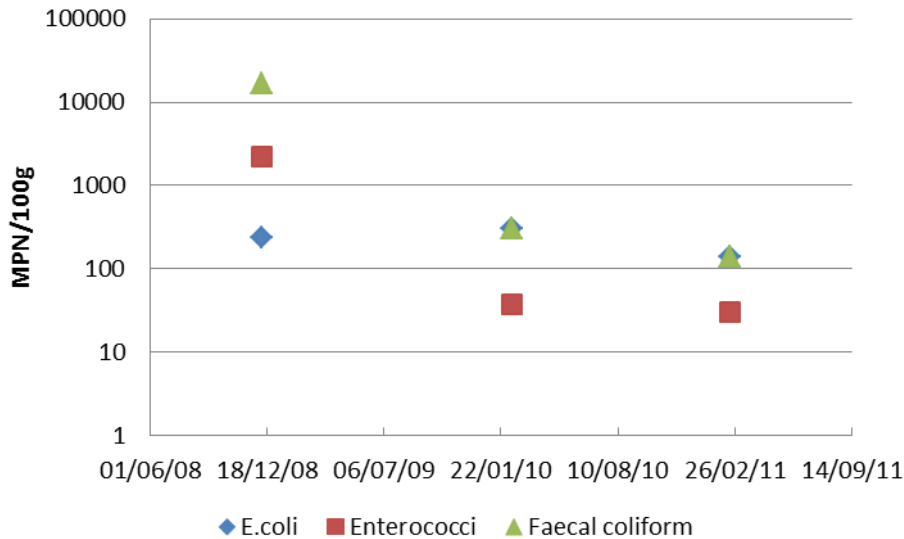
Figure 3.40 Indicator bacteria concentrations in Pukehina shellfish.

There have been only a few shellfish samples taken from the Pukehina coastal area. Tuatua results for Pukehina are shown in Figure 3.40 with one result showing elevated faecal coliform and enterococci concentrations although low *E. coli*. Viral and F-RNA-bacteriophage analyses were also undertaken on the sample taken in February 2011 and were found to be negative for enteric viruses and FRNA phage (GI and GII).

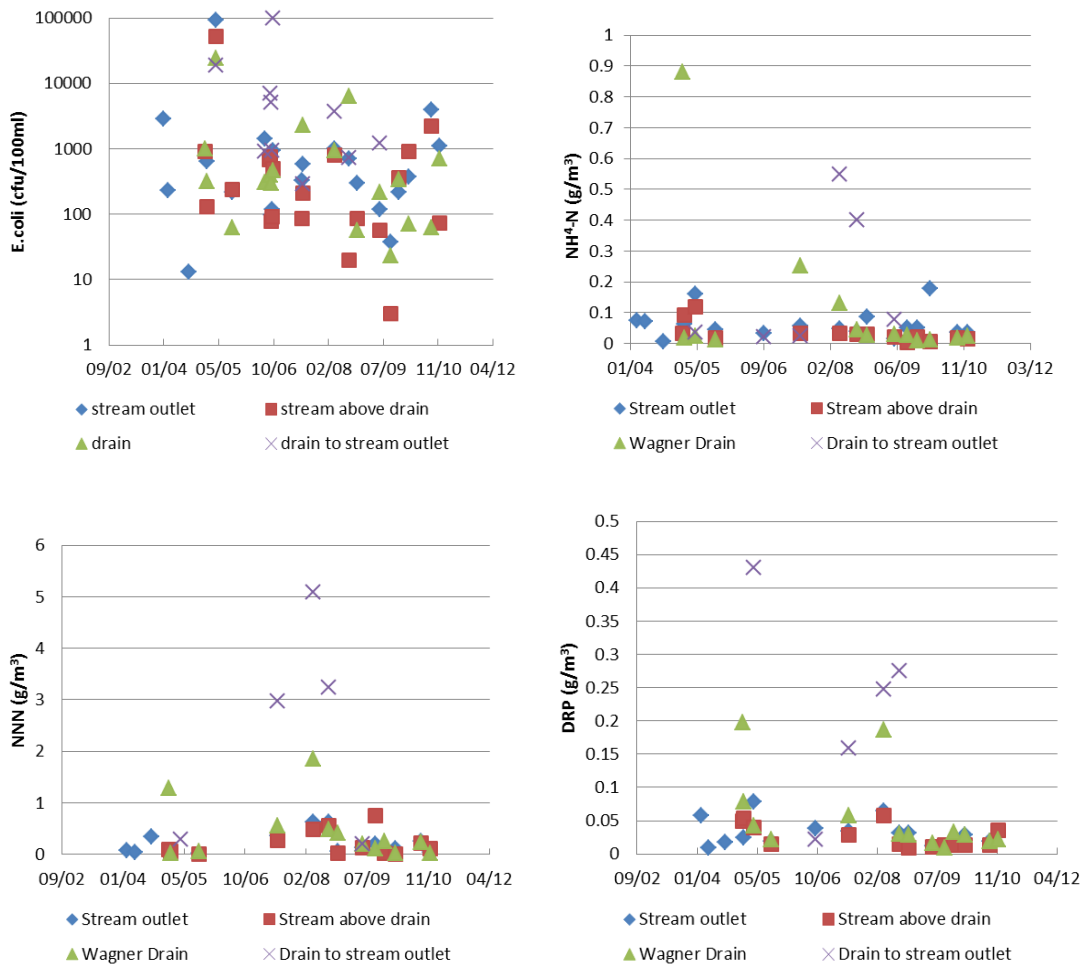
Figure 3.42 Nutrient and *E. coli* concentrations from stream and drains, Bryans Beach.

Nutrients have only been elevated on some occasions, mainly in a small drain to the beach and in the Wagner Street stormwater drain (Figure 3.42). DRP has a correlation with *E. coli* for both the Wagner Street drain and the stream outlet (Pearson $r=0.678$ & 0.651 respectively, $p<0.05$) and the stream outlet *E. coli* data also correlate with ammonium-nitrogen data (Pearson $r=0.660$, $p<0.05$). Such a correlation would suggest the source of bacterial contamination is septic tank effluent, particularly as ammonium nitrogen in the stream outlet is higher than the upstream site.

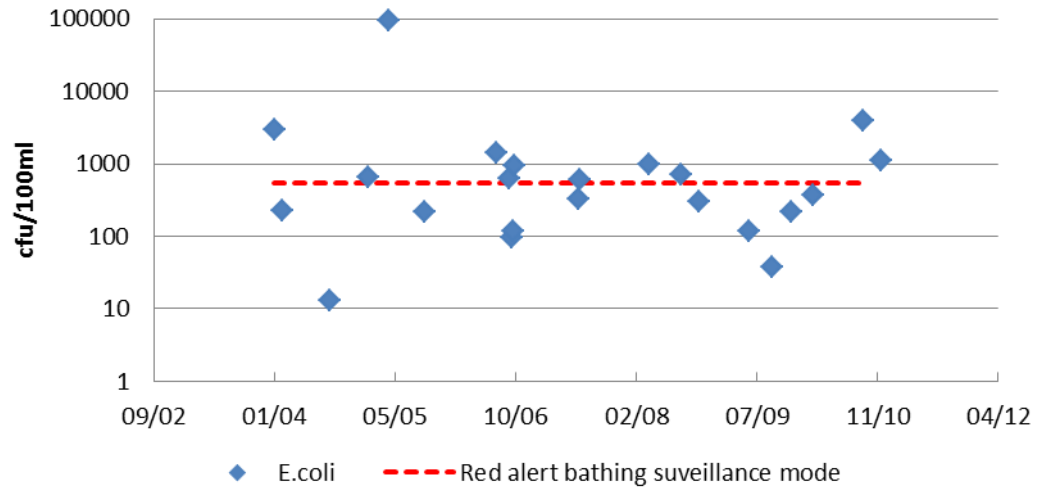
Figure 3.43 *E. coli* concentrations, Stream outlet, Bryans Beach.

The *E. coli* data for the stream is more variable with only five of the 18 sample points for the upstream sampling site being an order of magnitude higher than in the downstream. This suggests contamination as indicated by *E. coli* is intermittent and that there is a bacterial loading from the rural source as well as septic tanks. The concentrations of *E. coli* and other indicator bacteria are high in the drain to stream outlet showing contamination must be from septic tanks.
