*InSitu Heritage Ltd.*

25 October 2018

**ARCHAEOLOGICAL ADVICE – PROPOSED STREAM  
EROSION PROTECTION WORKS, WAITANGI STREAM, 341  
SPENCER ROAD, LAKE TARAWERA, ROTORUA DISTRICT**

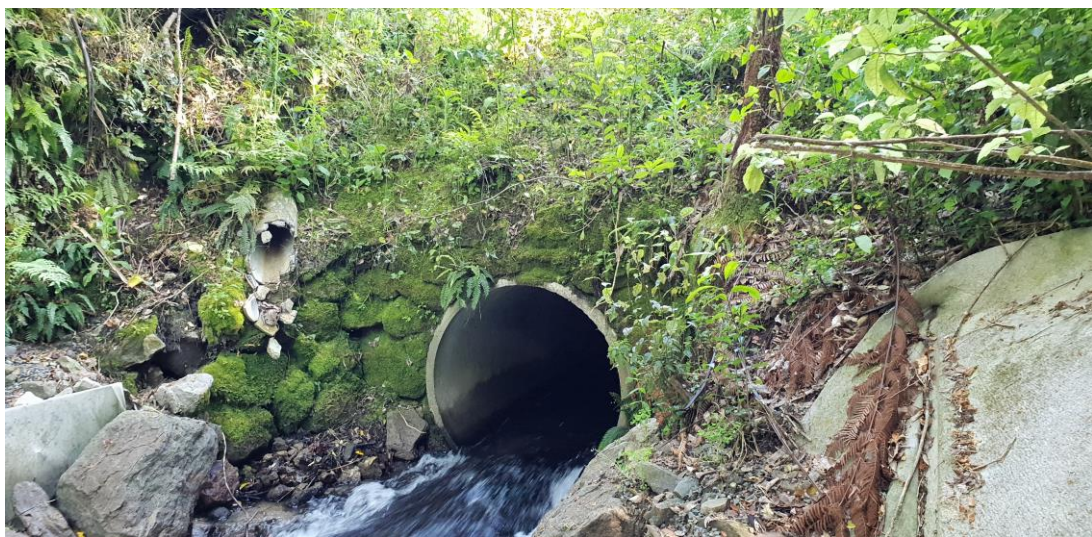
*Figure 2: Current culvert outlet (installed approximately 30 years ago), at the northern end of the proposed stream works.*

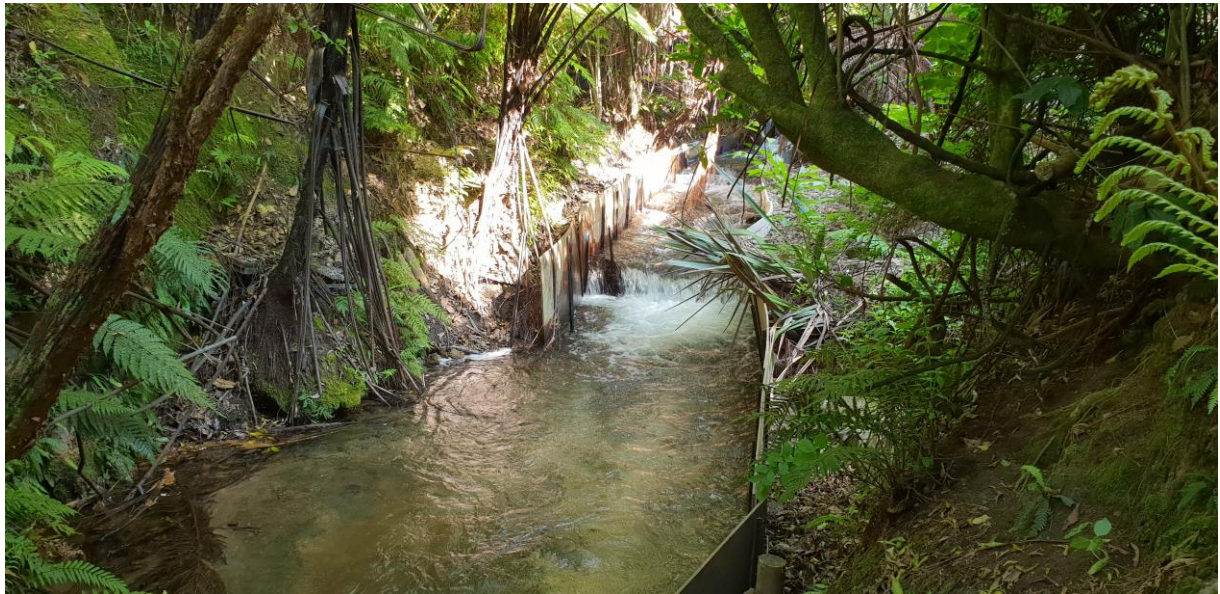
No archaeological sites were identified during the field inspection carried out on 24<sup>th</sup> October 2018. The area of proposed stream works has been subject to significant erosion, which has resulted in considerable incising and widening of the stream. It is highly likely that any archaeological evidence that may have been present immediately adjacent to the stream has already been eroded out. The proposed works will be confined to the incised portion of the stream course, and will involve very minor cutting of slumped material. The majority of works will relate to importing of rock and fill to reinstate the eroded sides of the stream.

*Figure 3: View upstream over the area of proposed works (looking toward the culvert outlet), illustrating stream incising and erosion. Protective boards have been installed as a temporary measure to reduce bank erosion.*

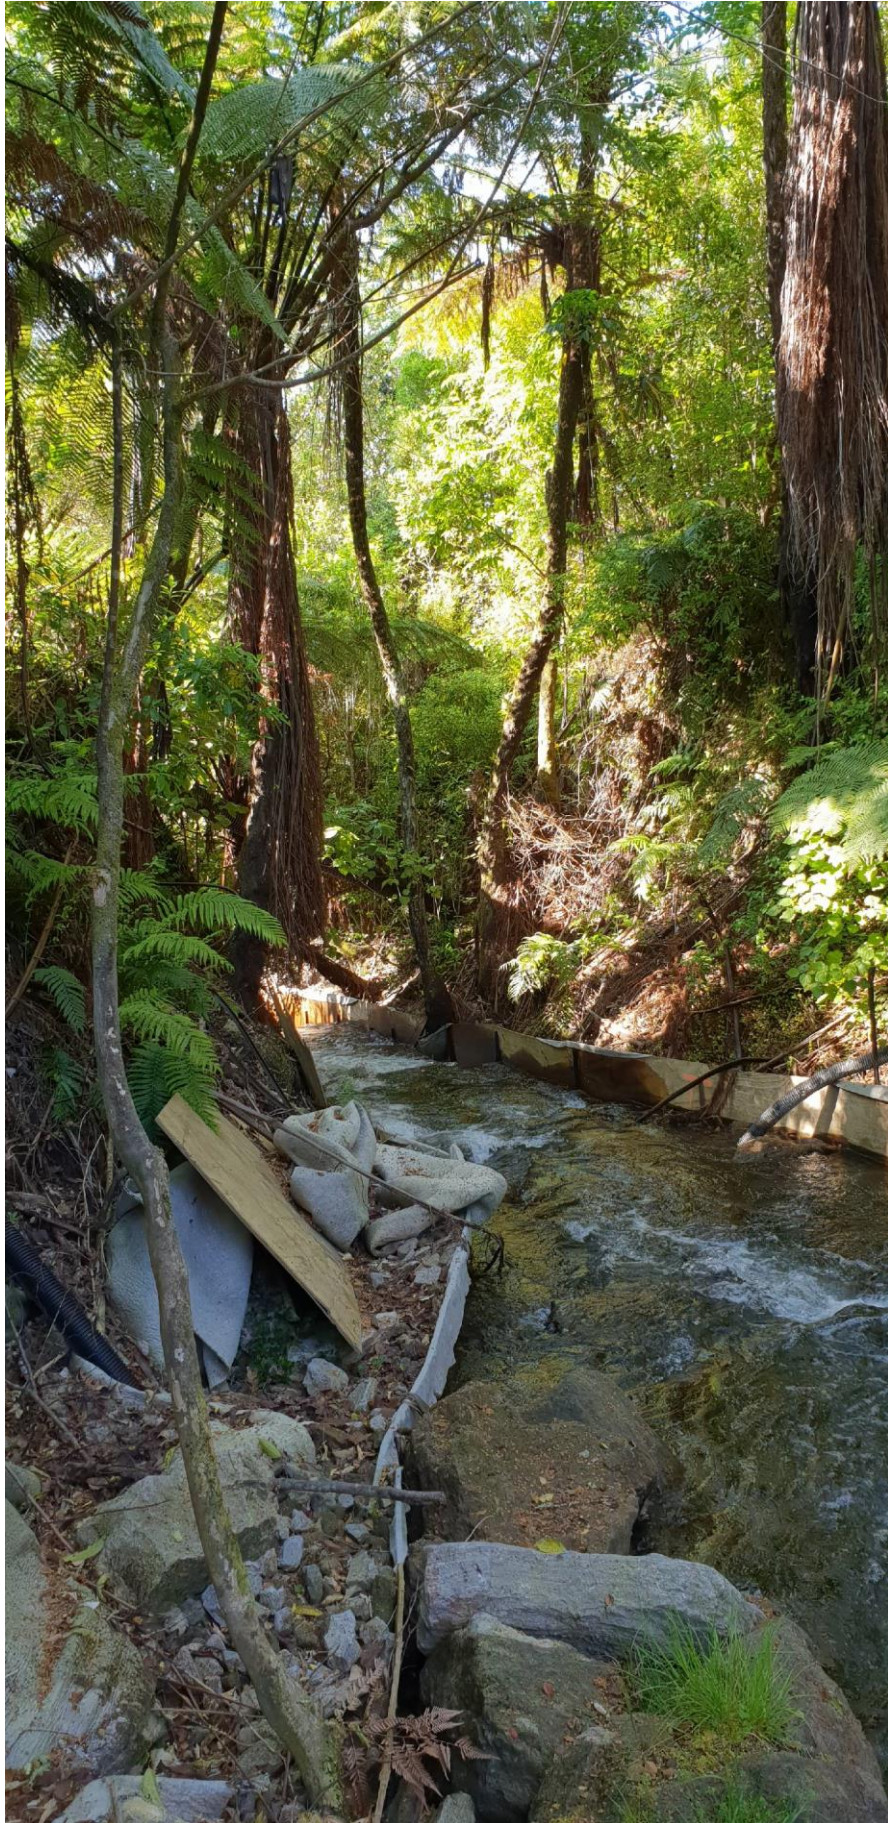
*Figure 4: View downstream within area of proposed works (looking toward Lake Tarawera) illustrating current erosion and previous modification.*
