Rangitaiki Tarawera Floodplain Management Strategy

Stage 1

Prepared by Robbin Britton, Project Engineer

Environment Bay of Plenty
Rivers & Drainage Publication 2008/01
September 2008

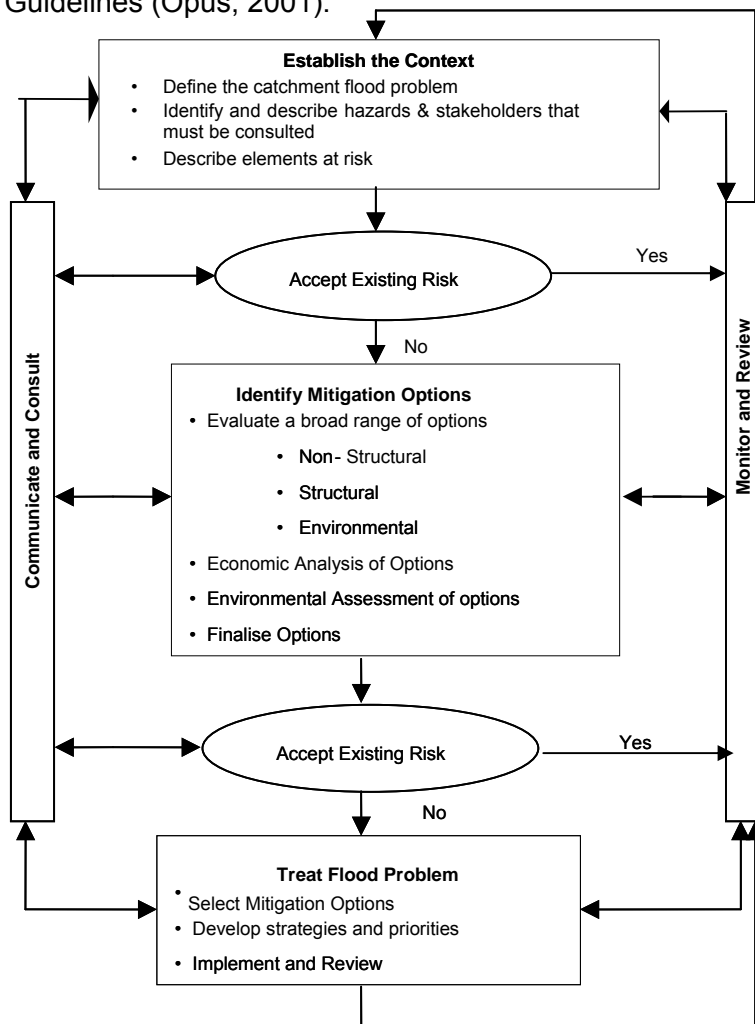
Figure 1.1 Floodplain Management Planning framework.

This strategy is developed using the floodplain management planning methodology presented in Figure 1.1. It is based on the framework provided in the FMP Guidelines (Opus, 2001).

The process in Figure 1.1 outlines a streamlined process that cannot be followed exactly for the RTFMS. The July 2004 flood that included a breach of Rangitaiki River stopbanks resulted in recommendations to construct structural improvements to the high risk Edgecumbe and Reid's Central Canal. While this work is out of

As indicated in the planning framework (Figure 1.1) consultation with key stakeholders is a fundamental requirement to ensure the success and acceptability of the Flood Management Strategy.

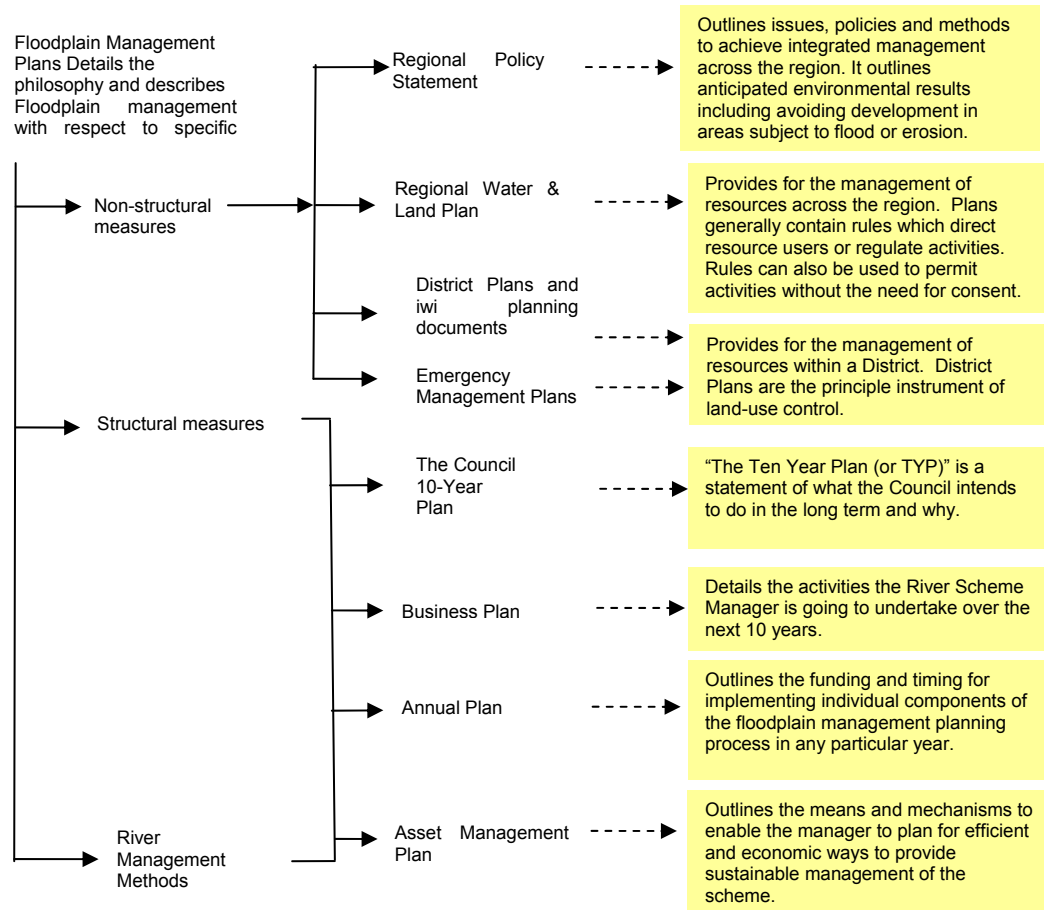
Figure 1.2 Relationship between Floodplain Management Strategies, regional and territorial authority plans.

The relationship between the RTFMS and other local authority plans is summarised in Figure 1. 2.

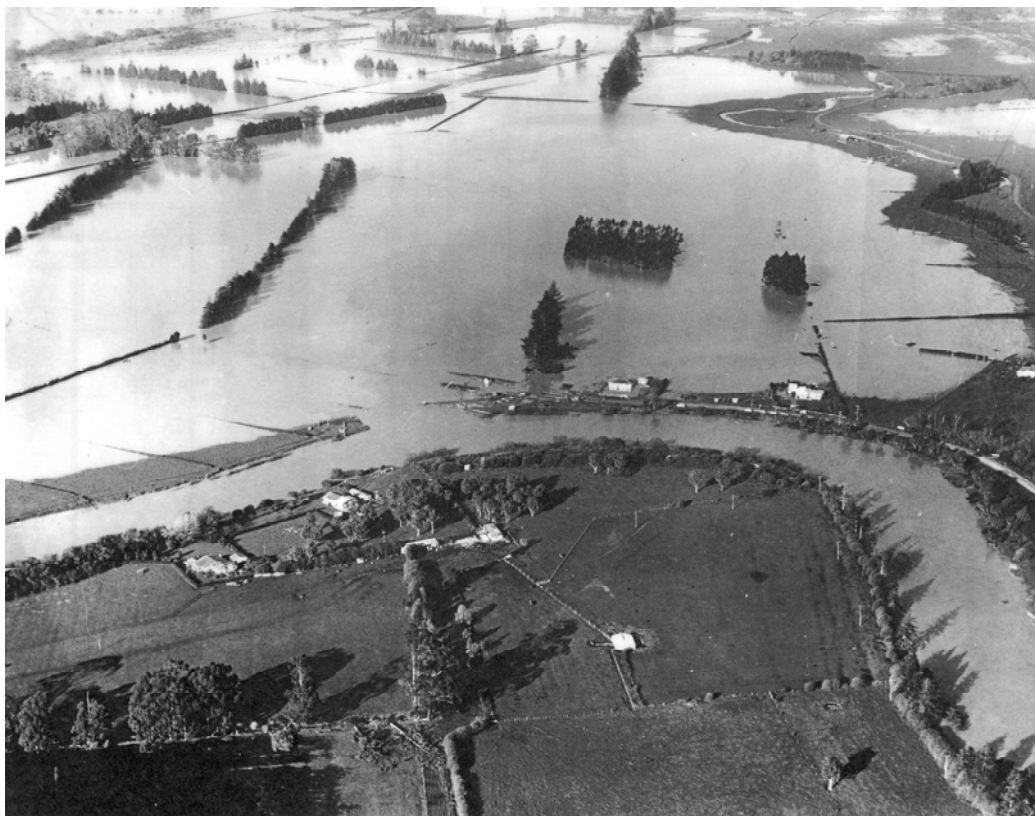
Figure 1.6 Stopbank breach at Reynolds Bend, Rangitaiki River in 1962 (river flow direction is from right to left in downstream direction).

Further heavy rain caused a second flood peak of 416 m³/s (14,700 cusecs) and on Friday, 1 June the newly repaired bank was again breached and severe flooding occurred once more. But worse was still to come. During the night of 1-2 June the Tarawera River overtopped and breached the right bank at 3.61 km (2 m 70 ch) and on Saturday, 2 June the Kopeopeo West Canal burst its banks and by that evening over 3,238 ha (8,000 acres) was inundated. (BOPCC, 1985, p14).

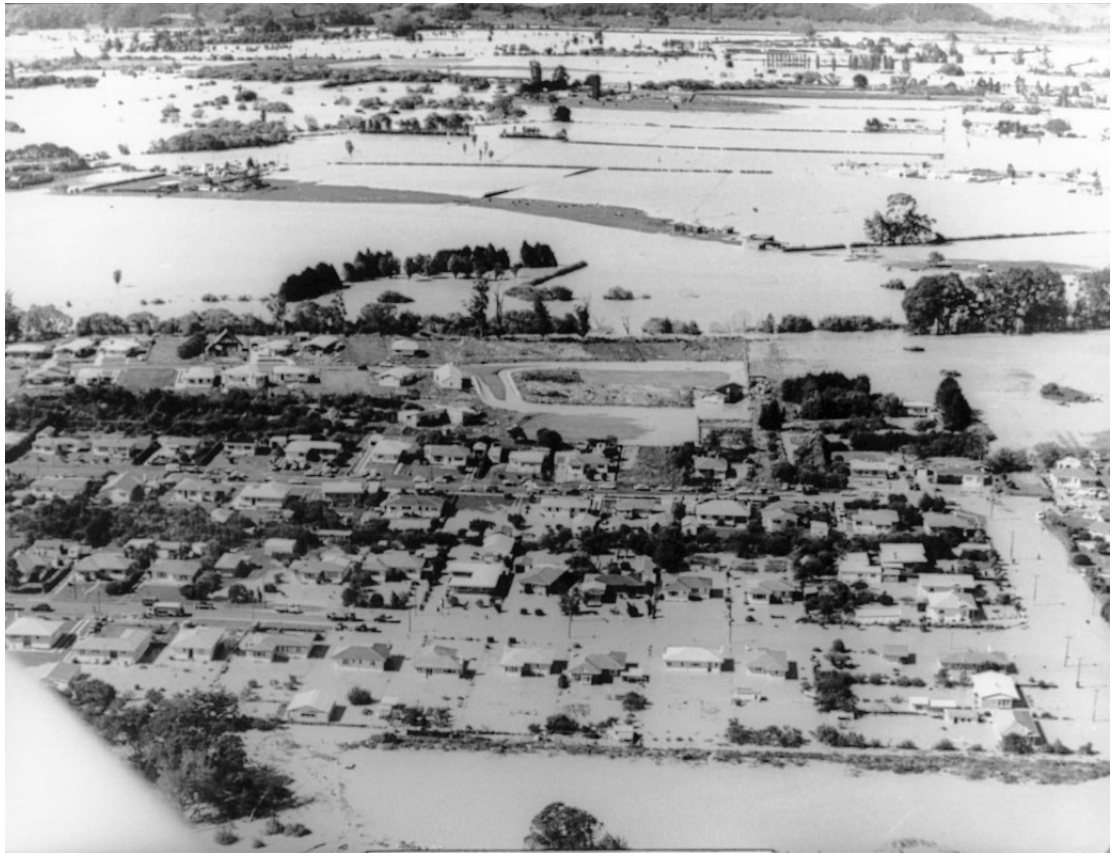
Figure 1.7 Photo from over the Board Mills looking towards Whakatane West Station (i.e. the Rangitaiki Plains) (February 1965).

High floods occurred again in February 1965, 596 m³/s (21,050 cusecs) and overflow at Pepperells Bend on Rangitaiki River flooded approximately 1,416 ha (3,500 acres) (BOPCC, 1985, p14).

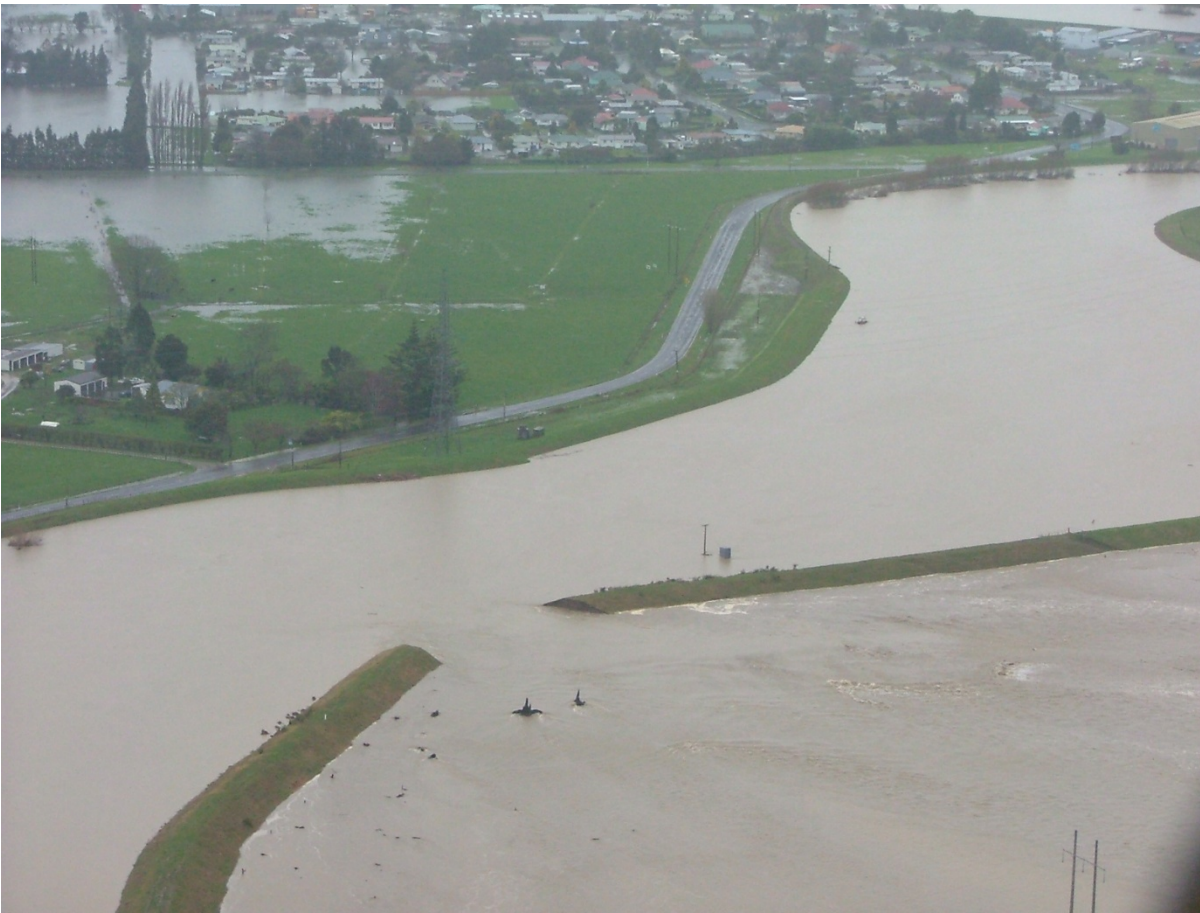
Figure 1.8 Stopbank breach at Sullivan's Bend, Rangitaiki River July 2004 (SW Edgecumbe in background).

At approximately 10.00 am on 18 July, a 100 m wide section of the main Rangitaiki true right stopbank upstream of Edgecumbe failed without warning. This breach immediately sent between a quarter and a third of the Rangitaiki floodwaters onto the Plains which flowed both northwards and eastwards overwhelming the Reid's Central Canal floodway as it did so. Over the next two days the breach floodwaters seriously inundated thousands of hectares of farmland and associated property infrastructure. Much of the Lower Rangitaiki/Tarawera River Scheme and Rangitaiki Drainage Scheme infrastructure was also overwhelmed.

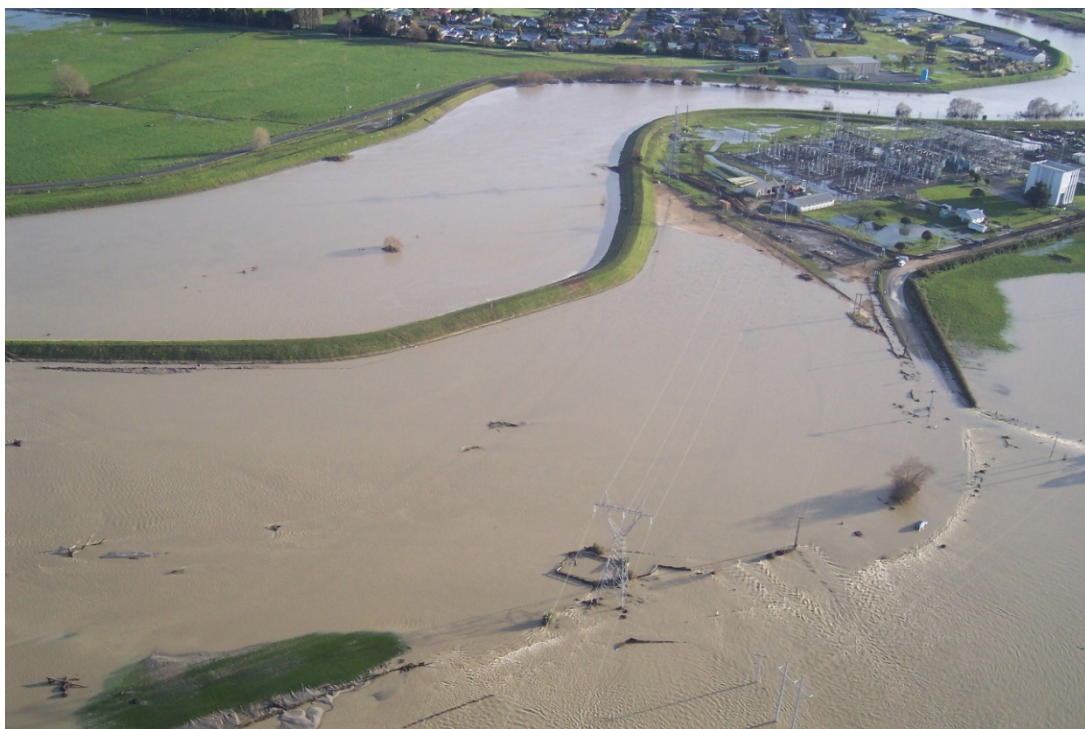
Figure 1.10 View of Rangitaiki River looking downstream at Edgecumbe with TransPower substation to right, July 2004.

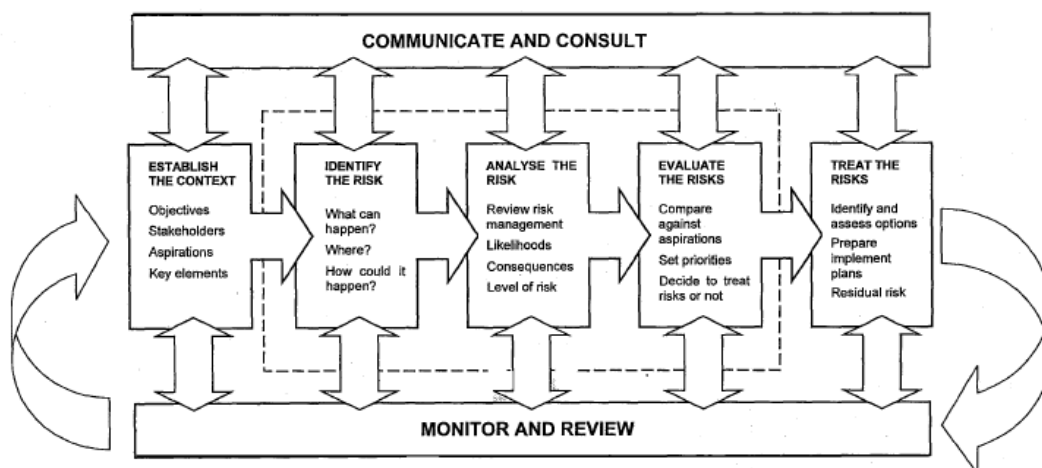
Figure 1.12 Risk management process proposed in draft NZS9401

The draft flood hazard standard provides a risk based framework for comprehensive management of flood risk in New Zealand. The risk management process shown in Figure 1.11 is very similar to the process adopted for this Flood Management Strategy as already shown in Figure 1.1. With reference to Figure 1.6 this Stage 1 report establishes the context and identifies the flood risk. Stage 2 will analyse and evaluate the flood risk and final Stage 3 will treat the flood risk.

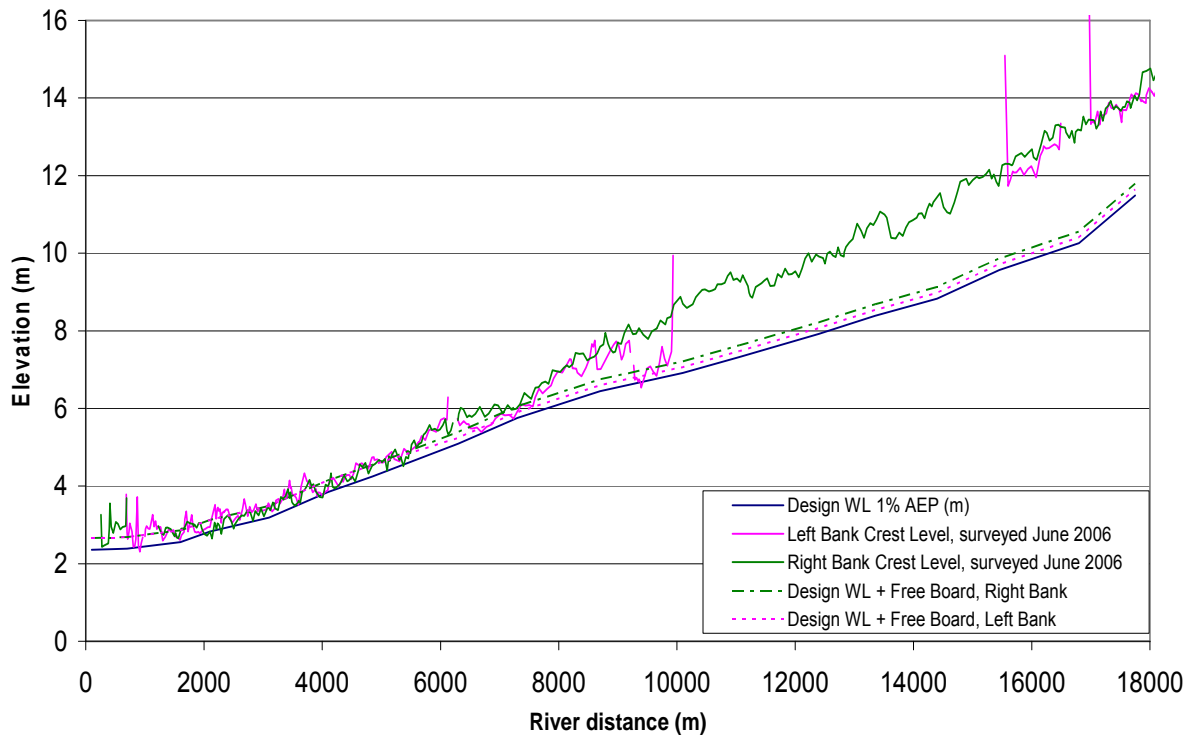
Figure 2.1 Flood levels in Tarawera River below State Highway 30 and stopbank crest levels (from Everitt and Medwin, 2005).

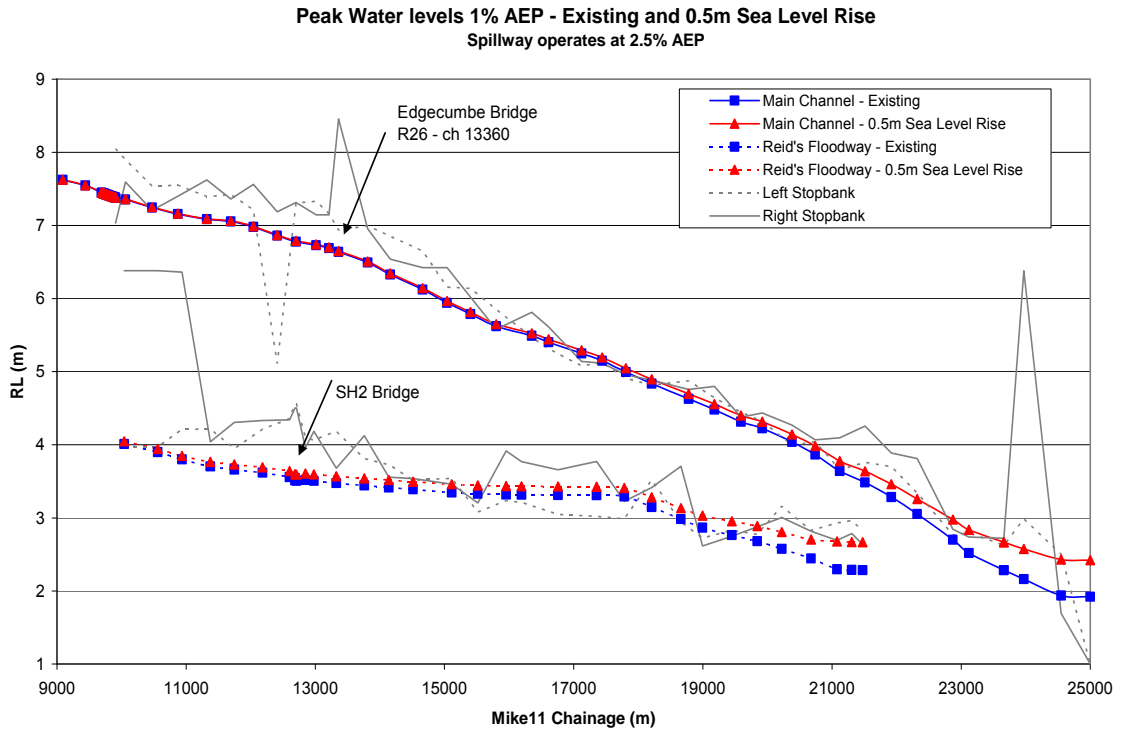
Figure 2.2 Modelled maximum water levels under existing and predicted sea level rise of 0.5 m (from OPUS, 2007). Levels exclude freeboard.

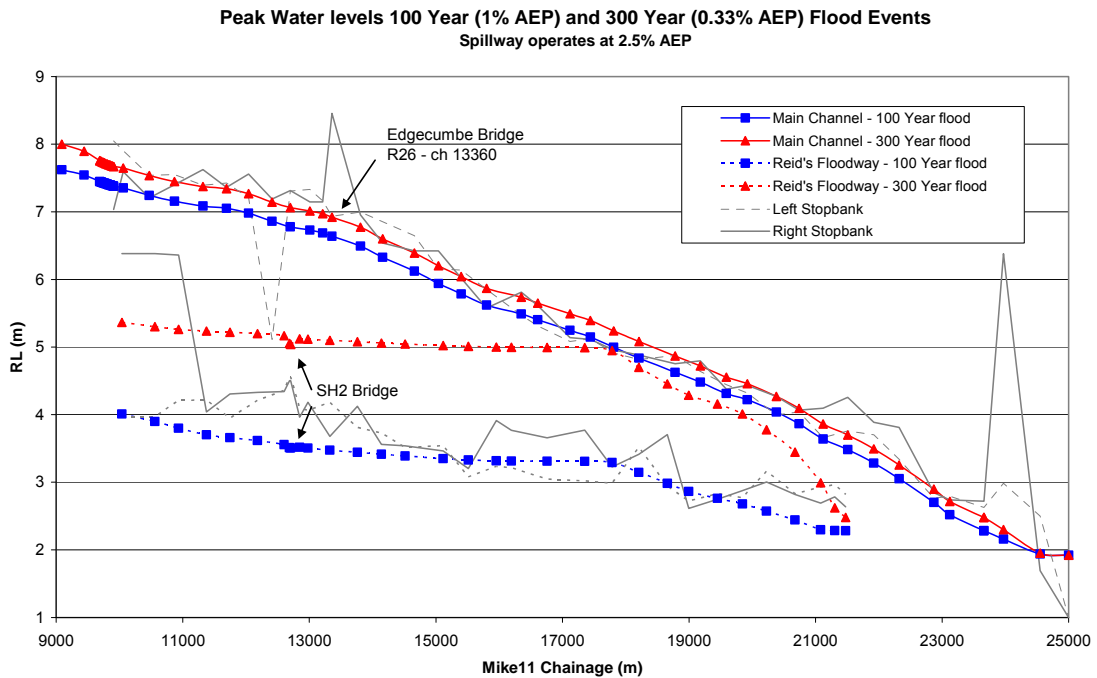
Figure 2.3 Modelled maximum water levels under 100 and 300 year flood events (300 year flood predicted to be future 100 year flood in 2080) (from OPUS, 2006). Levels exclude freeboard.
