Coastal State of the Environment Report

April 2014

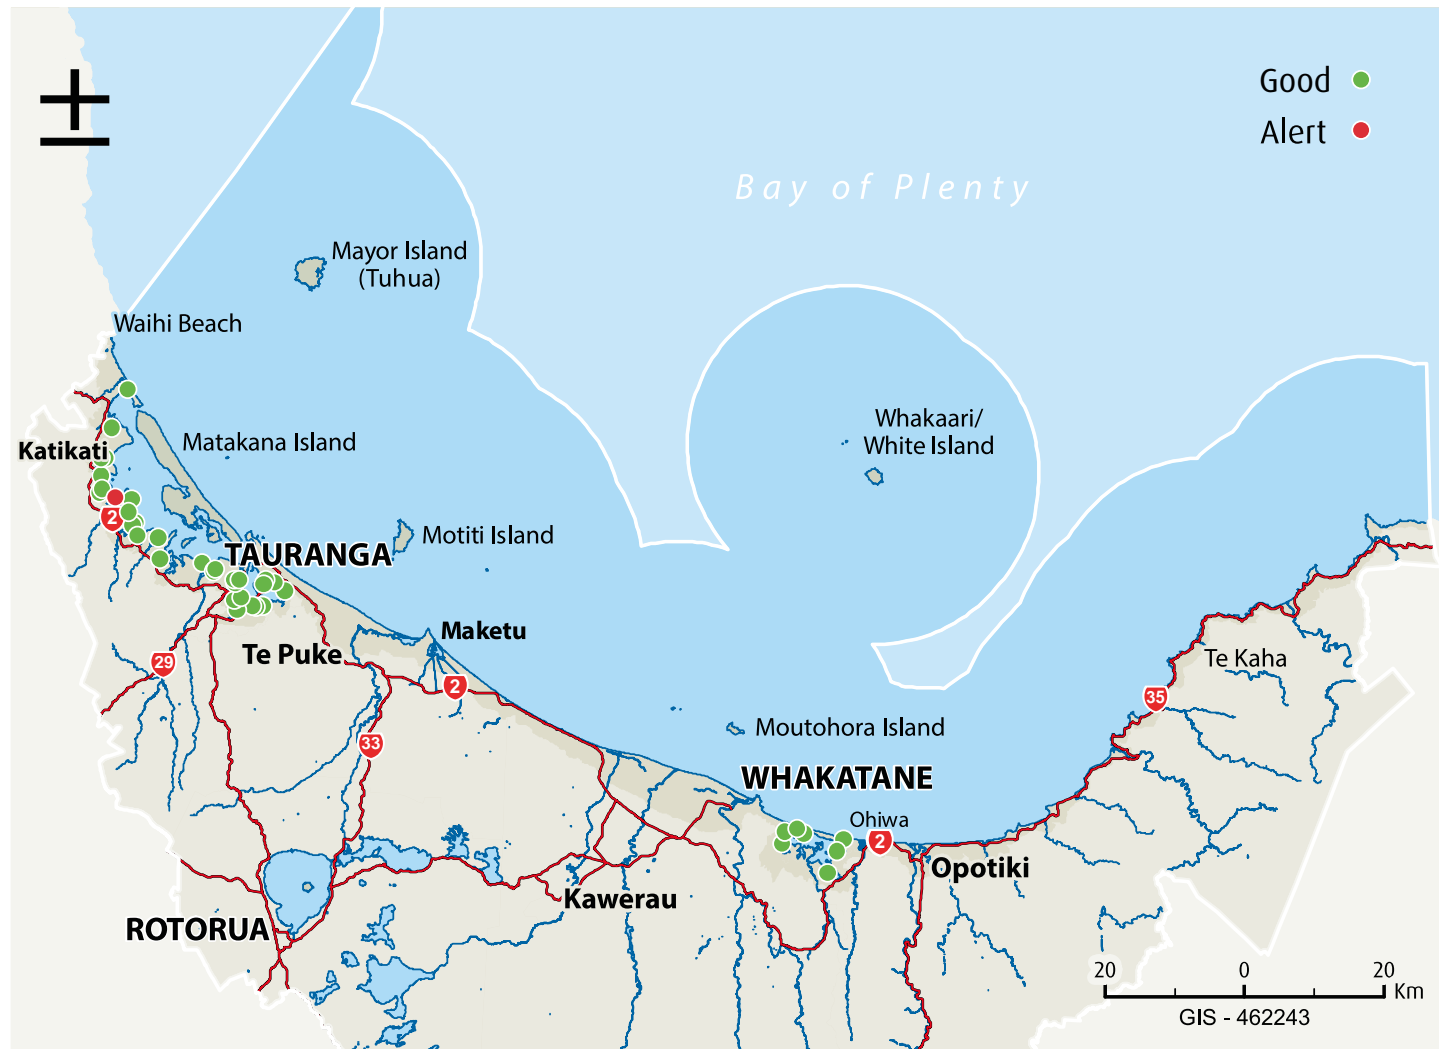
Sediment quality in Tauranga and Ōhiwa Harbour

Similar to a trend shown in the Auckland region, sites next to urban or commercial development appear to have elevated levels of contaminants. However, with the exception of the Matahui site in Tauranga Harbour, none of the 38 sites sampled to date have exceeded the guidelines. The Matahui site consistently has a higher mercury level than surrounding catchments. The source has not yet been identified and research is on-going.

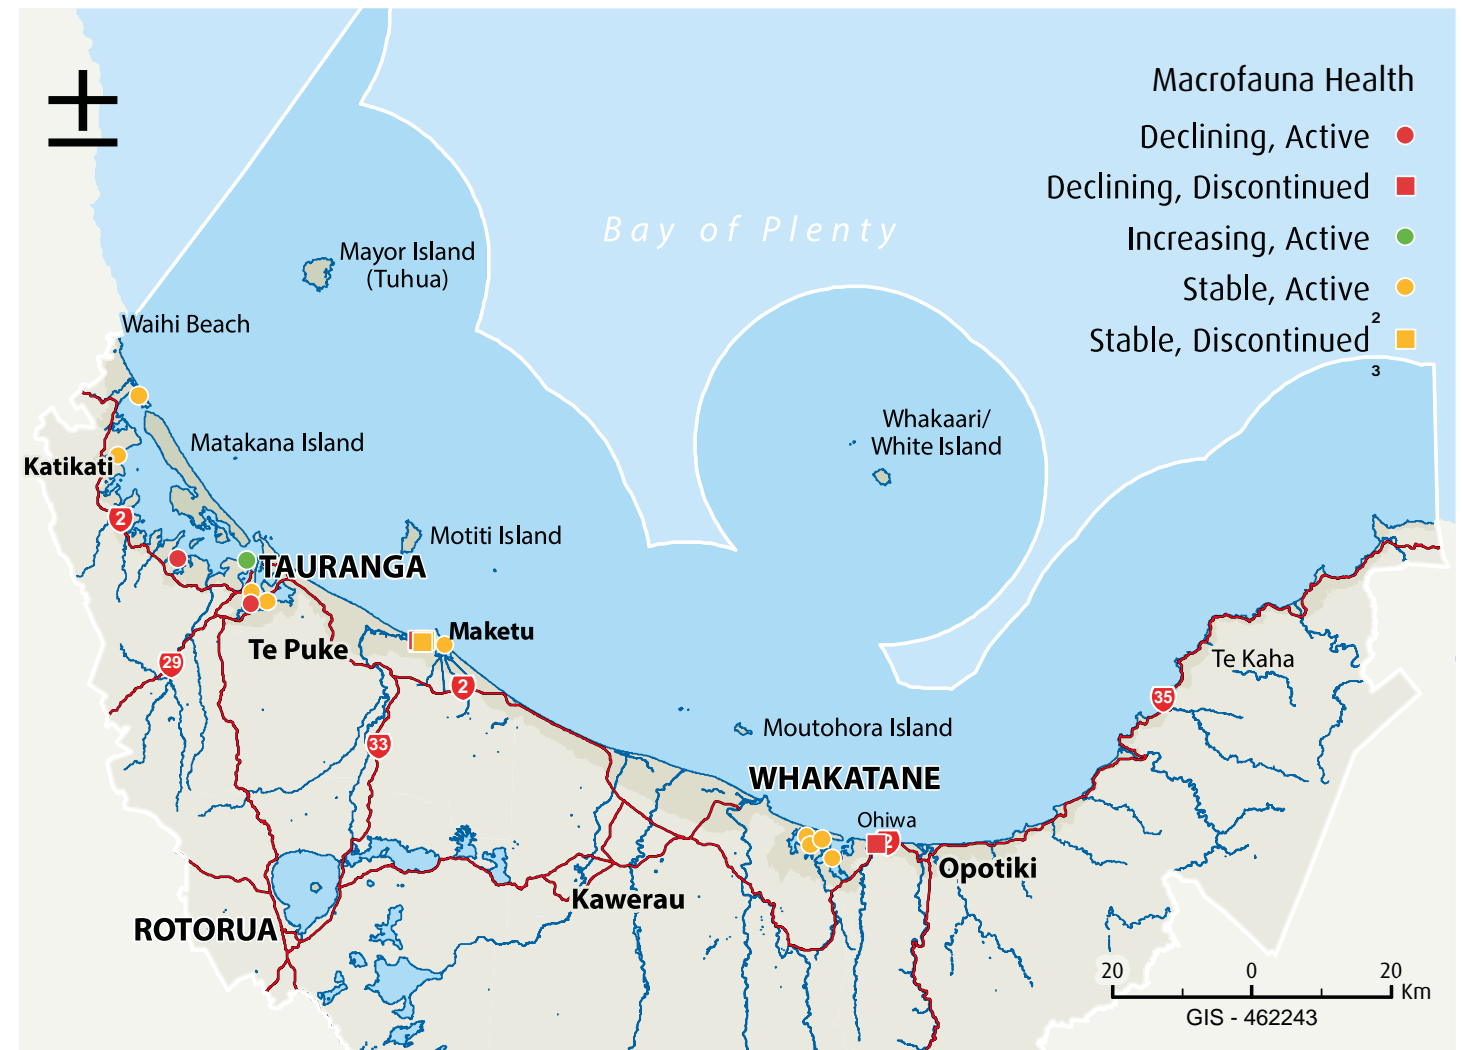
Results of macrofauna monitoring along the Bay of Plenty coast

Macrofauna are animals larger than 0.5 mm in size. A coastal and estuarine monitoring programme was established in 1990 to monitor macrofauna health at exposed and sheltered soft-shore sites. Animals found in these areas include shellfish, worms, crabs and isopods (such as sea-slaters).

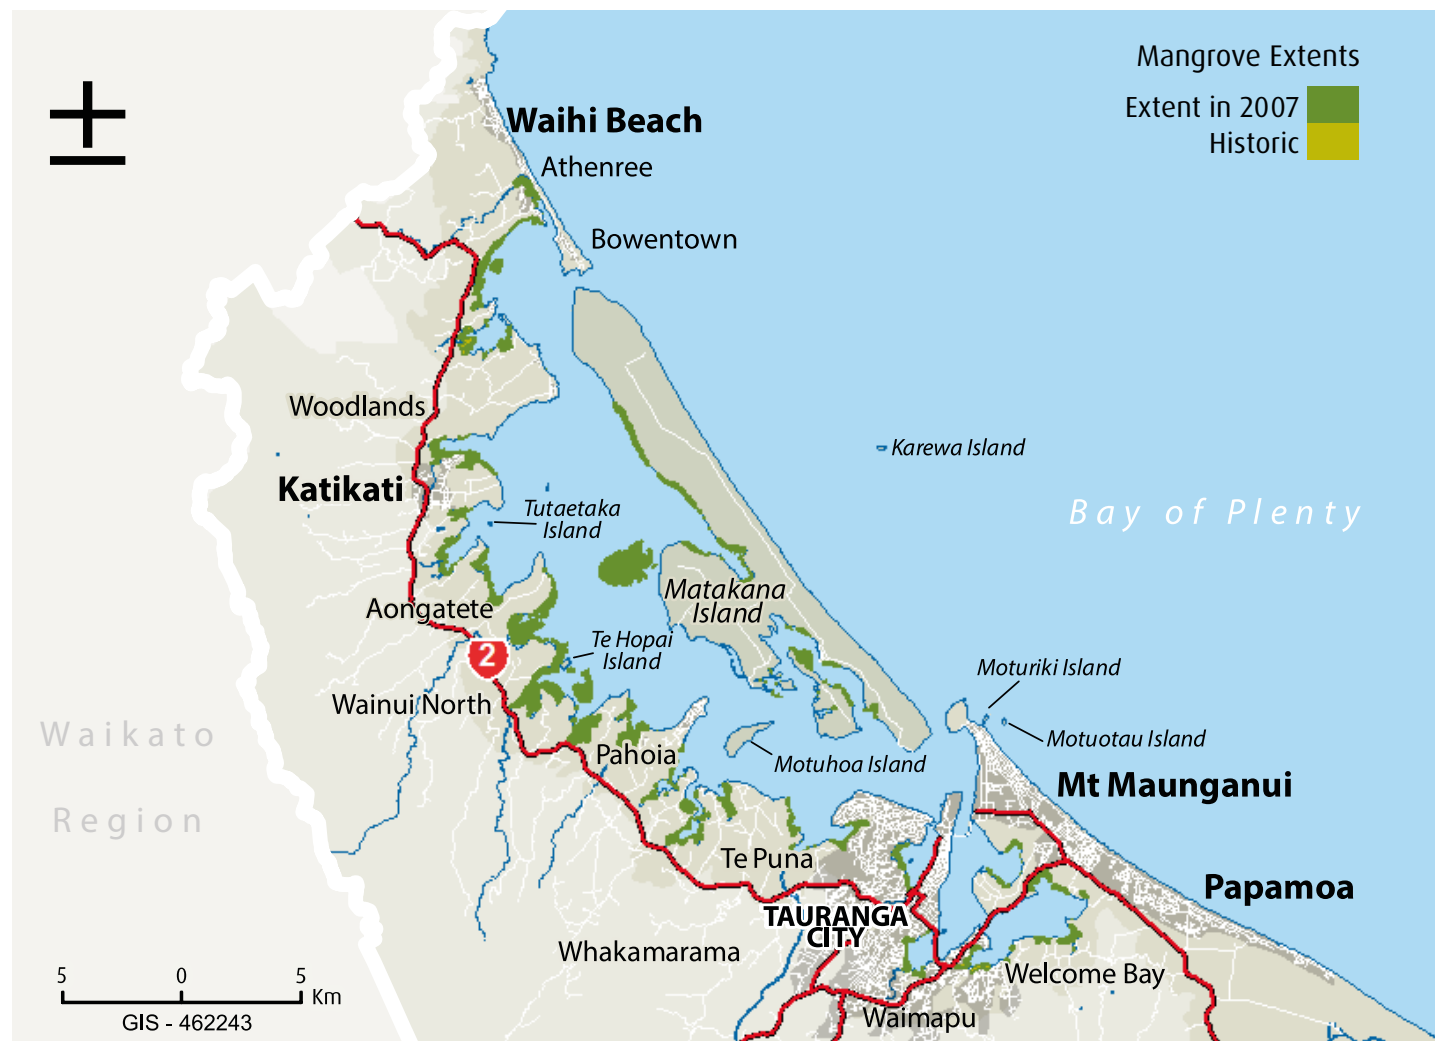
Mangrove extents in Tauranga Harbour

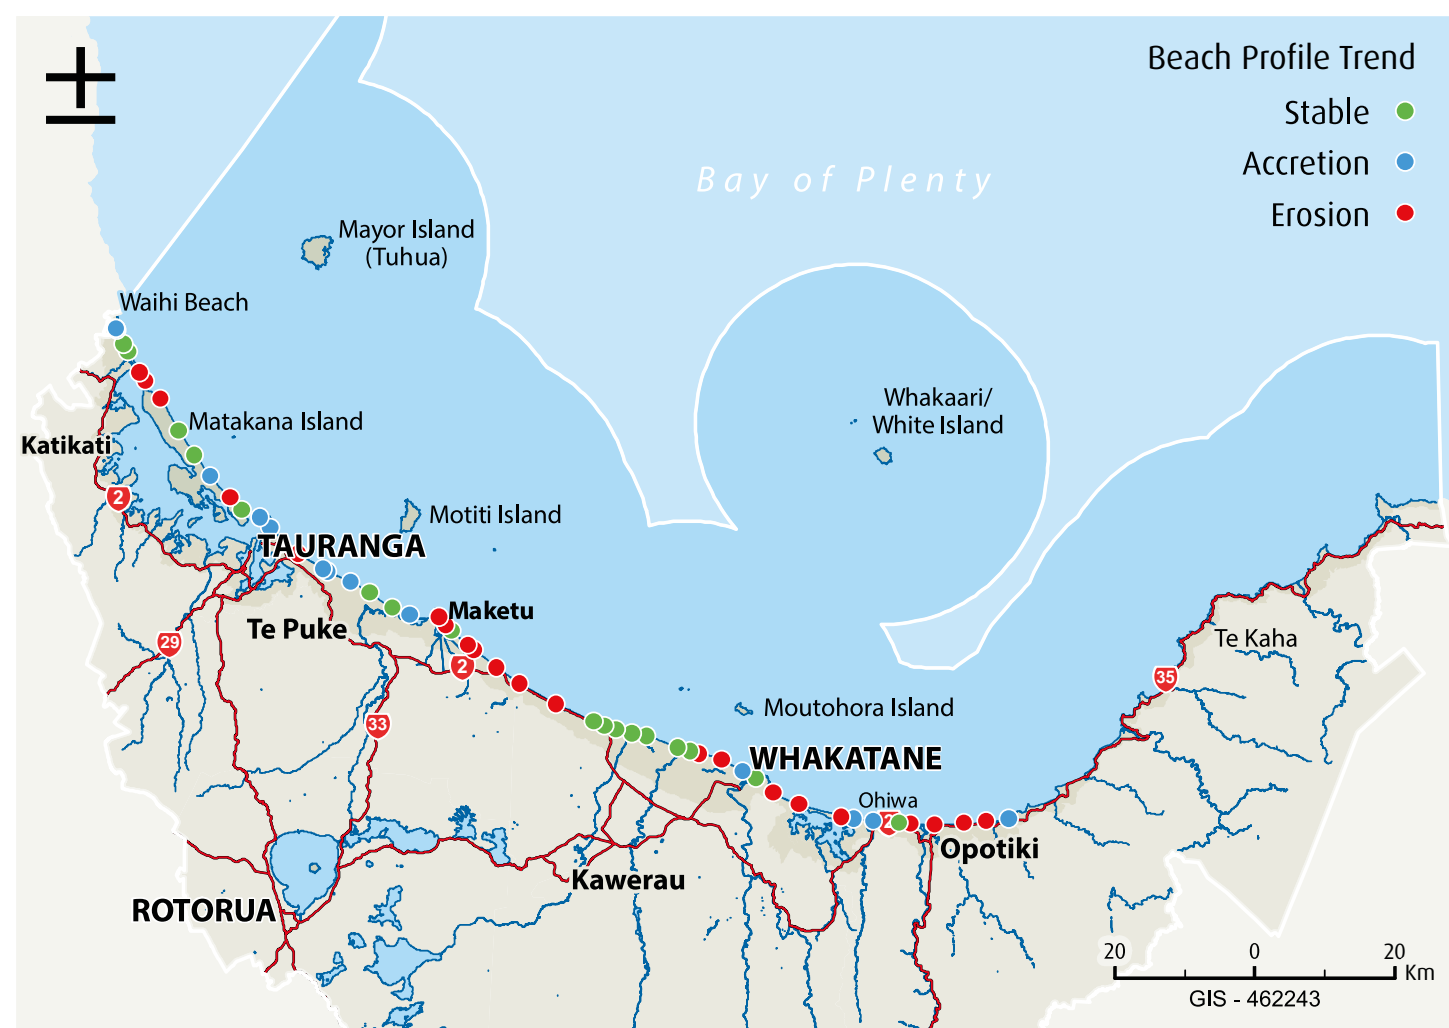
State of sandy beaches along the Bay of Plenty coast 2011

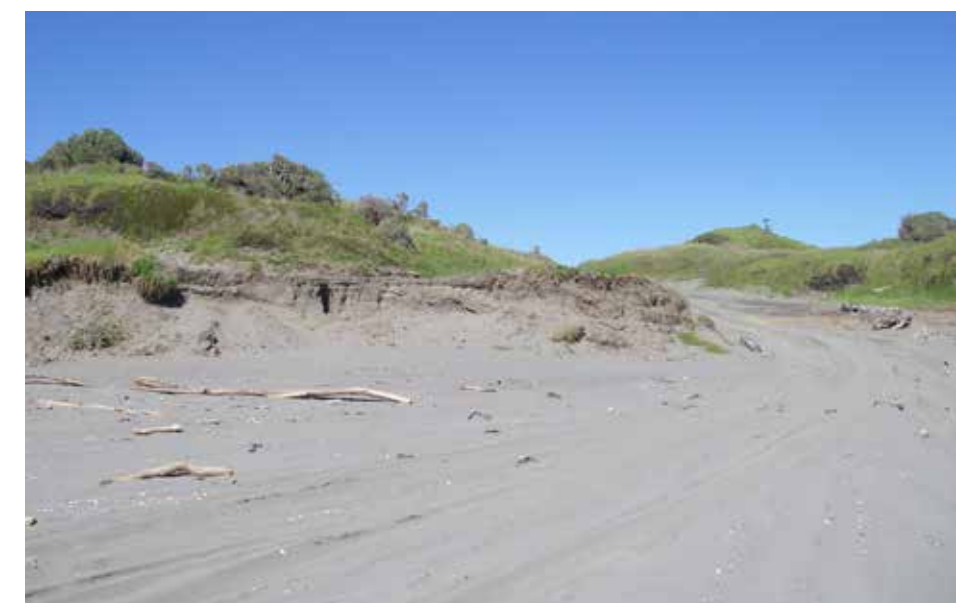
Hikuwai Beach - well-used vehicle access track and eroded fore dune
