ARCHAEOLOGICAL ASSESSMENT

PROPOSED STORM WATER UPGRADE MATUA, TAURANGA

KEN PHILLIPS

JULY 2014

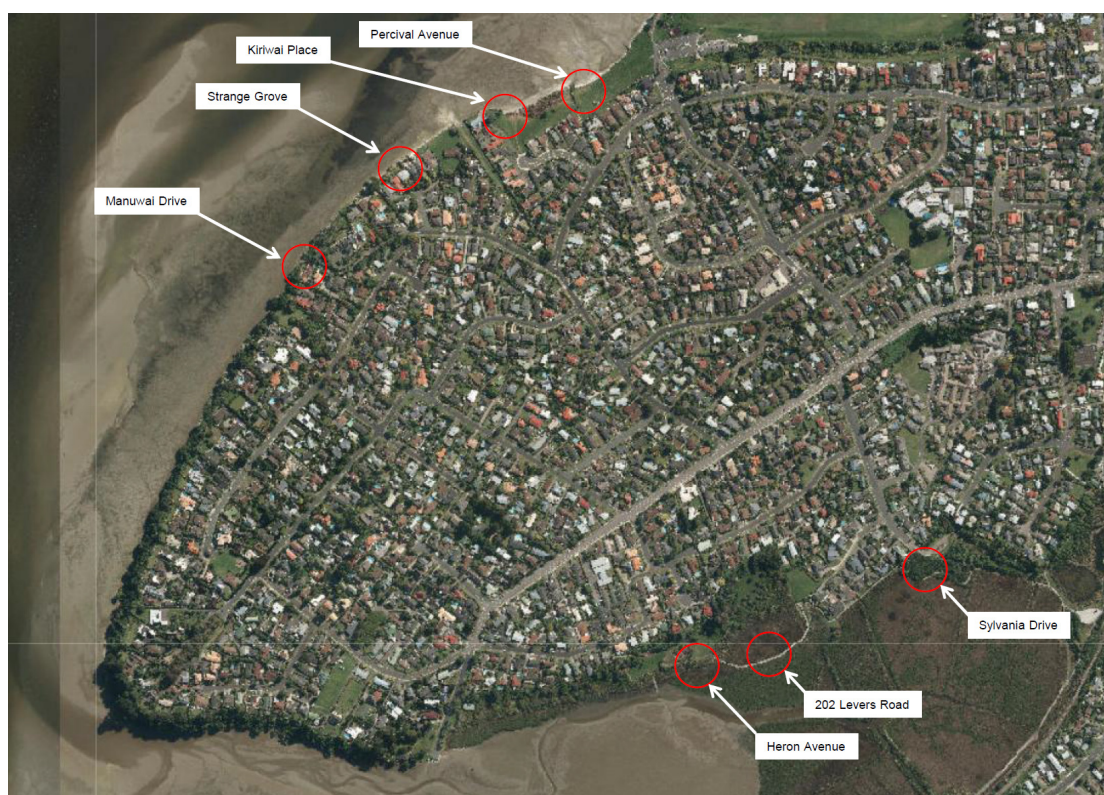
Figure 2. Aerial photo showing the location of the seen possible stormwater outfalls.

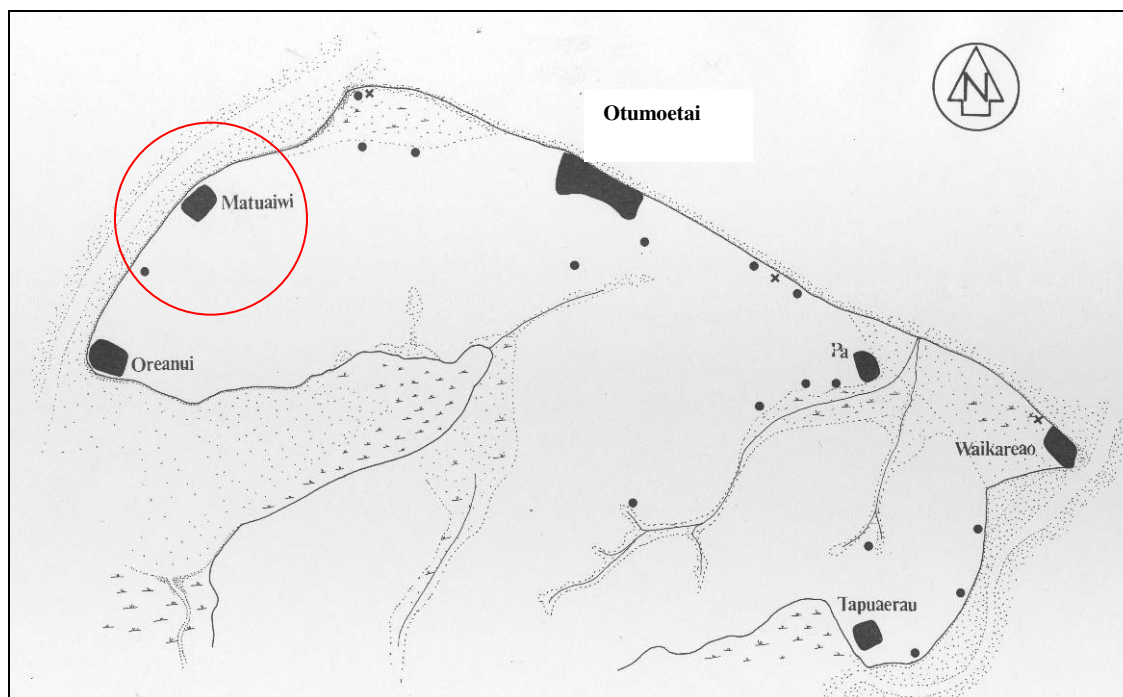
Figure 4. Sketch plan showing the location of the six pa on the northern end of the Matua / Otumoetai peninsula in relation to the project area circled red. Black dots indicate recorded midden sites. (Sketch by K. Phillips 2002).

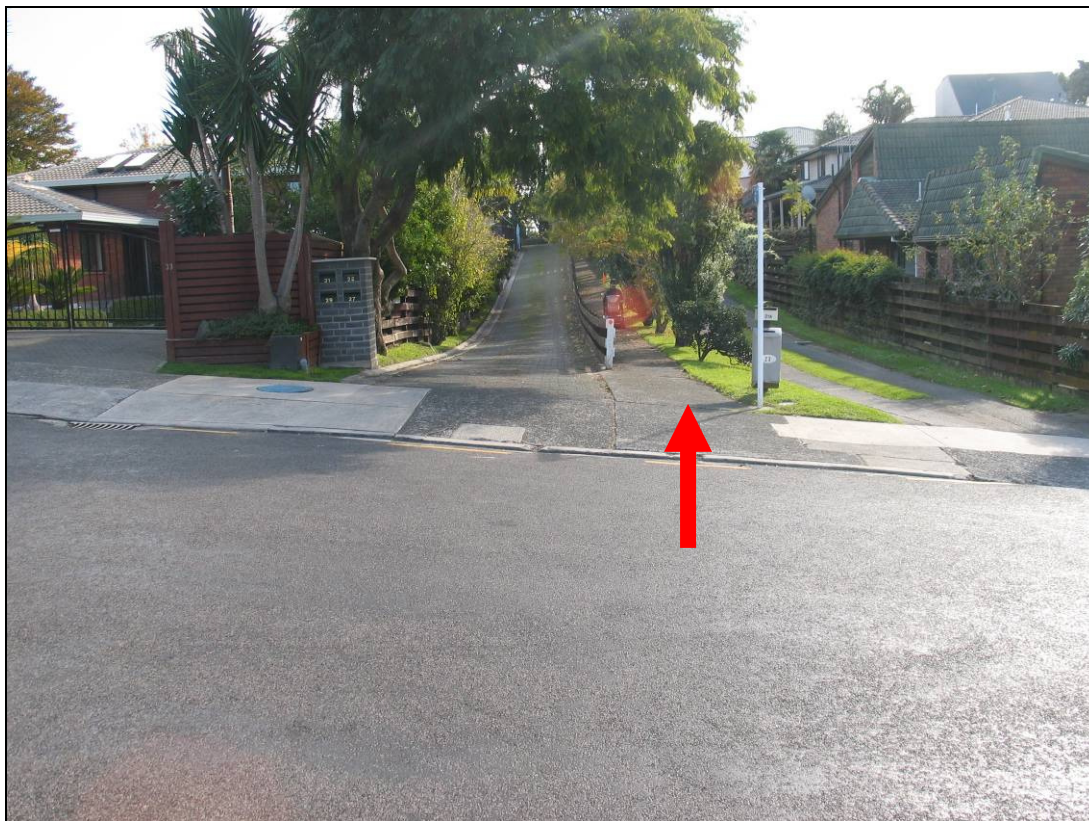
The proposed pipe alignment between 17 and 33 Manuwai Drive is located within a Local Purpose Reserve (Lot 15 DP 34289). The reserve is located within 50 metres of the southwestern end of Matuaiwi Pa. While land affected by the alignment is bounded by intensive residential development it appears to retain its original contour with only minor earthwork for the construction of the concrete path and coastal escarpment steps.

Figure 6. View of southern entrance to Lot 15 DP 34289 between 17 & 33 Manuwai Drive.

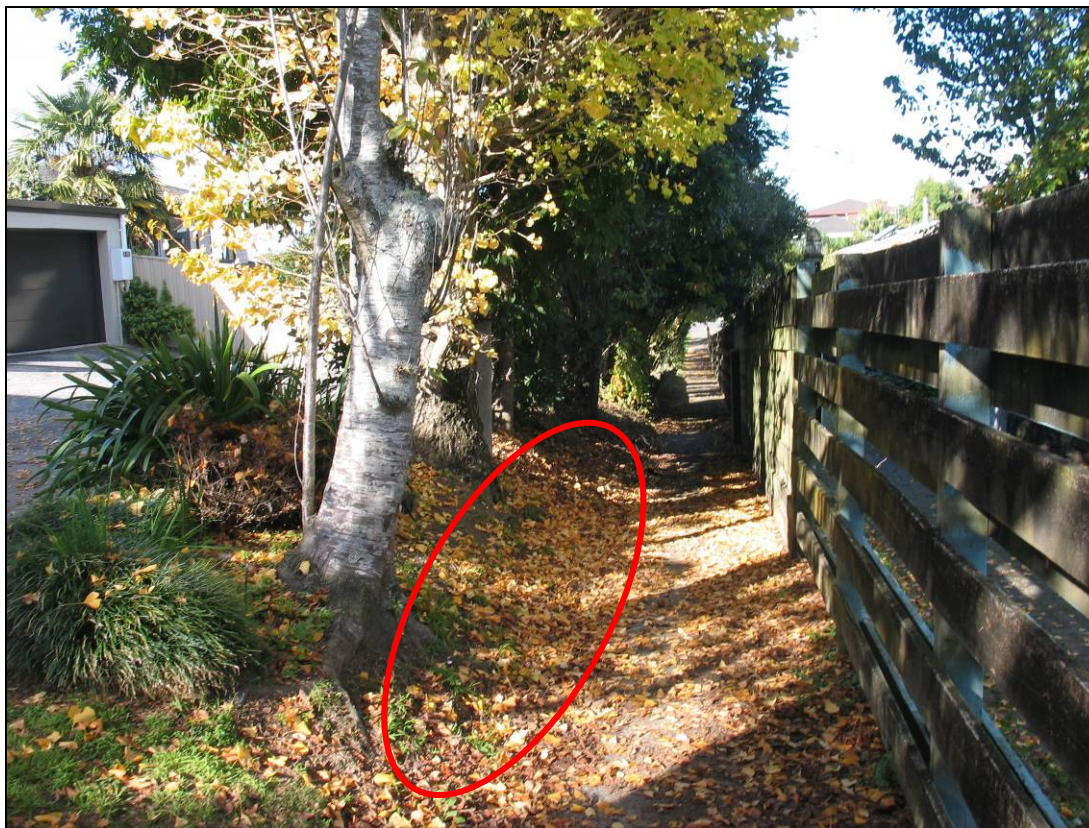
Eroding shell midden was noted along the eastern side of the concrete path and extensive shell midden deposits are eroding down the coastal escarpment on either side of the steps down to the beach. The shell is indicative of occupation on the raised level ground immediately above the escarpment and may relate to undefended occupation directly associated with Matuaiwi Pa.

Figure 7. View of minor cutting on north side of footpath within Lot 15 DP 34289 where shell midden is exposed.

The proposed directional drilling of the storm water pipe through the reserve will limit ground disturbance to entry and exit points, however given the intensive nature of the archaeological landscape there is a possibility that subsurface archaeological features will be disturbed at both locations.

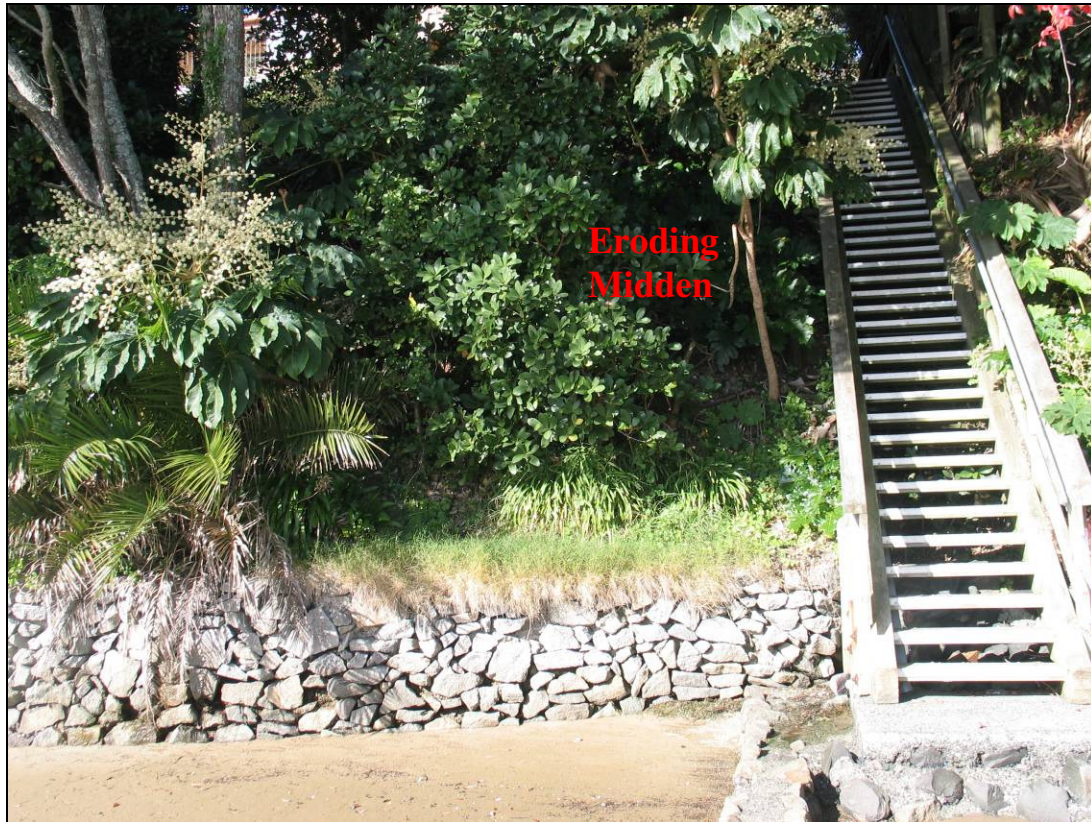
Figure 8. View of steps down coastal escarpment at northern end of Lot 15 DP 34289. Eroding shell midden is visible on the escarpment immediately adjacent to the steps and in the immediate vicinity of the proposed storm water pipe exit.

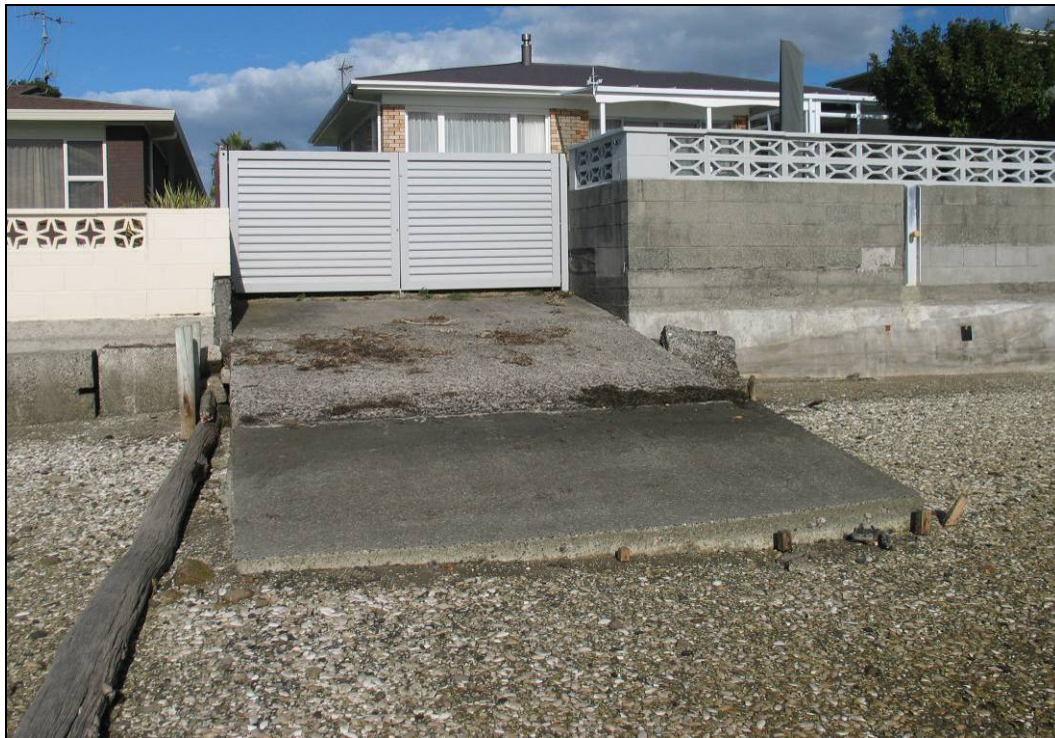
This property is situated on a low coastal terrace on the west side of a former wetland and stream and approximately 100 metres north east of Matuaiwi Pa. The construction of the existing dwelling and section landscaping in the 1960s has likely had limited impact on the natural contour and substrata within the property.

Due to the current land use and surface treatments it was not possible to carry out subsurface testing along the two alignment options and the concrete wall covering the low coastal step prevented visual inspection of the former erosion scarp. The exposed coastal scarp 20 metres to the north east was equally uninformative due to reclamation fill obscuring the natural soil profile.

Figure 9. View of the concrete wall and slipway along the northern end of 11 Strange Grove where the storm water outlet is proposed.

Despite the lack of tangible archaeological information within 11 Strange Grove and the adjacent coastal and road reserves there is reasonable cause to suspect that intact subsurface archaeological features are present within the property that may be disturbed by either of the two storm water pipe alignment options.

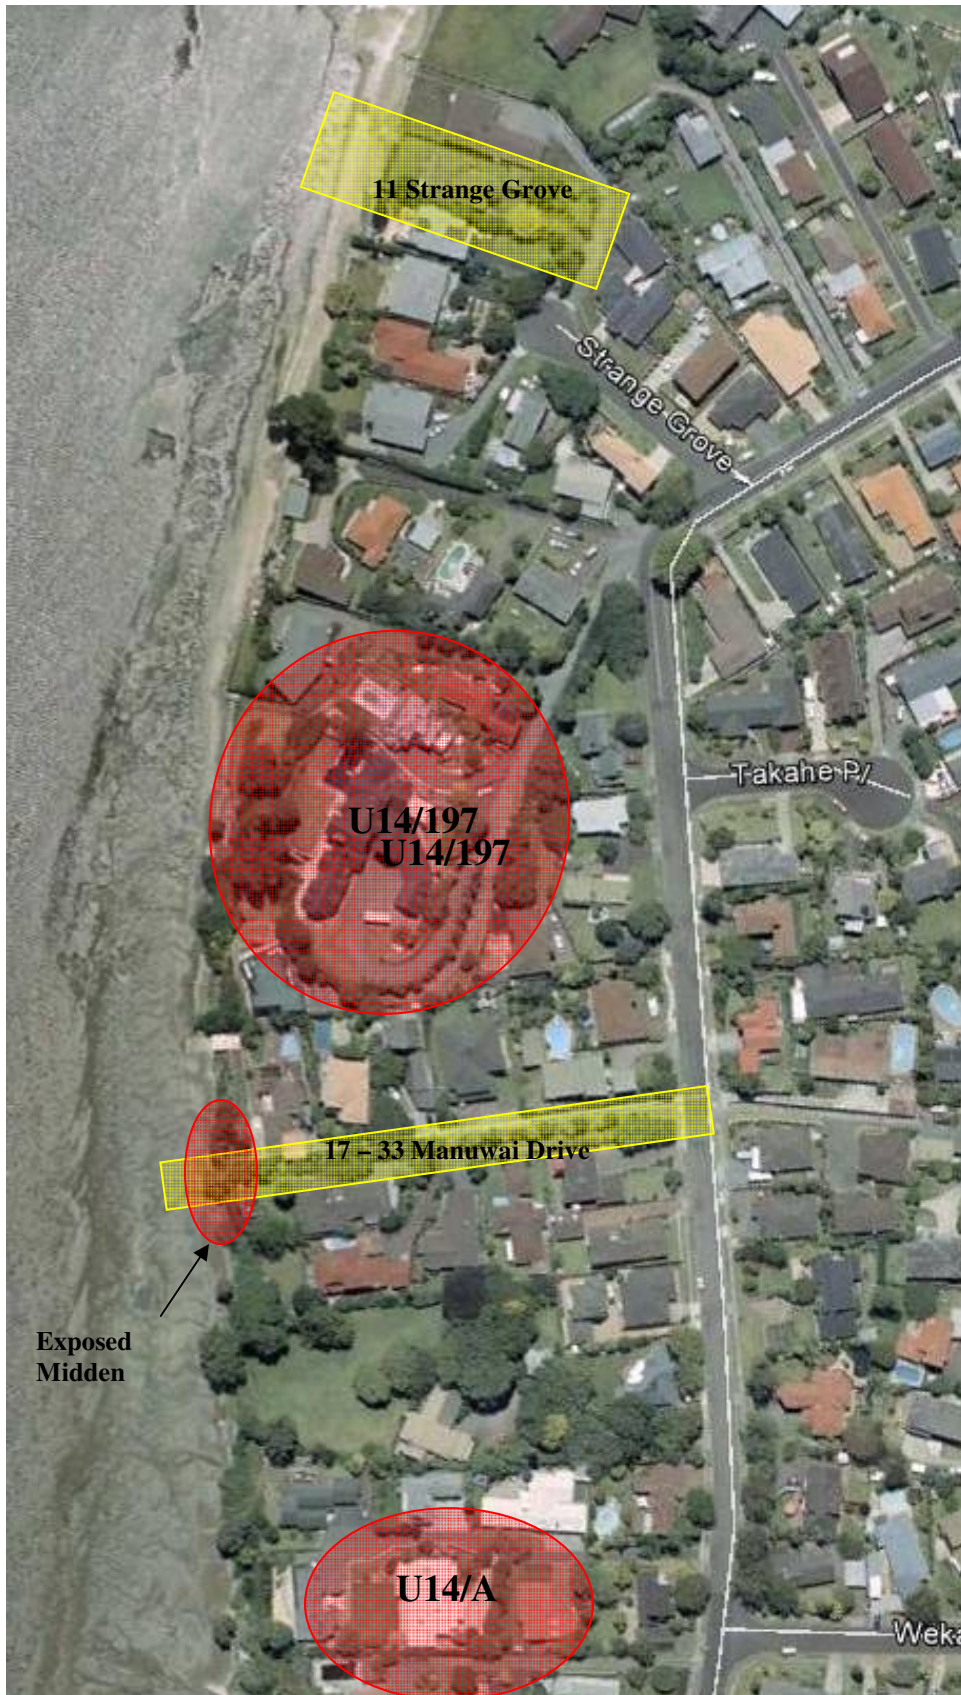
Figure 10. Aerial photo showing the location of known archaeological sites in relation to properties affected by the Stormwater upgrade proposal.

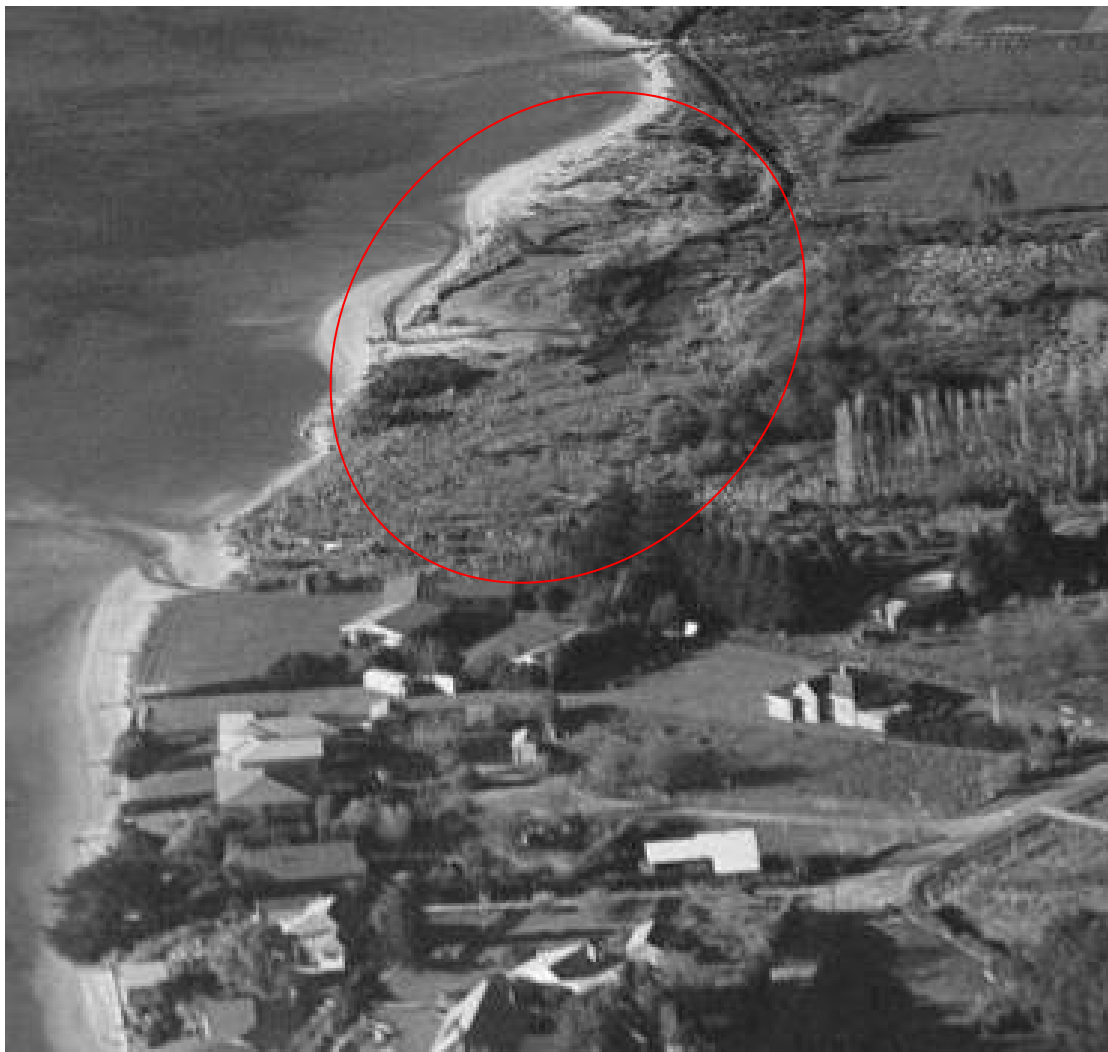
Both the Kiriwai Place and Percival Avenue outfall options are located within a section of the northern coast that was formerly a poorly drained wetland partially impounded by a mobile sand bank. There are no previously recorded archaeological sites within the immediate area of the two options and no archaeological sites were identified during the June 2014 archaeological survey of the area.

The two natural spring fed streams that enter the harbour in this area and the resources typically associated with wetlands may have been the focus of pre 1900 activity however it is considered unlikely that insitu archaeological remains associated with pre 1900 occupation will be encountered in this area.

Figure 11. Oblique aerial photo taken in 1968 showing the former wetland where the Kiriwai and Percival outfall options are located.
