# Kaitemako

## Sub-Catchment Action Plan 2012

The Kaitemako Sub-Catchment Action Plan is one of a series about the sub-catchments surrounding Tauranga Harbour. This action plan provides an analysis of the current land management issues, a summary of the available physical resources in the Kaitemako sub-catchment, and planned action for land and resource use in the sub-catchment.

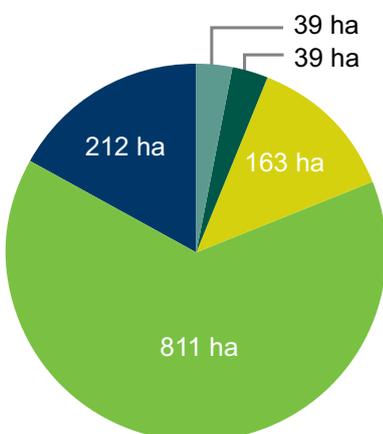
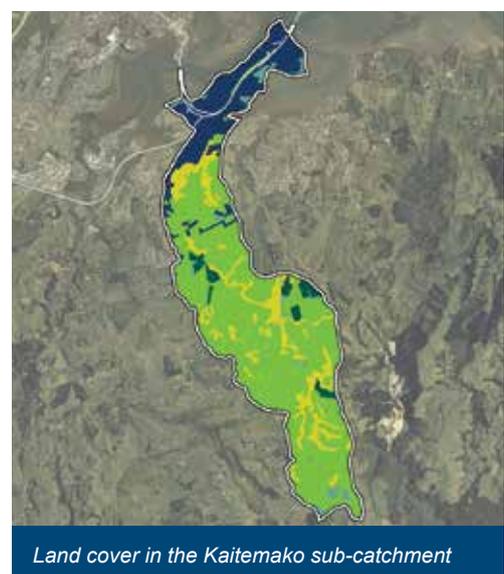
## Land cover in the Kaitemako sub-catchment

Vegetation	Percent
Exotic	3
Horticulture	3
Indigenous	13
Pasture	64
Urban	17

The most widely spread land cover in the sub-catchment is pasture at 45 percent. Native bush covers 33 percent, horticultural five percent and exotic forest eight percent. Large areas of estuarine wetlands surround the Welcome Bay estuary.

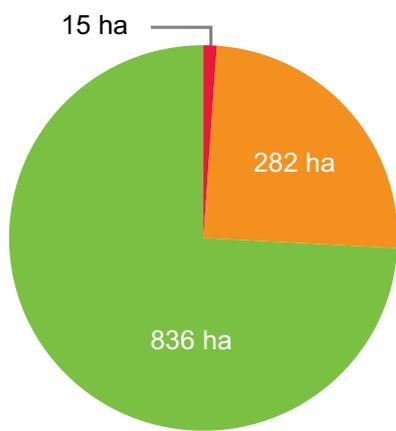
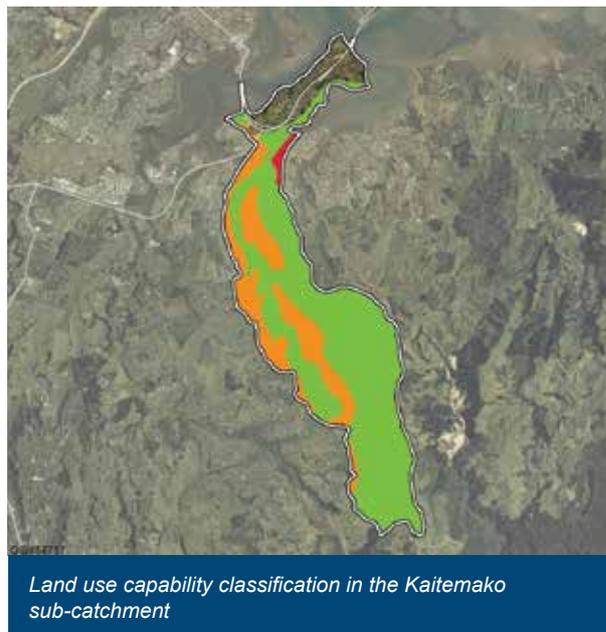
## Land use capability classification in the Kaitemako sub-catchment

The majority of land in this sub-catchment is Land Use Capability (LUC) Class 6 - steep landscapes. Highly productive LUC Class 3 and 4 - gentle to rolling lands - are also well represented across the sub-catchment.

LUC Class	LUC Units	Percent
3	3e 2	1
4	4e 2	22
6	6e 3, 6e 4	66

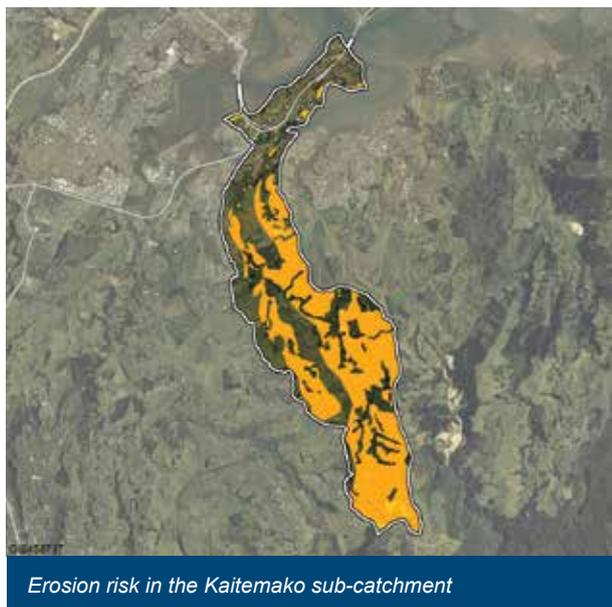
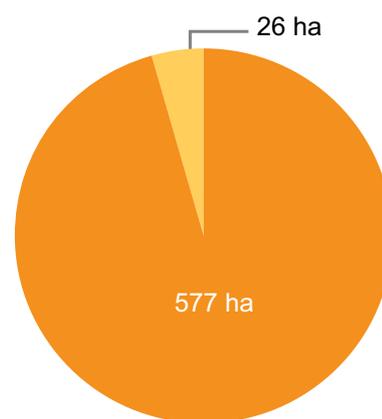
## Erosion risk in the Kaitemako sub-catchment

A large proportion of Land Use Capability Class 6 land in the Kaitemako sub-catchment has medium risk of erosion occurring due to pastoral land use. Forestry located on this class of land has a medium risk of erosion during the post-harvest phase.

Land Use	Risk	Percent
Pasture	Medium	45
Exotic forest	Medium	2

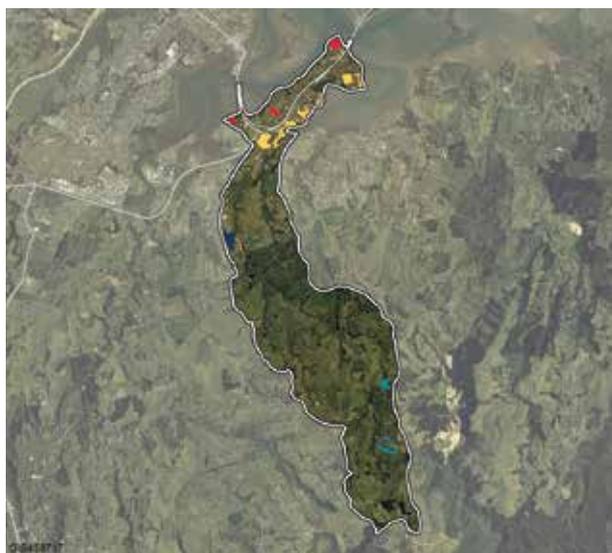
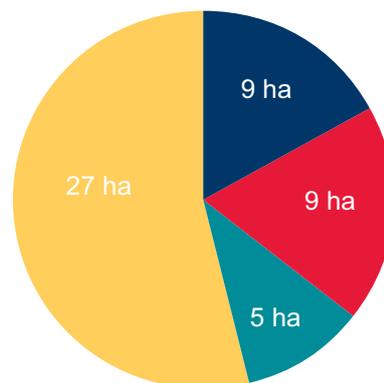
Existing protection status in the Kaitemako sub-catchment

Class	Percent
BOPRC Covenant	1
Māori	1
QEII	0.4
District Reserve	2
