Bore 3566 Information			
Monitoring type	Water quality	Depth (m)	122
Name	Thacker	Casing Depth (m)	70
Bore use	Agricultural/Domestic	Screen/open hole	From 88? to 122
Easting	281 7258	Temperature	Cold water
Northing	636 5278	Catchment	Kaikokopu-Pokopoko-Wharere
Bore log	-	Aquifer	Tauranga sediments
Monitoring period	Water level	-	
	Water quality	1997 - 2011	LabStar: BOP180070

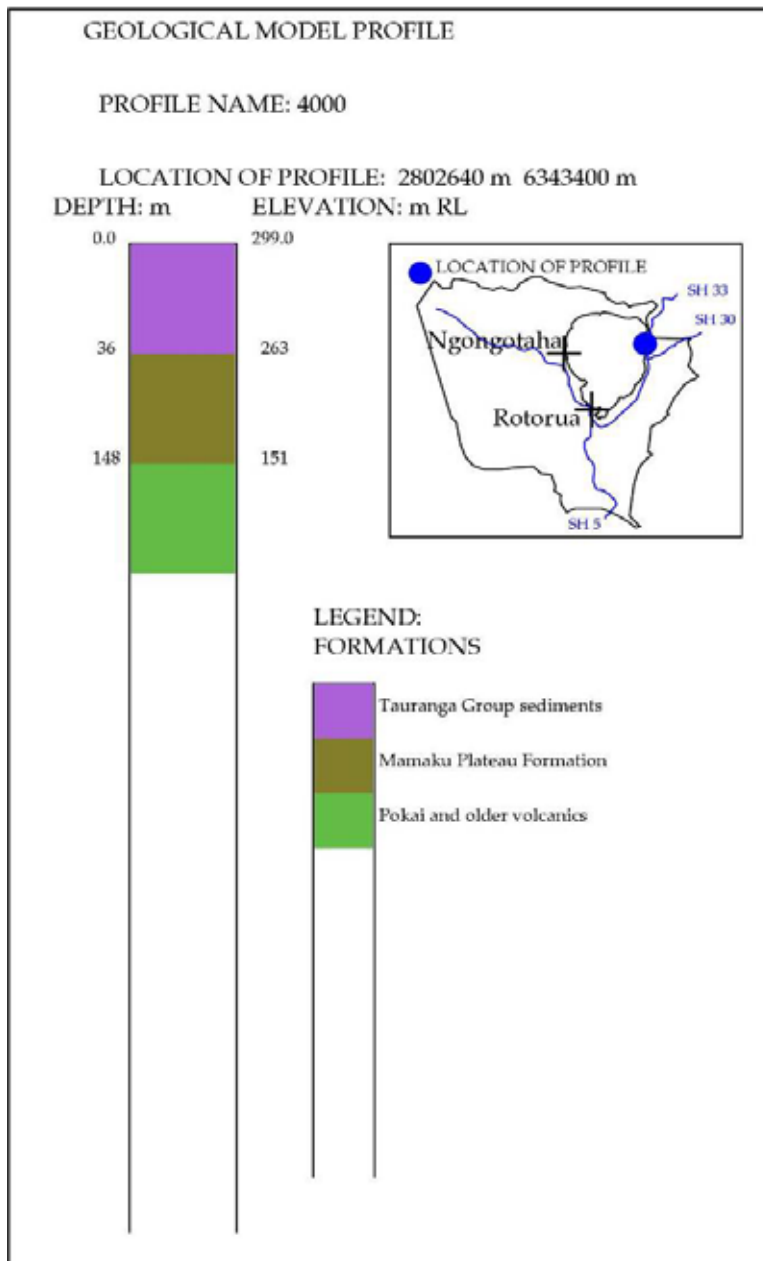
Bore 4000 geological profile (EBOF)

Bore 4000 Information			
Monitoring type	Water quality	Depth (m)	26
Name	Ludgate Hill	Casing Depth (m)	Unknown
Bore use	Irrigation	Screen/open hole	Unknown
Easting	2802640	Temperature	14°C
Northing	6343400	Catchment	Lake Rotorua
Bore log	–	Aquifer	Tauranga sediments
Monitoring period	Water level	-	
	Water quality	1991 to 1998

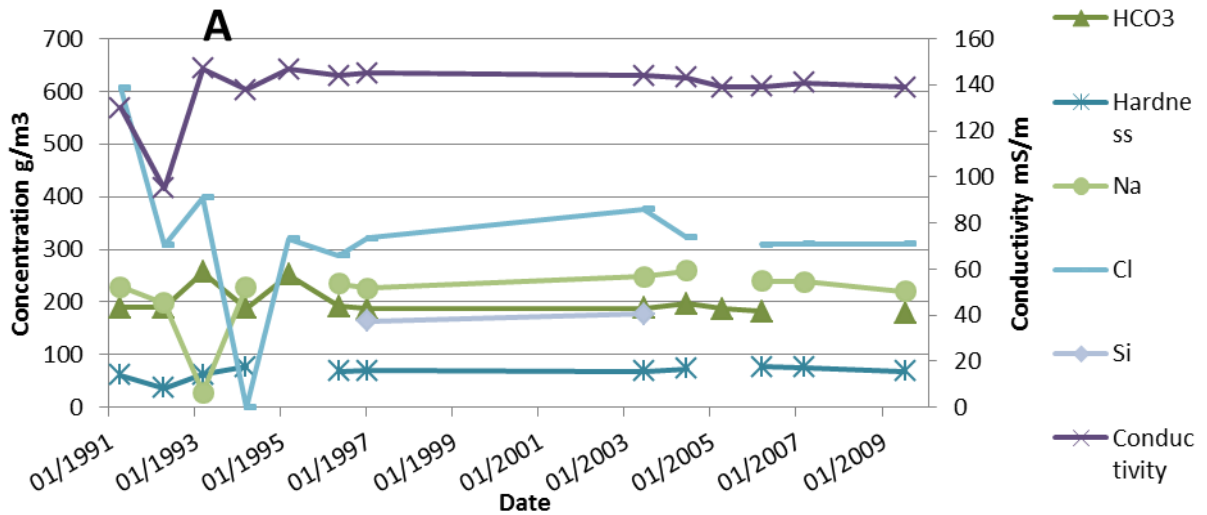
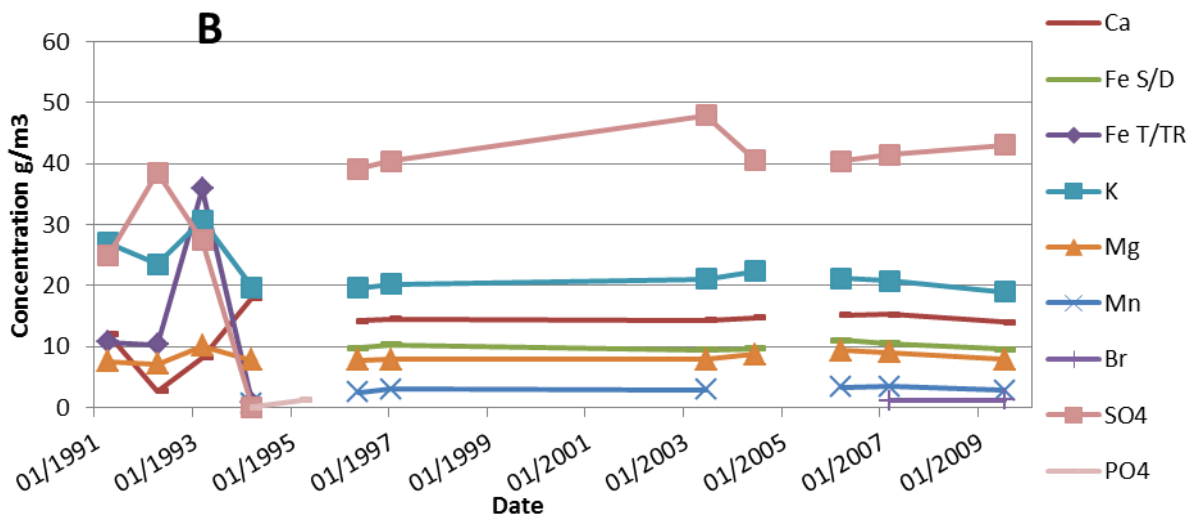
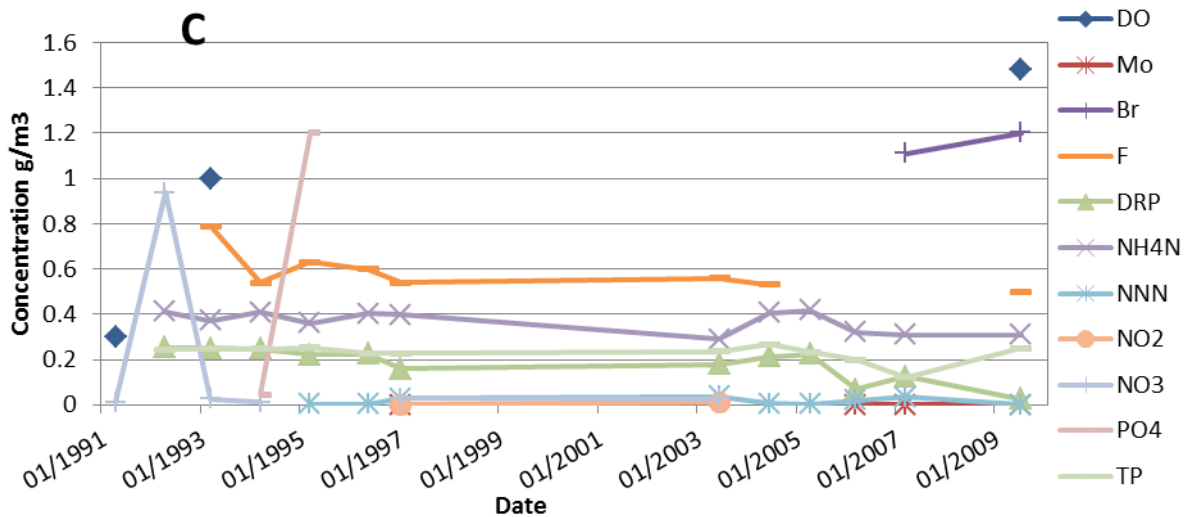
Bore 4001 water quality graphs

Bore 4001 Information			
Monitoring type	Water quality	Depth (m)	55
Name	Rotomā Holiday Camp	Casing Depth (m)	Unknown
Bore use	Swimming pool	Screen/open hole	Unknown
Easting	282 1500	Temperature	40°C
Northing	634 5100	Catchment	Lake Rotoehu
Bore log	–	Aquifer	Tauranga sediments
Monitoring period	Water level	-	
	Water quality	1991 to 2009

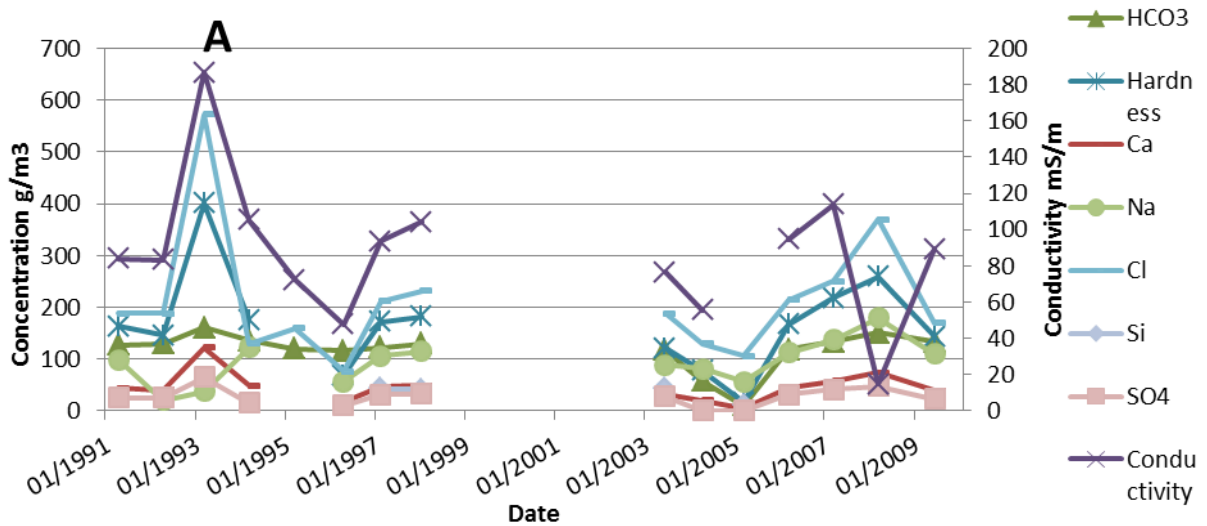
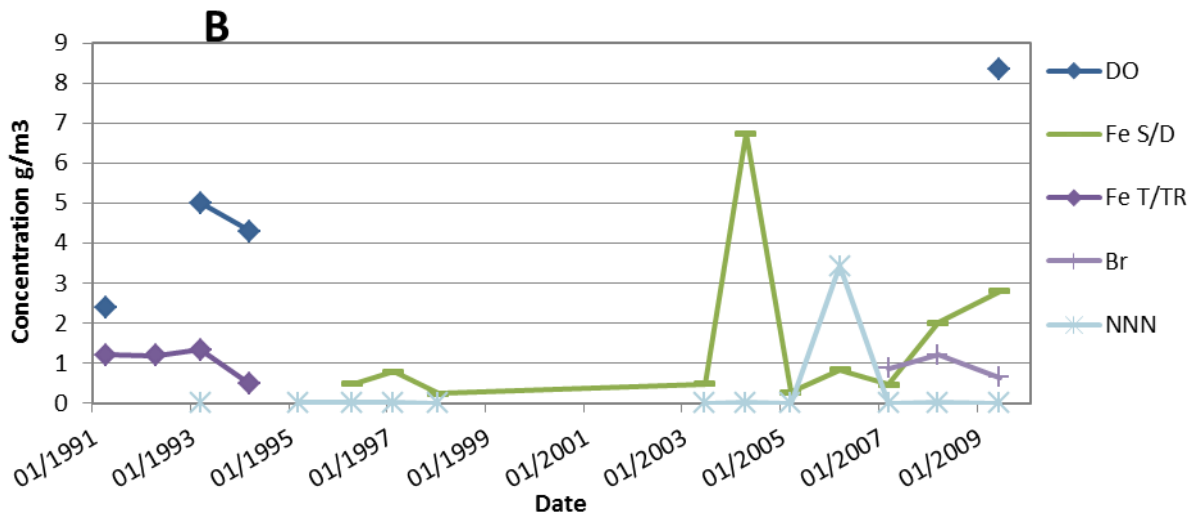
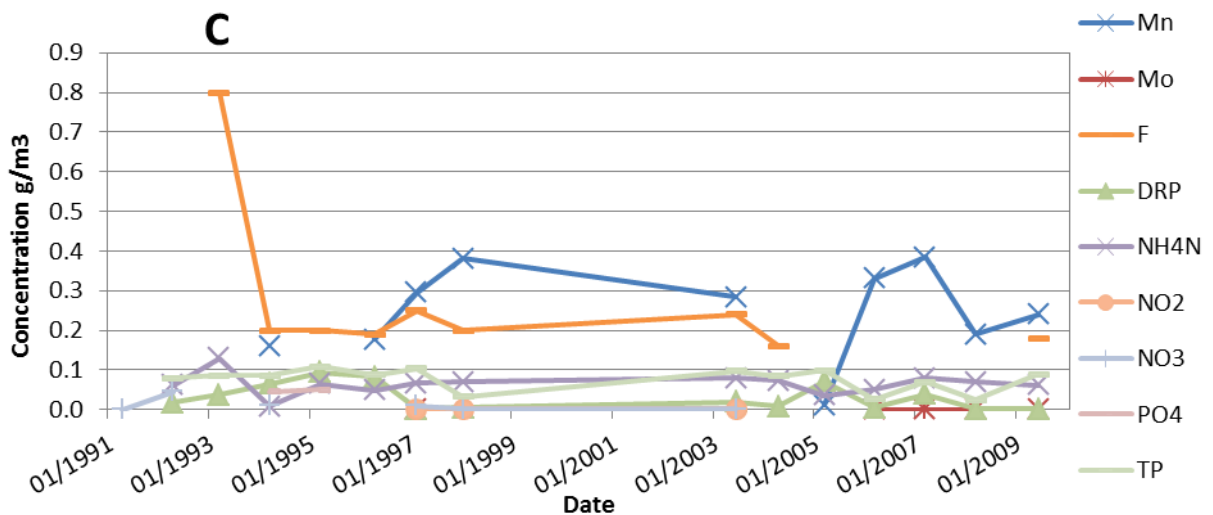
Bore 4002 water quality graphs

Bore 4002 Information			
Monitoring type	Water quality	Depth (m)	60
Name	Ōpōtiki Holiday Park	Casing Depth (m)	Unknown
Bore use	Unknown	Screen/open hole	Unknown
Easting	288 6200	Temperature	16.5°C
Northing	634 6600	Catchment	Opotiki Plains
Bore log	-	Aquifer	Tauranga Group Sediments
Monitoring period	Water level		
	Water quality	1991 to 2009	LabStar: BOP180029

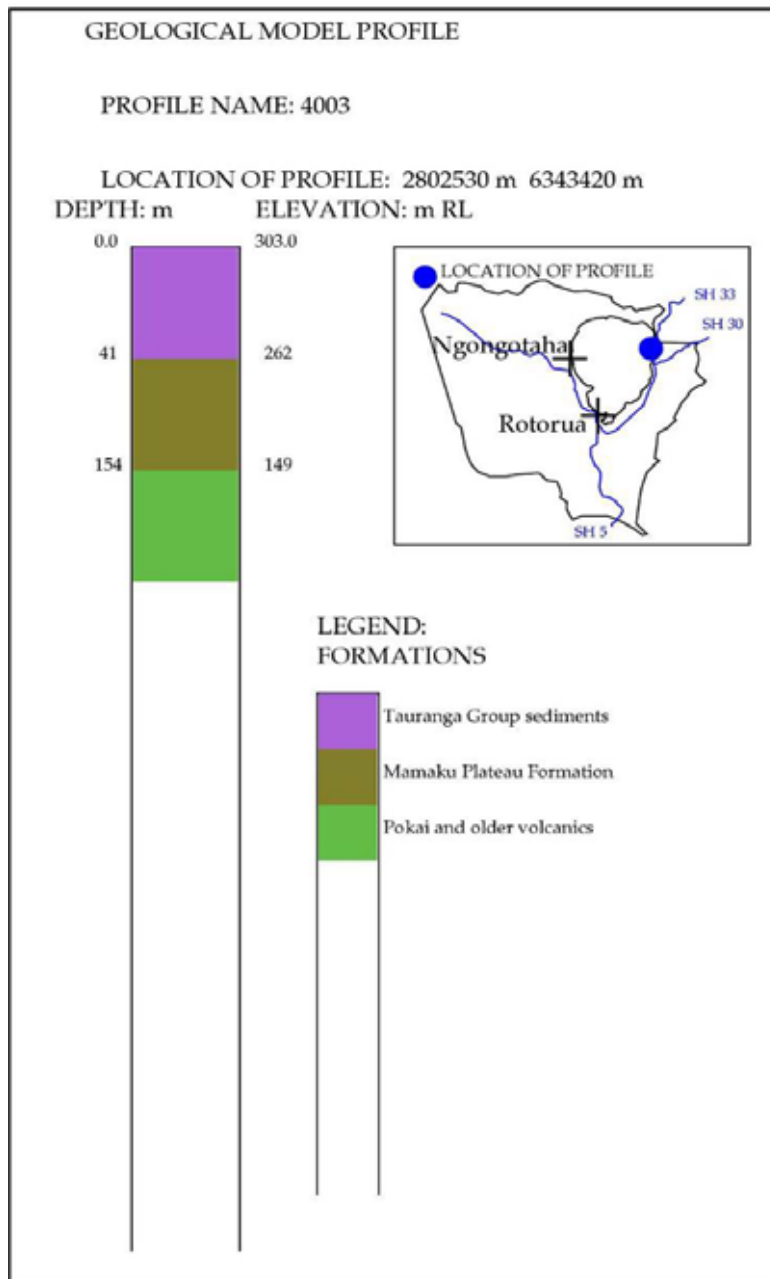
Bore 4003 geological profile (EBOF)

Bore 4003 Information			
Monitoring type	Water quality	Depth (m)	26
Name	Ludgate Hill	Casing Depth (m)	Unknown
Bore use	Domestic	Screen/open hole	Unknown
Easting	280 2530	Temperature	Unknown
Northing	634 3420	Catchment	Lake Rotorua
Bore log	–	Aquifer	Tauranga sediments
Monitoring period	Water level	-	
	Water quality	2003 to 2008

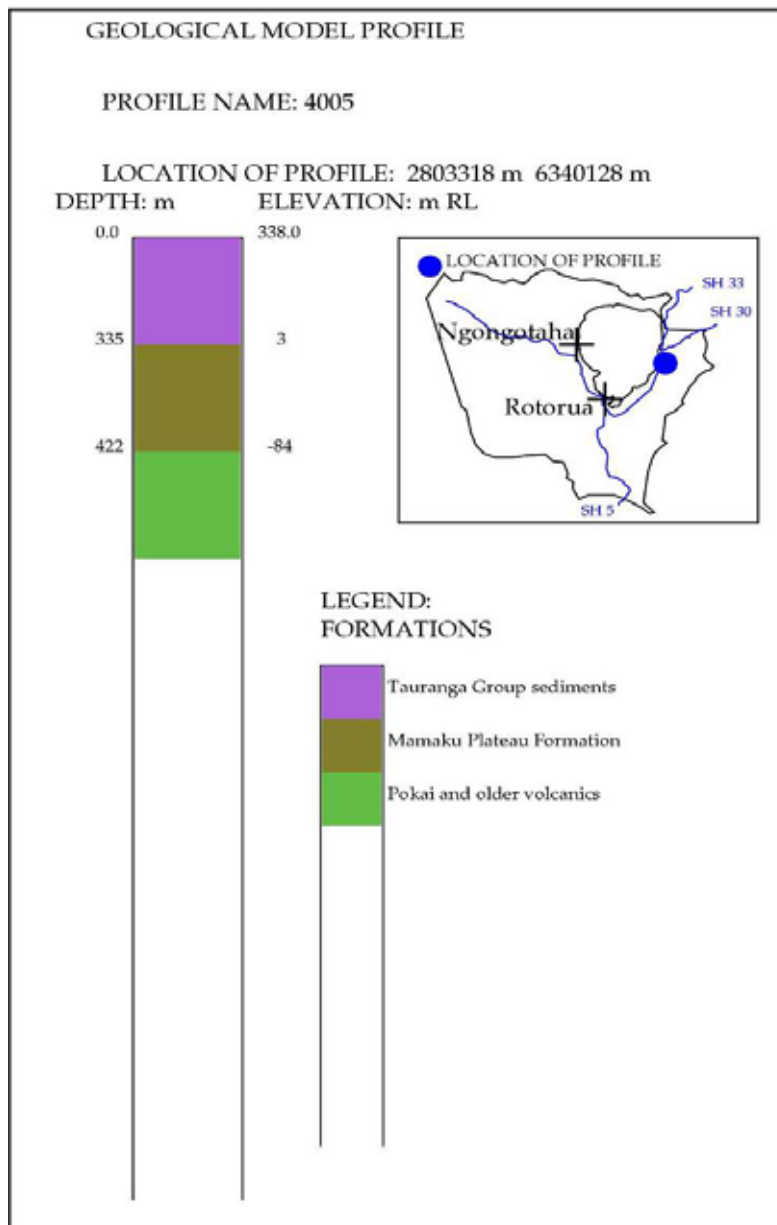
Bore 4005 geological profile (EBOF)

Bore 4005 Information			
Monitoring type	Water level	Depth (m)	180
Name	Geiss	Casing Depth (m)	167
Bore use	Irrigation/domestic	Screen/open hole	Unknown
Easting	280 3318	Temperature	Unknown
Northing	634 0128	Catchment	Rotokawa (Lake Rotorua)
Bore log	–	Aquifer	Tauranga sediments
Monitoring period	Water level	1995 to 2011	
	Water quality	-

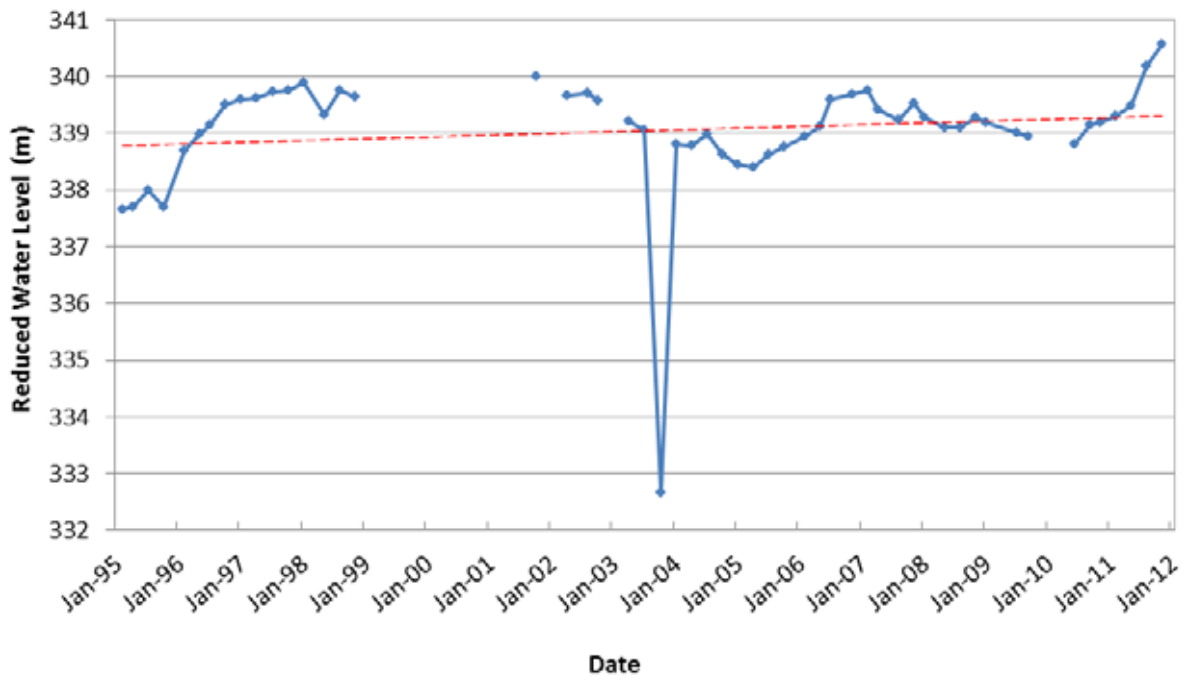
Bore 4005 Raw data

Bore 4005 water level graphs

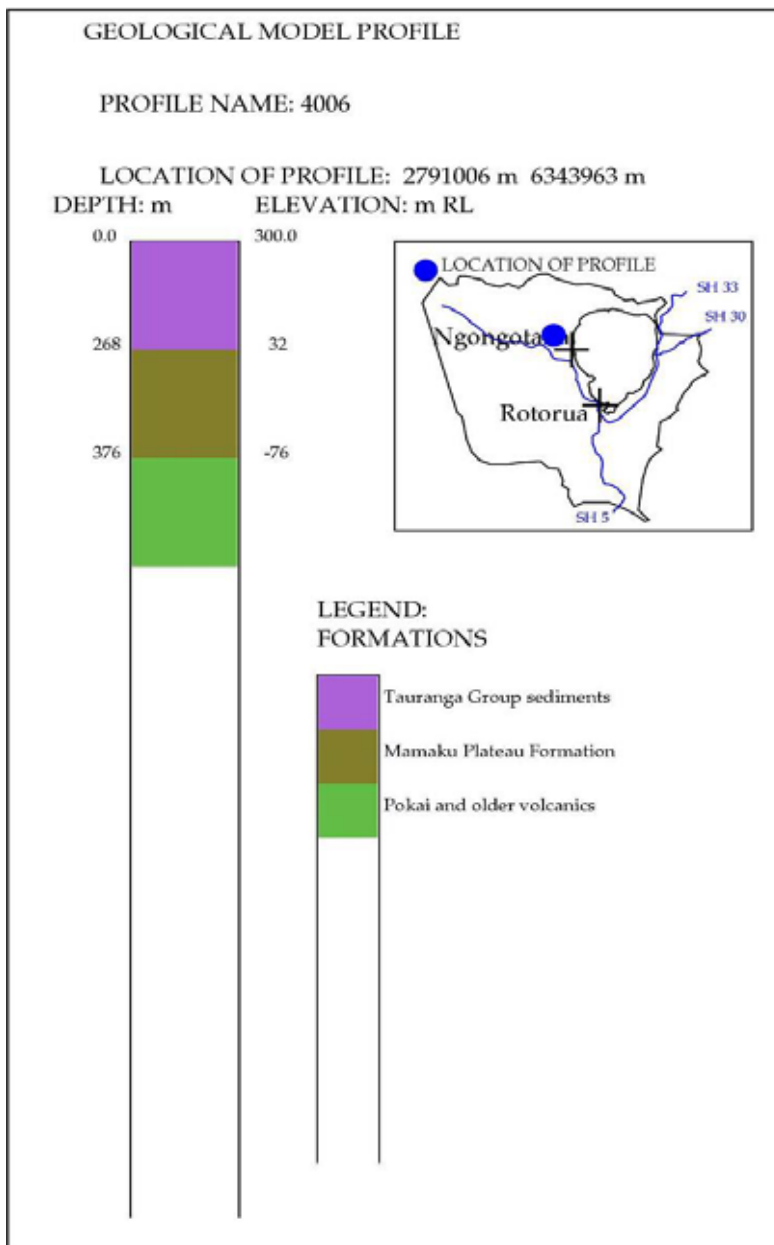
Bore 4006 geological profile (EBOF)

Bore 4006 Information			
Monitoring type	Water level	Depth (m)	85.3
Name	Field	Casing Depth (m)	Unknown
Bore use	Irrigation	Screen/open hole	Unknown
Easting	279 1006	Temperature	Unknown
Northing	634 3963	Catchment	Waimehia (Lake Rotorua)
Bore log	-	Aquifer	Tauranga sediments
Monitoring period	Water level	1995 to 2011	
	Water quality

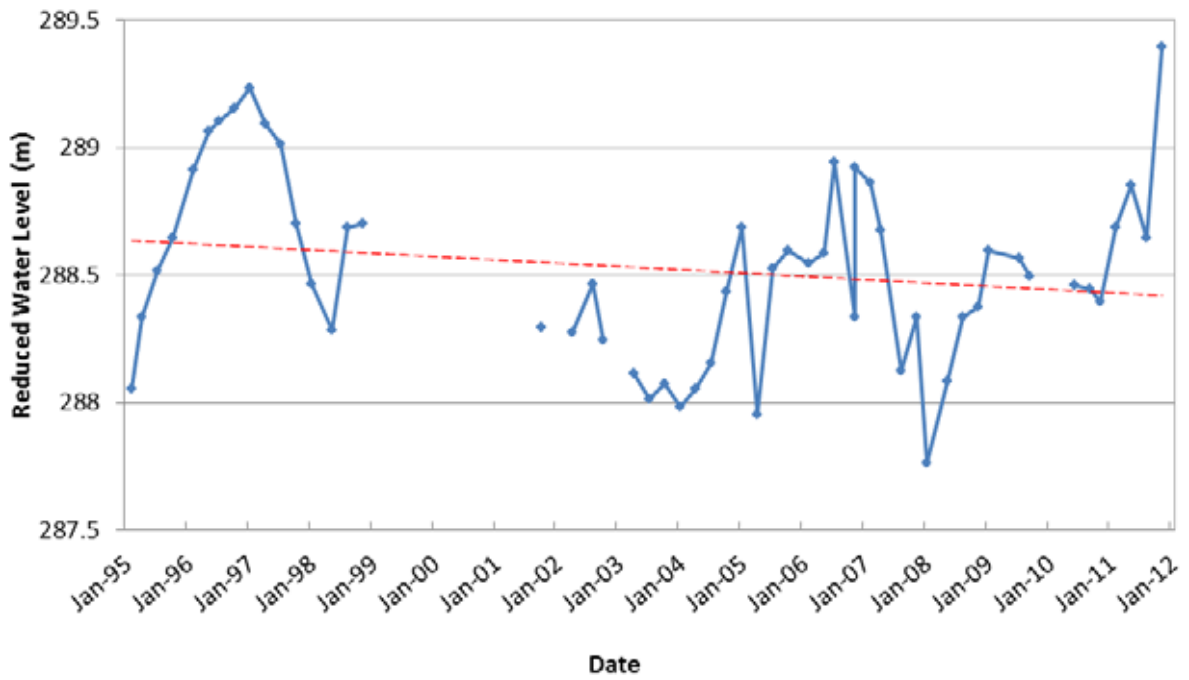
Bore 4006 Raw data

Bore 4006 water level graphs

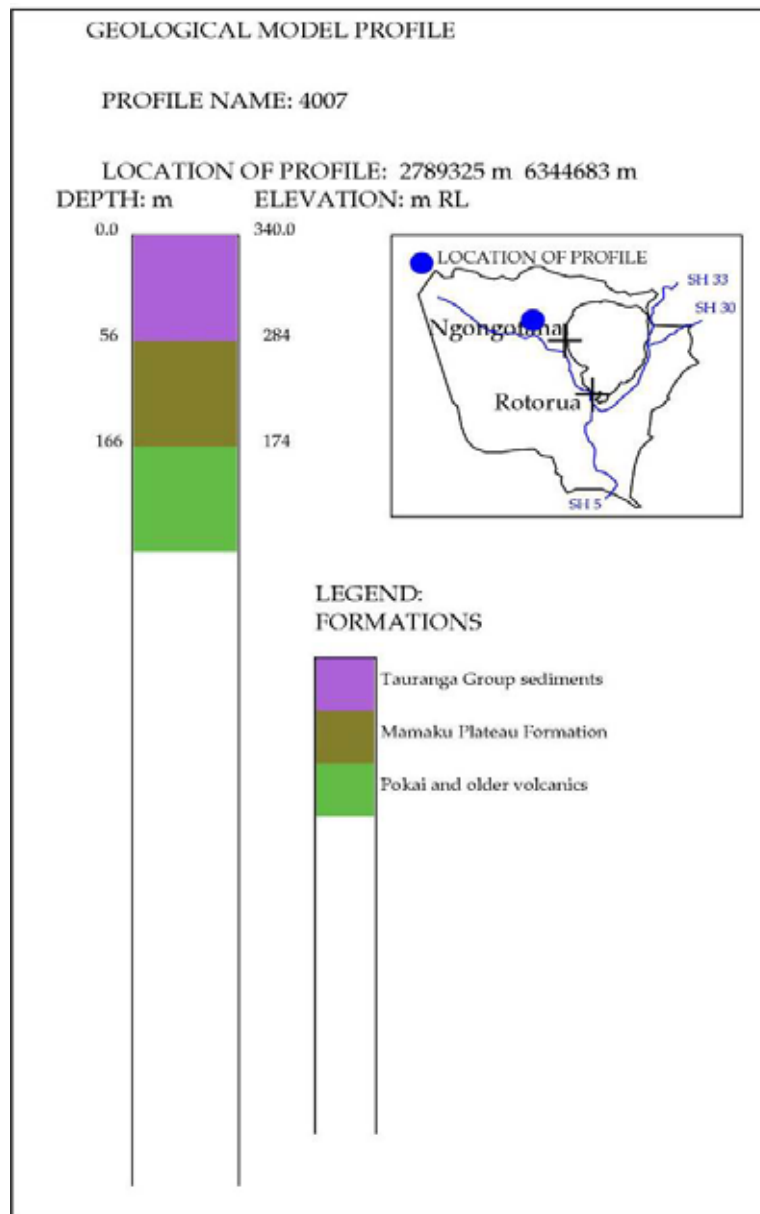
Bore 4007 geological profile (EBOF)

Bore 4007 Information			
Monitoring type	Water level & Water quality	Depth (m)	Unknown
Name	Pemberton	Casing Depth (m)	Unknown
Bore use	Lifestyle block/Domestic	Screen/open hole	Open hole
Easting	278 9325	Temperature	12.7°C
Northing	634 4683	Catchment	Waimehia (Lake Rotorua)
Bore log	-	Aquifer	Pokai and other volcanics
Monitoring period	Water level	1995 to 2011	
	Water quality	1996 to 2011	LabStar: BOP180061

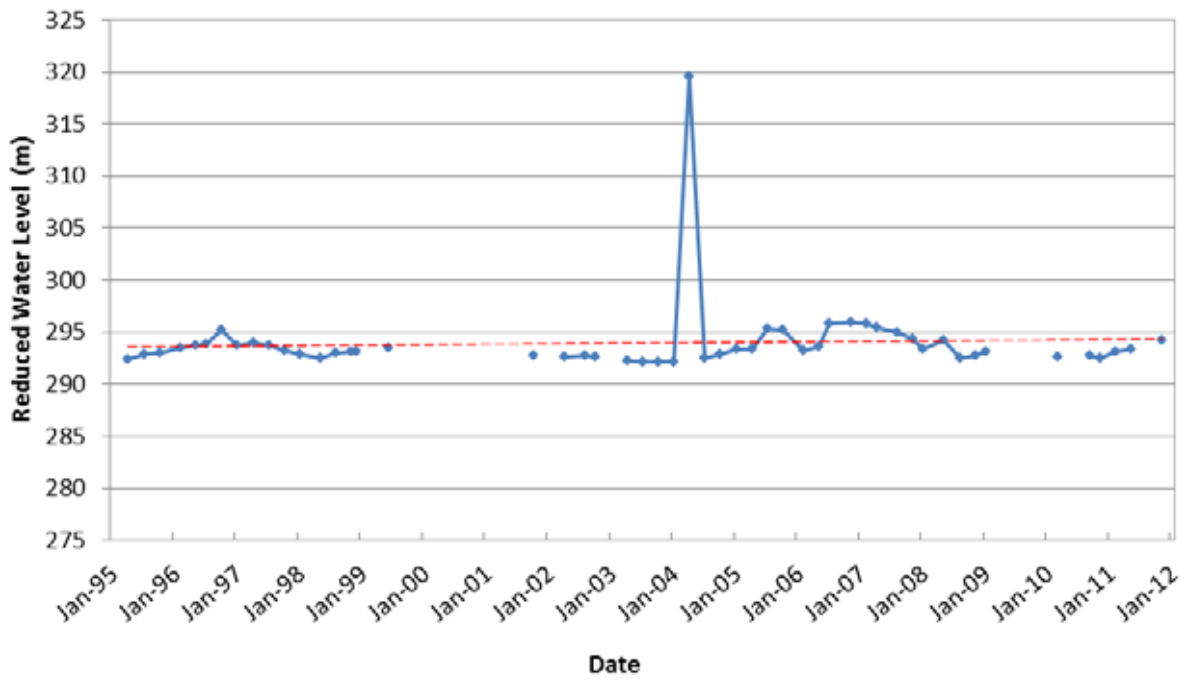
Bore 4007 Raw data

Bore 4007 water level graphs

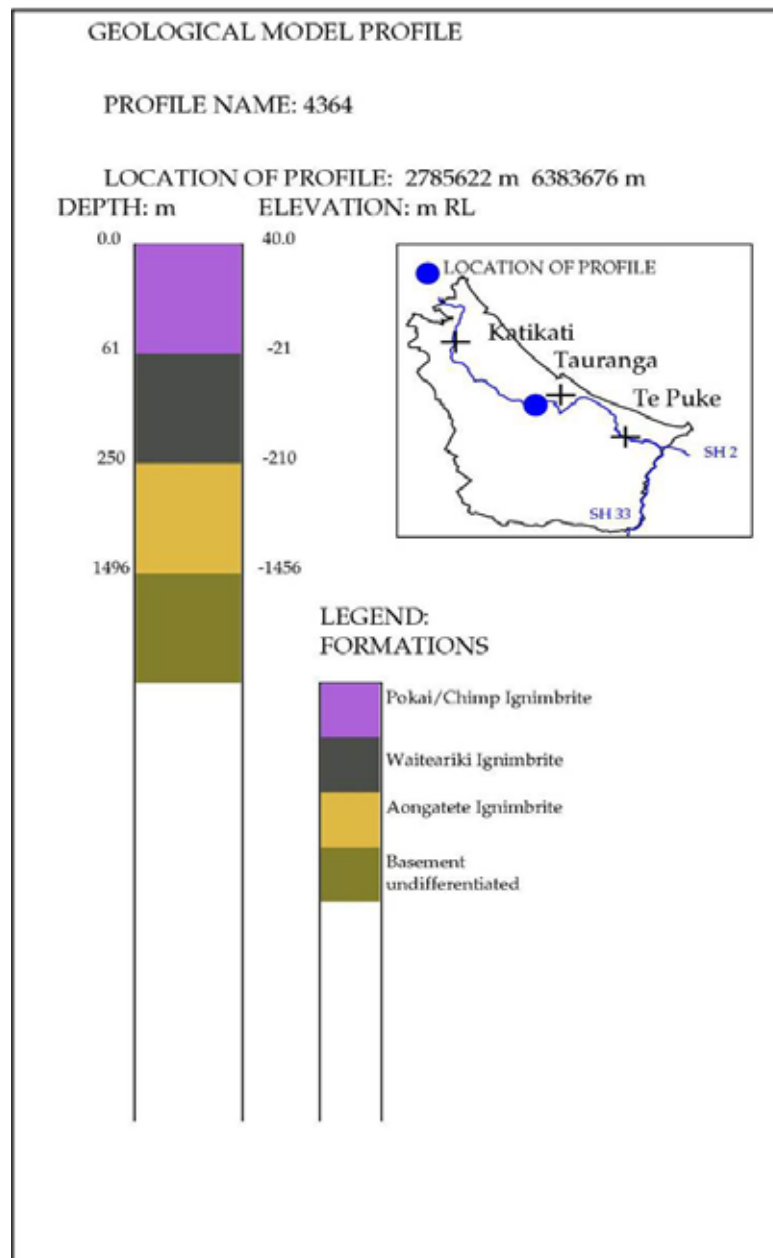
Bore 4364 geological profile (EBOF)

Bore 4364 Information			
Monitoring type	Water quality	Depth (m)	177
Name	Fernland Spa	Casing Depth (m)	-
Bore use	Commercial	Screen/open hole	Open hole
Easting	278 5622	Temperature	37.4
Northing	638 3676	Catchment	
Bore log	Complete	Aquifer	Waiteariki (WAI)
Monitoring period	Water level		
	Water quality	1996 to 2011	LabStar: BOP180062

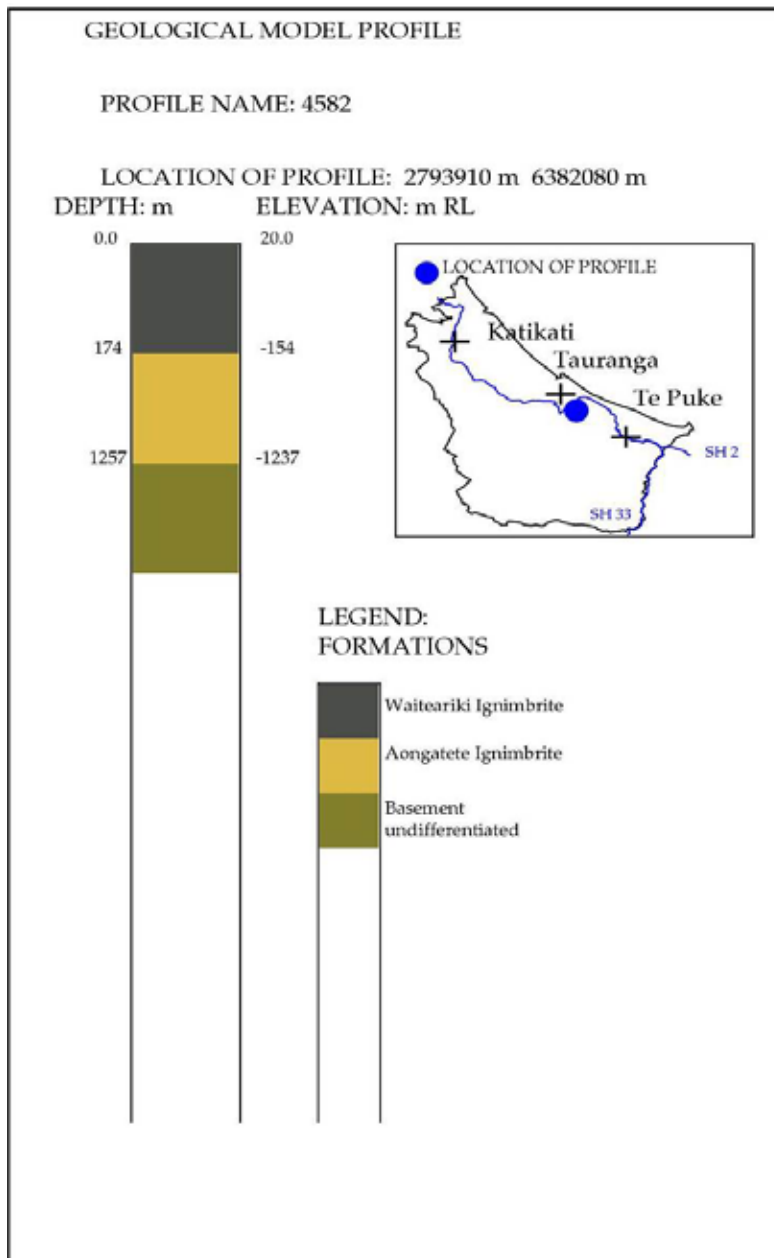
Bore 4582 geological profile (EBOF)

Bore 4582 Information			
Monitoring type	Water quality	Depth (m)	350
Name	MacLean	Casing Depth (m)	Unknown
Bore use	Unknown	Screen/open hole	Open hole
Easting	279 3910	Temperature	26.7°C
Northing	638 2080	Catchment	Welcome Bay
Bore log	–	Aquifer	Aongatete (WAI)
Monitoring period	Water level		
	Water quality	1997 to 2008	LabStar: BOP180069

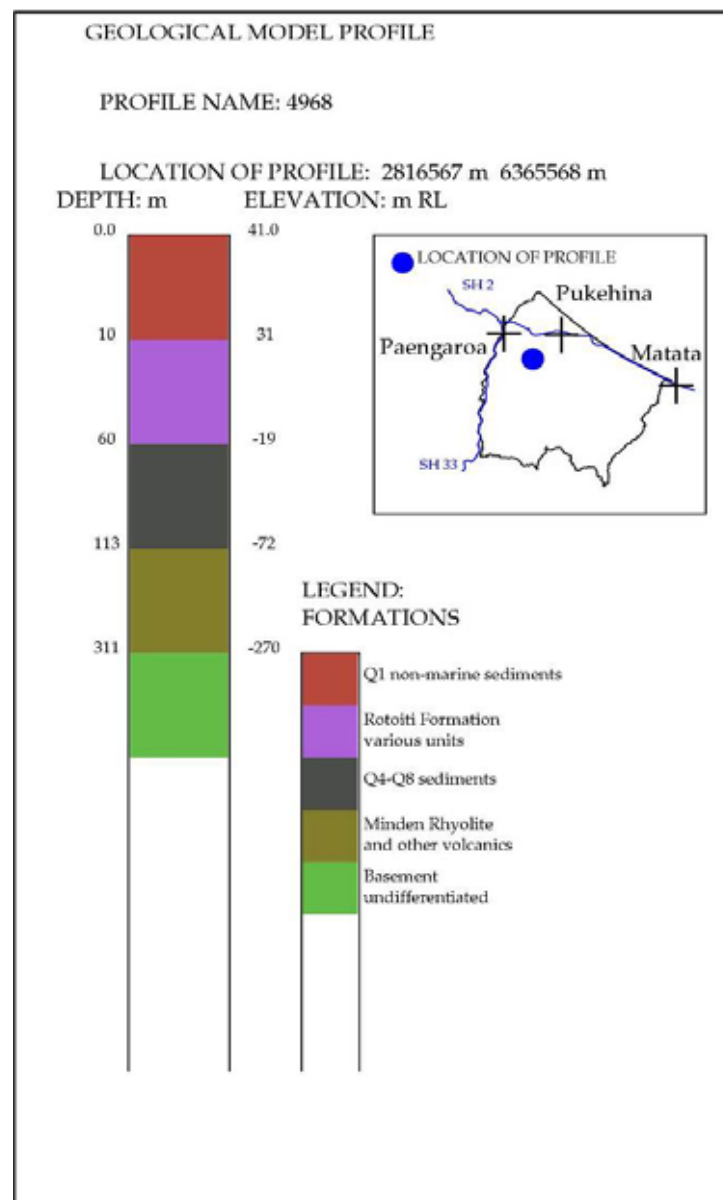
Bore 4968 geological profile (EBOF)

Bore 4968 Information			
Monitoring type	Water quality	Depth (m)	10
Name	Wharenui Green Ltd.	Casing Depth (m)	unknown
Bore use	Irrigation/frost	Screen/open hole	unknown
Easting	2816567	Temperature	-
Northing	6365568	Catchment	Kaikokopu- Pokopoko-Wharere
Bore log	-	Aquifer	Tauranga sediments
Monitoring period	Water level	-	
	Water quality	2002 to 2011	LabStar: BOP180406
