Wainui Te Whara Stream:
Urban Channel improvement works

**Wainui Te Whara Stream:
Urban Channel Improvement Works**

Stage Two – Channel works

**Comprising Earthworks, erosion protection, channel reshaping, deepening
and stream realignment**

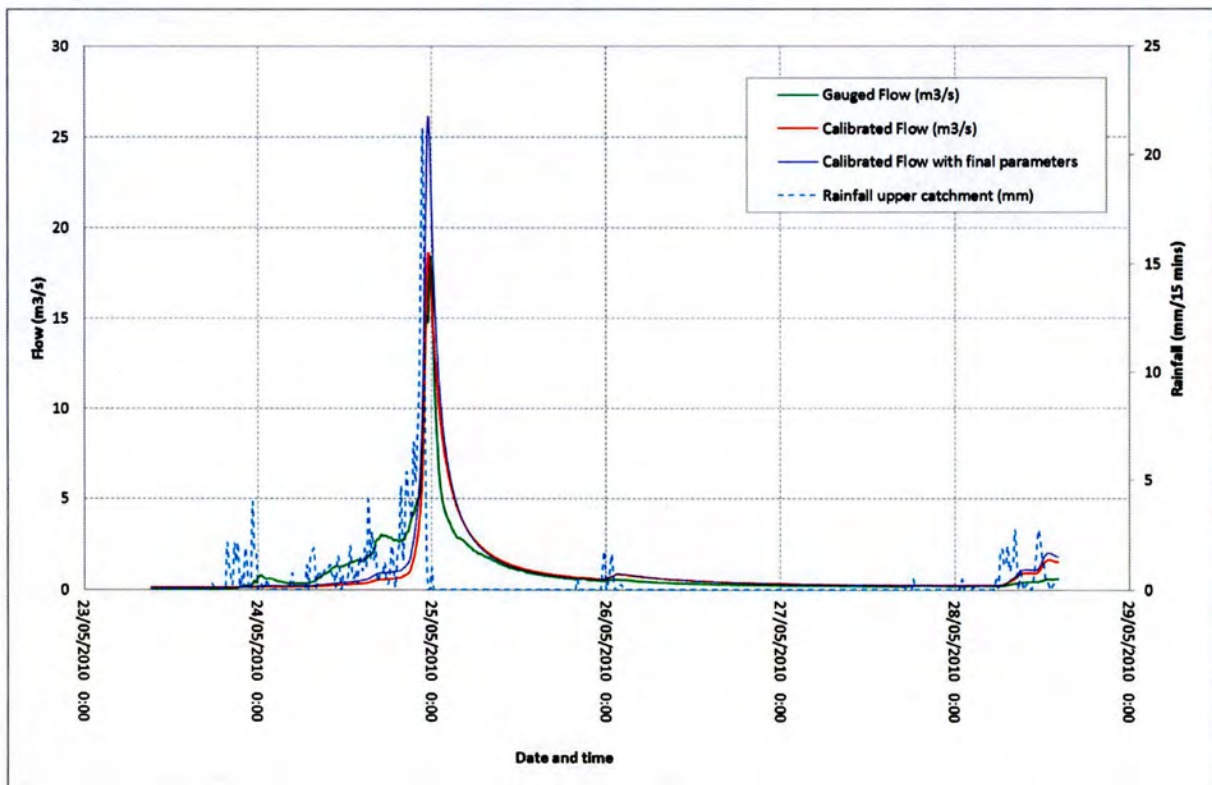
Figure 2: Calibration Wainui te Whara Stream at Mokorua Gorge – 24 May 2010 event

Appendix C shows the modelled and observed hydrographs for the four calibration events. Modelled hydrographs are shown using both the 'best fit' parameters for the individual event and the final adopted parameters. The final parameters (refer to Table 8) chosen were a weighted average of the calibrated parameters for the individual events. The contribution of the 'best fit parameters' for each event was weighted based on the magnitude of the peak flow of the event, with a higher peak flow event carrying a higher weighting.

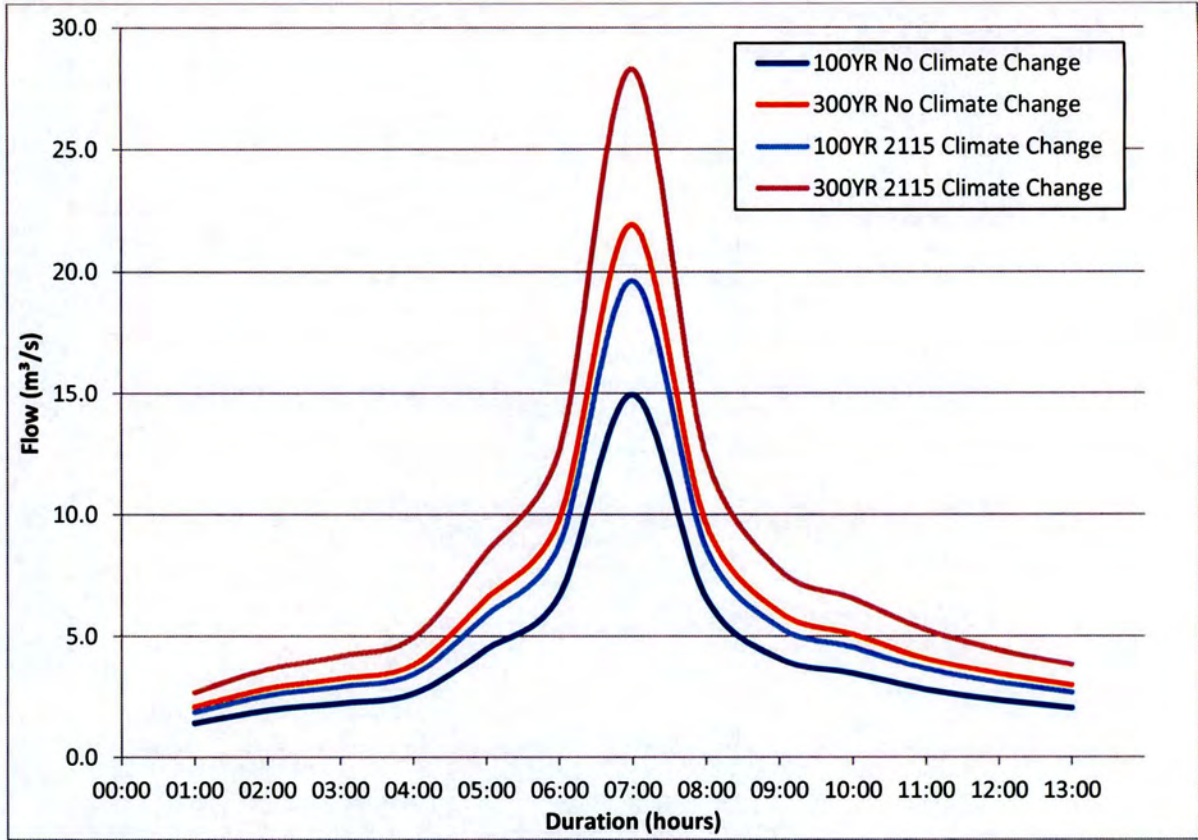
Figure 3: Design inflow hydrographs for proposed detention dam

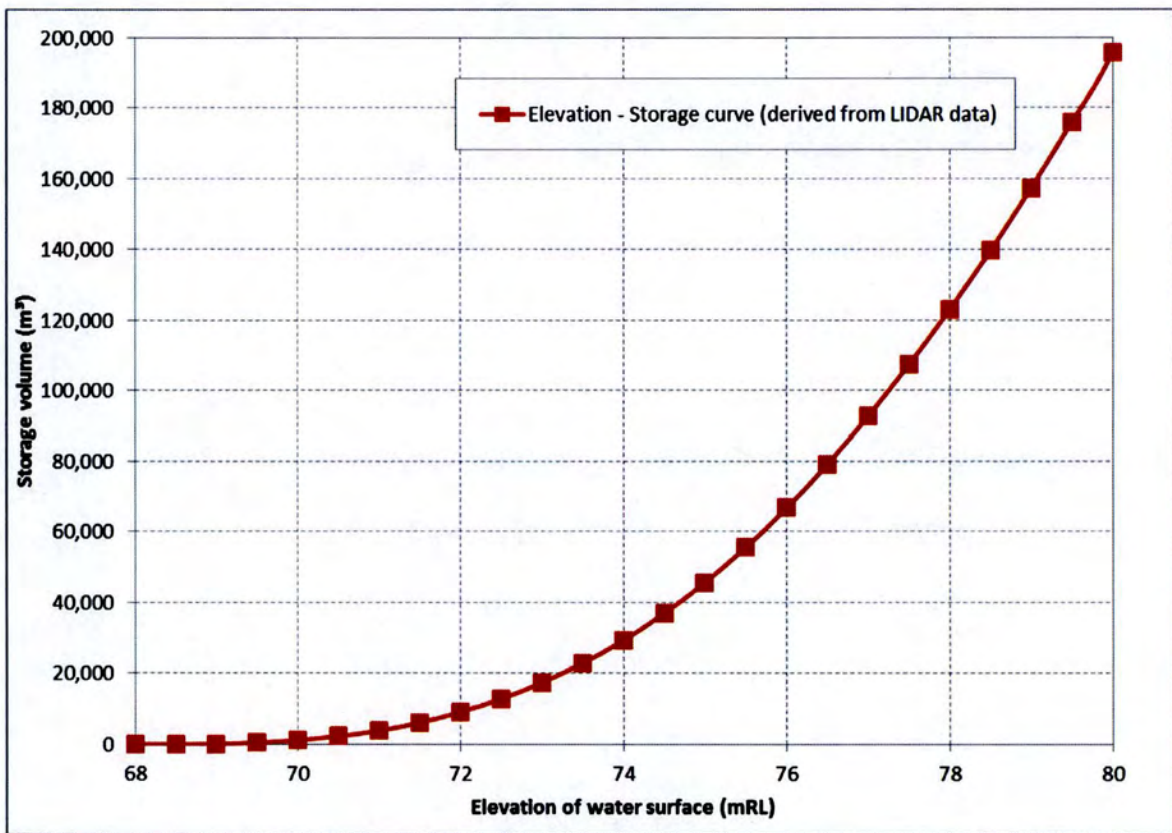
Appendix F: Elevation - storage curve for proposed detention dam

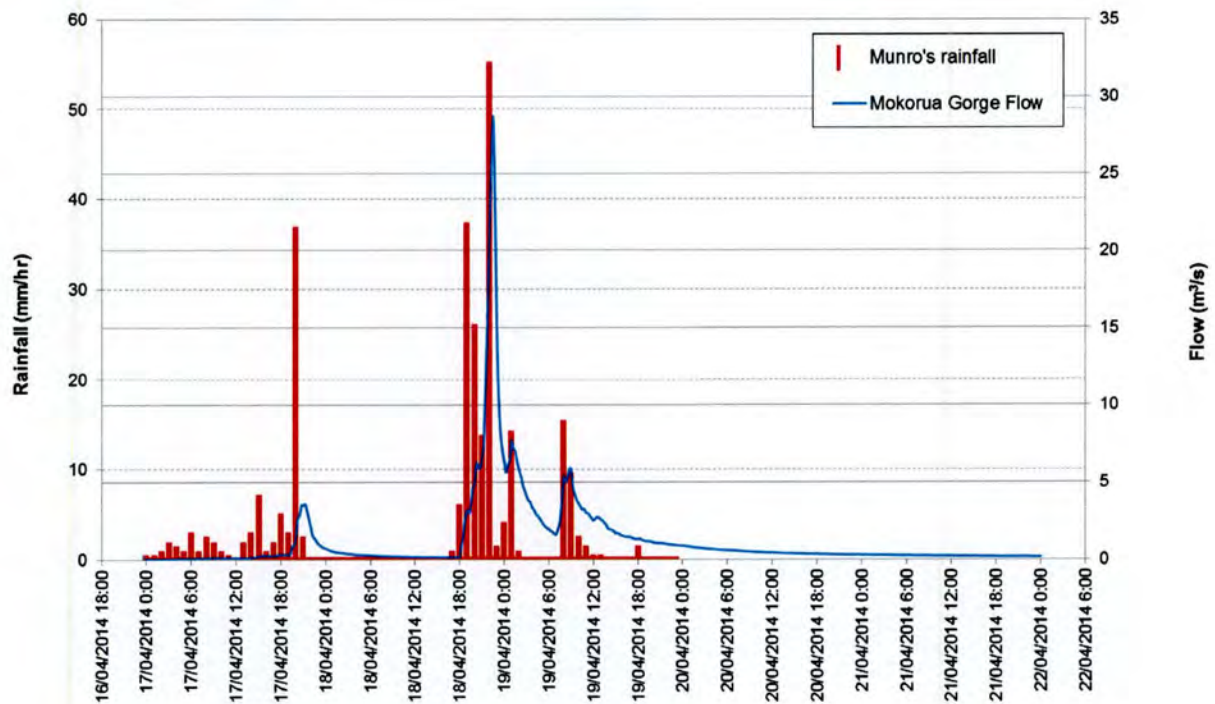
Figure 1: WtW at Munro's hourly rainfall totals and WtW at Mokorua Gorge flow

Figure 1 below shows the hourly recorded rainfall totals for WtW at Munro's together with the recorded flows for WtW at Mokorua Gorge. The 18 April 2014 event resulted in a peak flow of approximately 29 m³/s at the recorder site. This compares with a peak flow of around 31 m³/s for the June 2010 event and a flow of around 27 m³/s for the 100 year return period as estimated by PDP in the February 2014 report. As can be seen the rainfall on 17 April 2014 resulted a peak flood flow of around 3.5 m³/s which is close to the mean annual flood for the catchment.

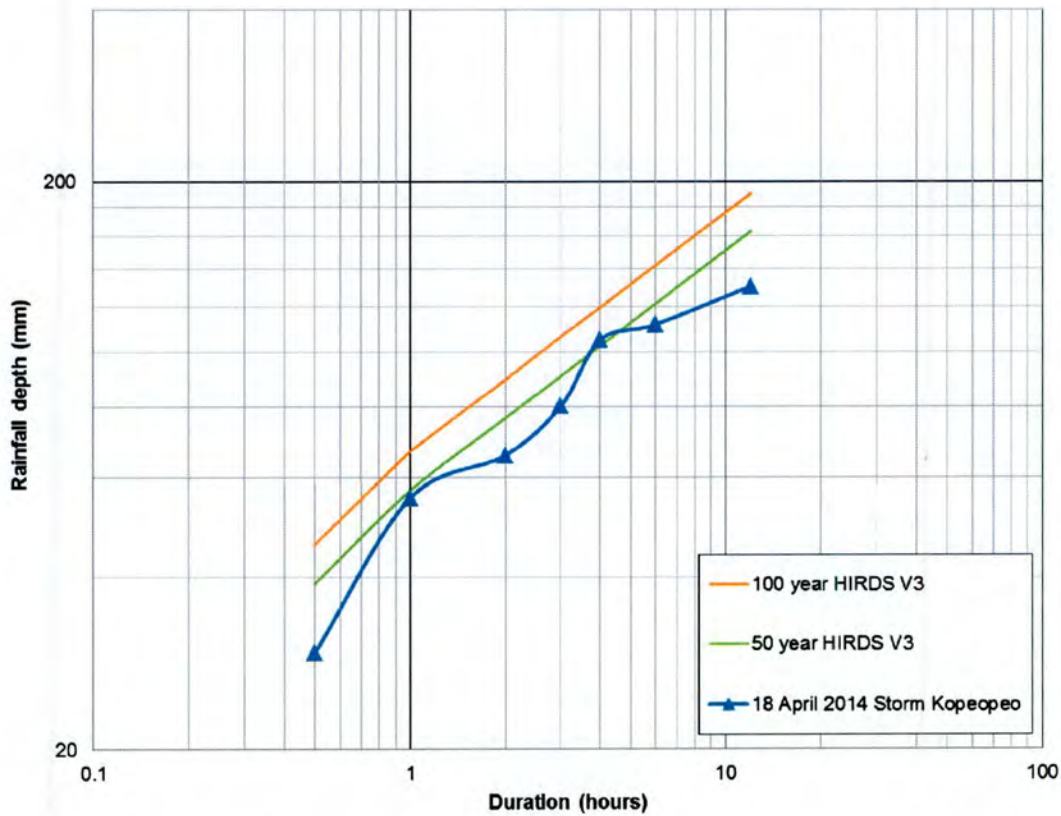
Figure 4: HIRDS V3, 18 April 2014 depth-duration curve

Based on the considerations above it appears that the 18 April 2014 rainfall event (in the area around the Kopeopeo gauge) has a return period of around 50 years for durations of one and four hours and is less than the 50 year return period for other durations. Based on the previous PDP analyses (February 2014) the resulting peak flood flow of approximately 29 m³/s in Wainui te Whara Stream at Mokorua Gorge appears to be around the 100 year return period. This is likely to be a result of the relatively saturated antecedent conditions of the catchment due to the high rainfall on 17 April (a total of around 80 mm at the Munro's gauge). It is also worth noting that a rainfall event of a particular return period does not necessarily result in a peak flood flow with the same return period.

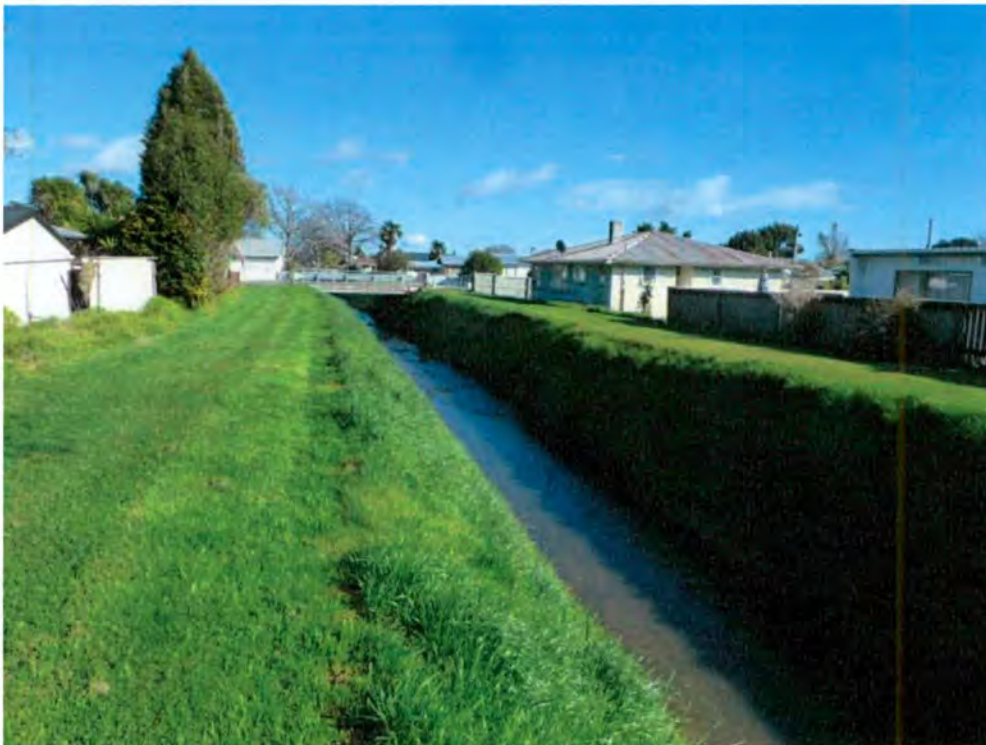
Figure 1 Typical reach of Wainui Te Whara Stream

Wainui Te Whara Stream (Figure 1) is a small highly-modified stream in an urban environment that discharges into the Awatapu Lagoon in Whakatane. Insufficient channel capacity has historically caused significant flooding for local residents near the stream. This report details the results of an investigation into the current channel capacity and the effects of various channel modifications.

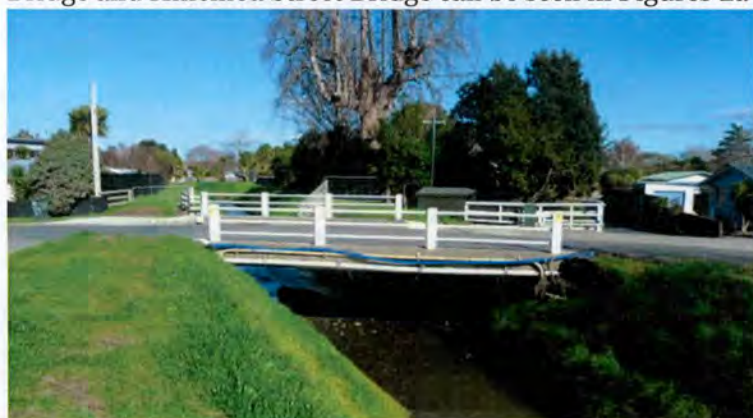
Figure 2a Douglas Street Bridge looking downstream

Photos of Douglas Street Bridge, Peter Snell Street Bridge, King Street Bridge, Tuhoe Avenue Bridge and Hinemoa Street Bridge can be seen in Figures 2a – 2e.

Figure 7 shows that, by removing Douglas Street Bridge (Figure 2a), water levels upstream of the bridge are reduced by up to 200 mm over a distance of at least 200 m. This reduction in level is sufficient to prevent floodwaters from breaking out of the stream channel along the left bank upstream of the site of the Douglas Street Bridge.

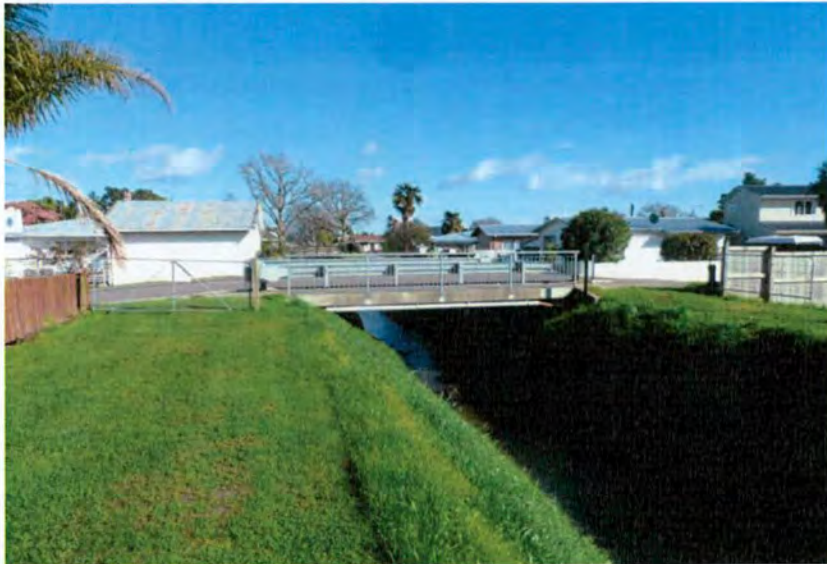
Figure 2b Peter Snell Street Bridge

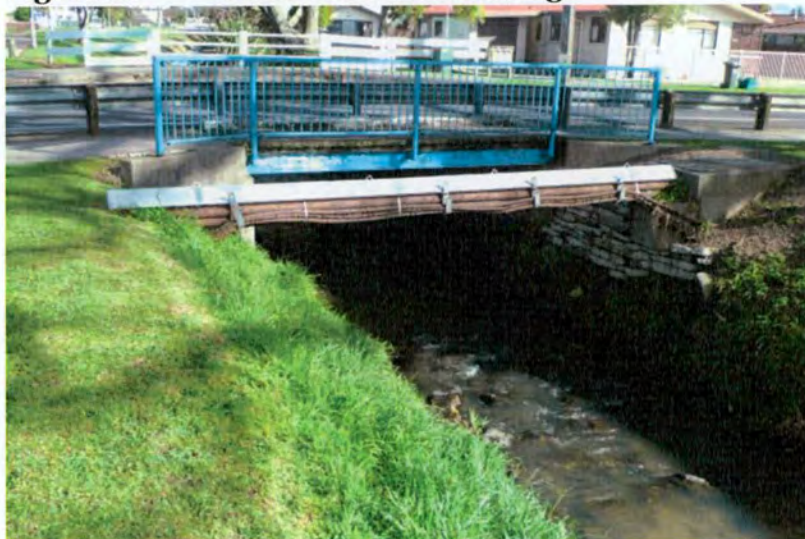
Figure 2c King Street Bridge

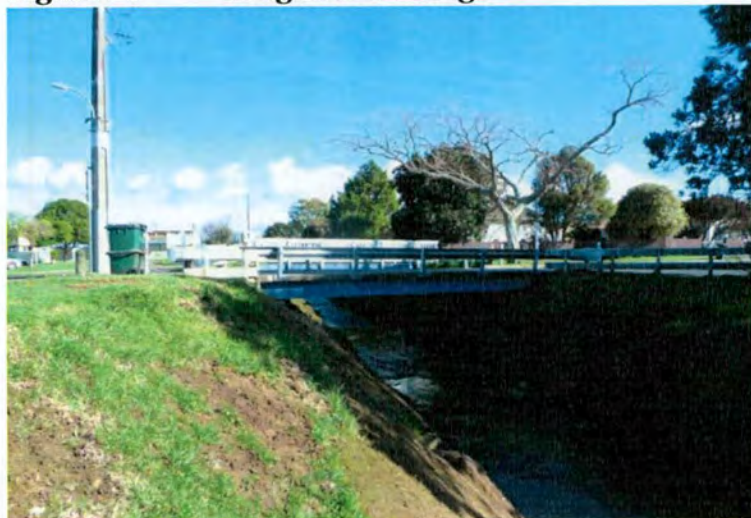
Figure 2d Tuhoe Avenue Bridge

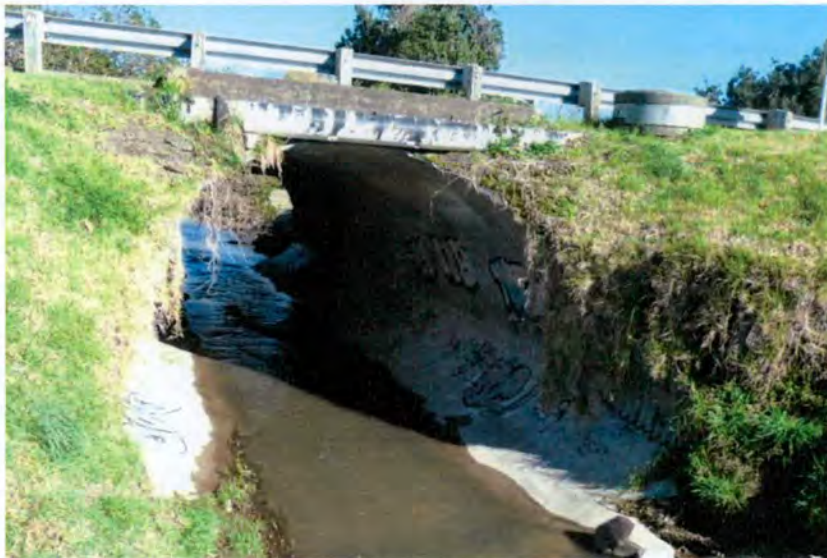
Figure 2e Hinemoa Street Bridge

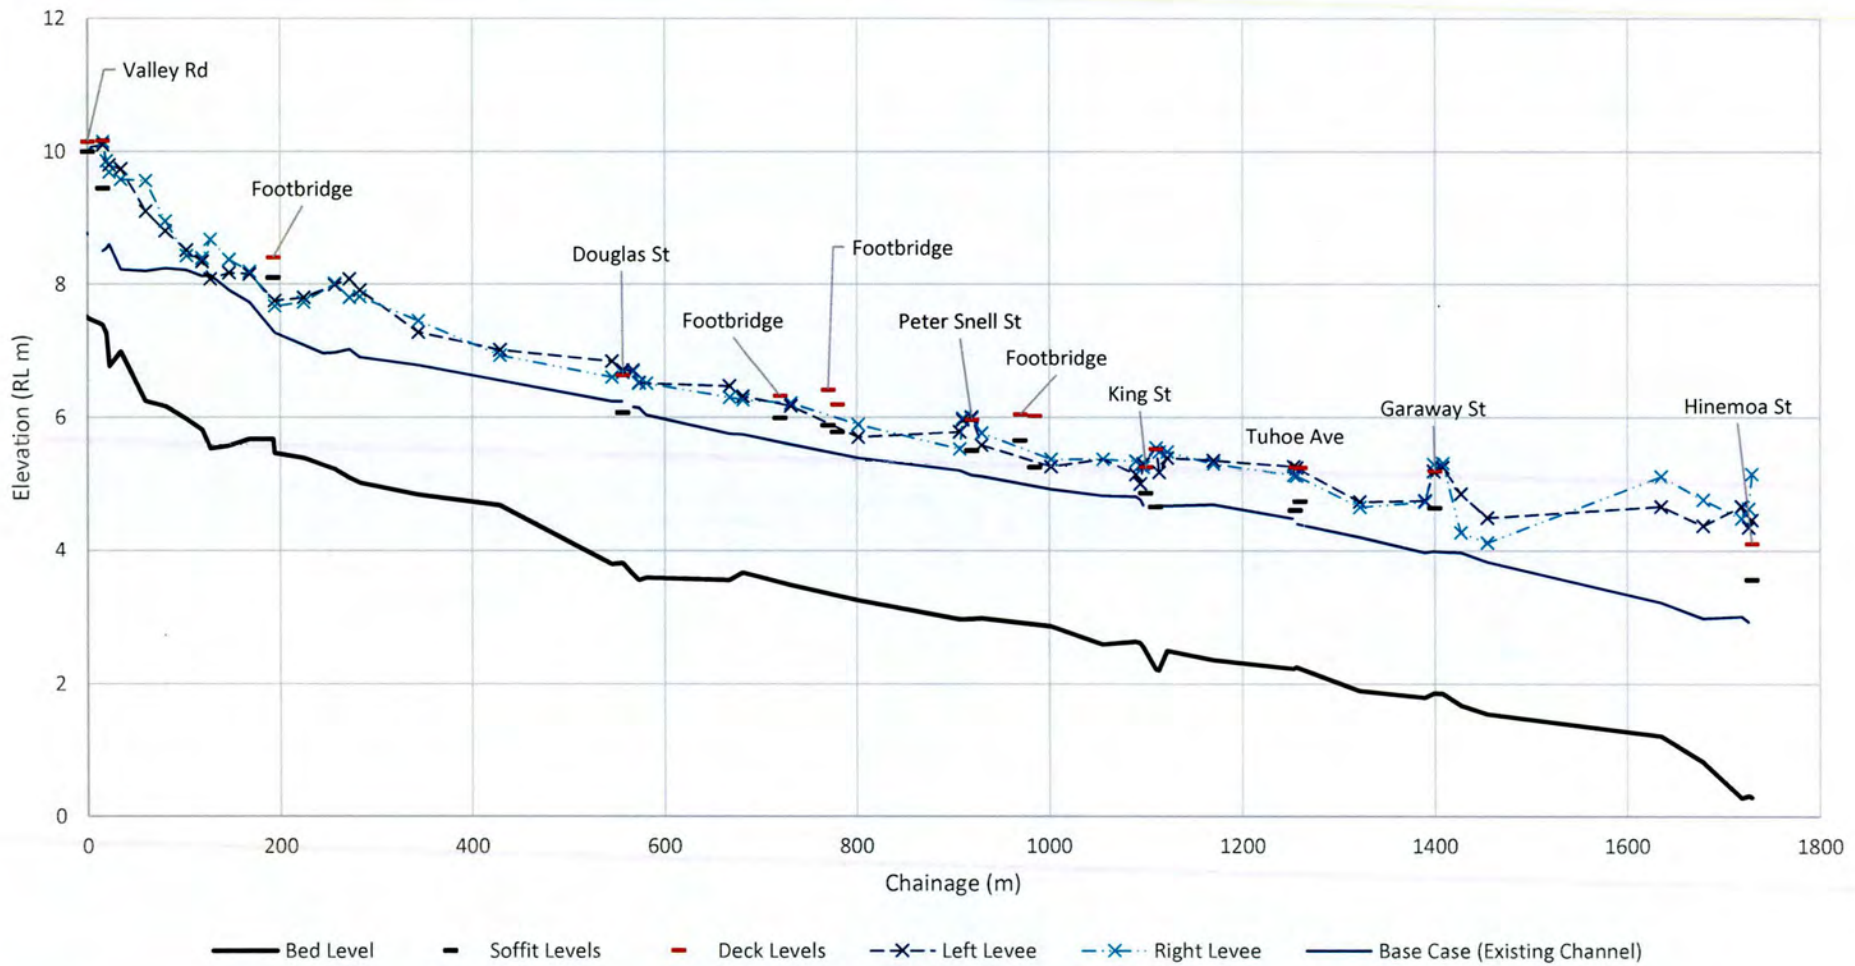
Figure 4 Profile of the existing Wainui Te Whara Stream at full channel capacity during a flow of 20 m³/s (Base Case)

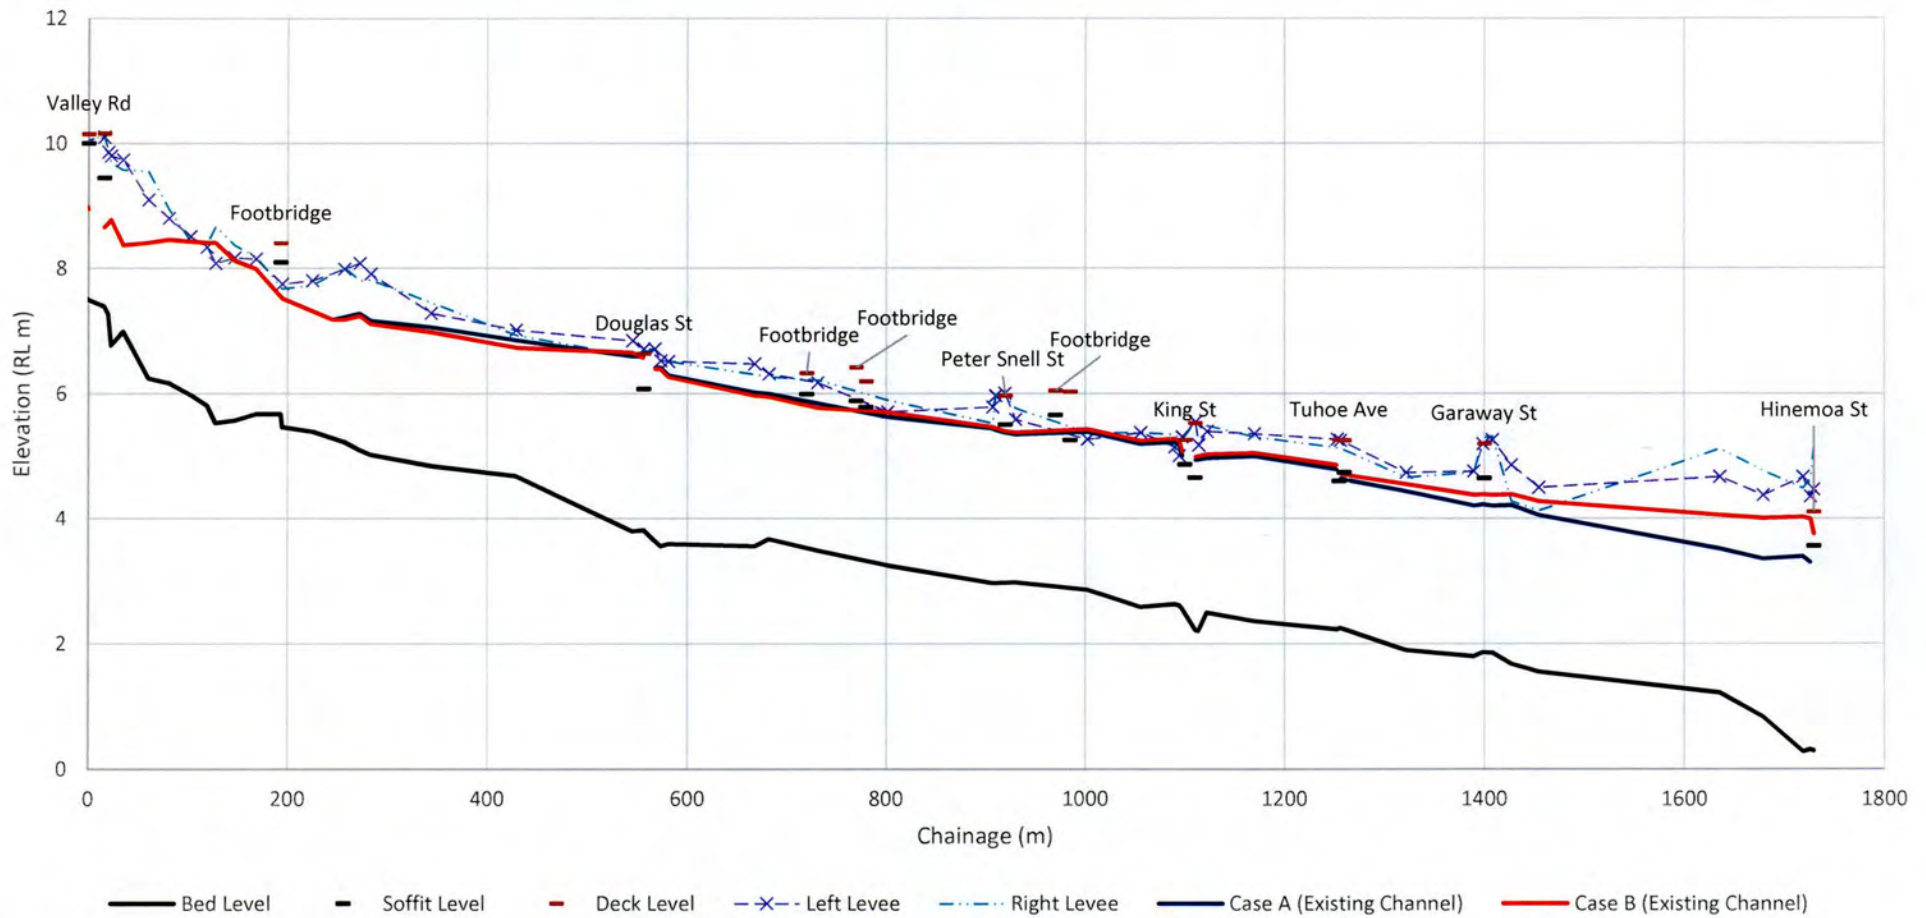
Figure 5 Profile of the existing Wainui Te Whara Stream showing the effect of a varying downstream water level at Awatapu Lagoon for a flow of 25 m³/s (Cases A and B)

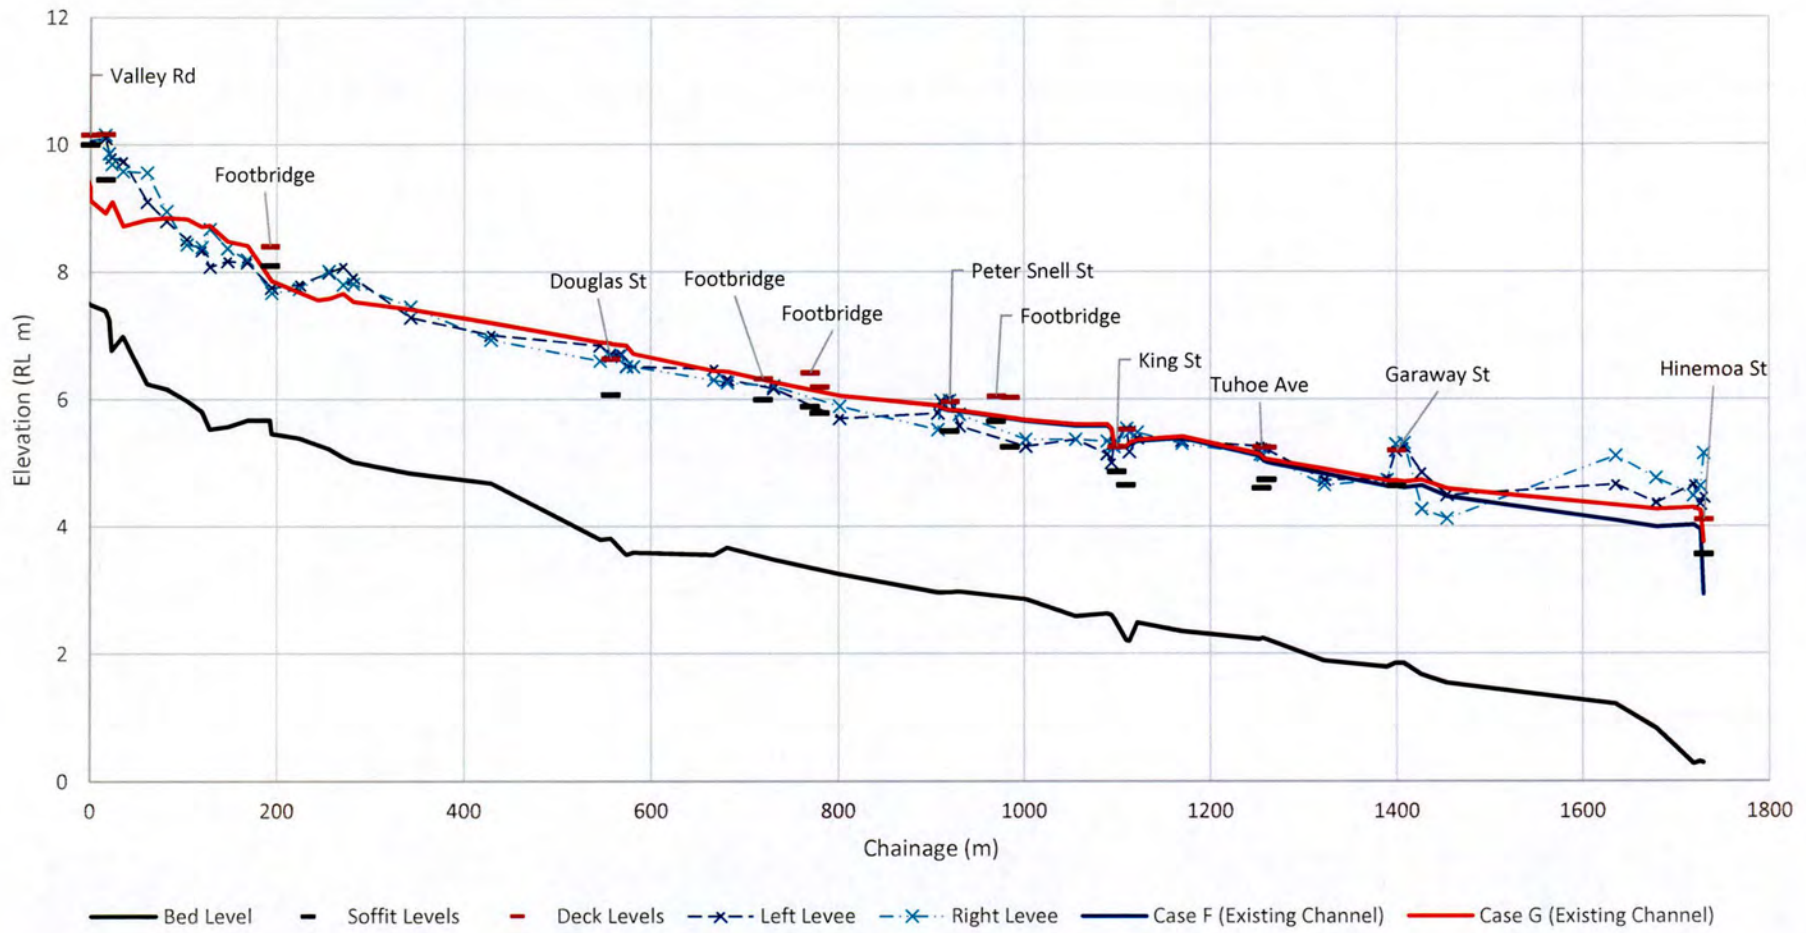
Figure 9 Profile of the existing Wainui Te Whara Stream with all the bridges removed showing the effect of a varying downstream water level at Awatapu Lagoon for a flow of 35 m³/s (Cases F and G)

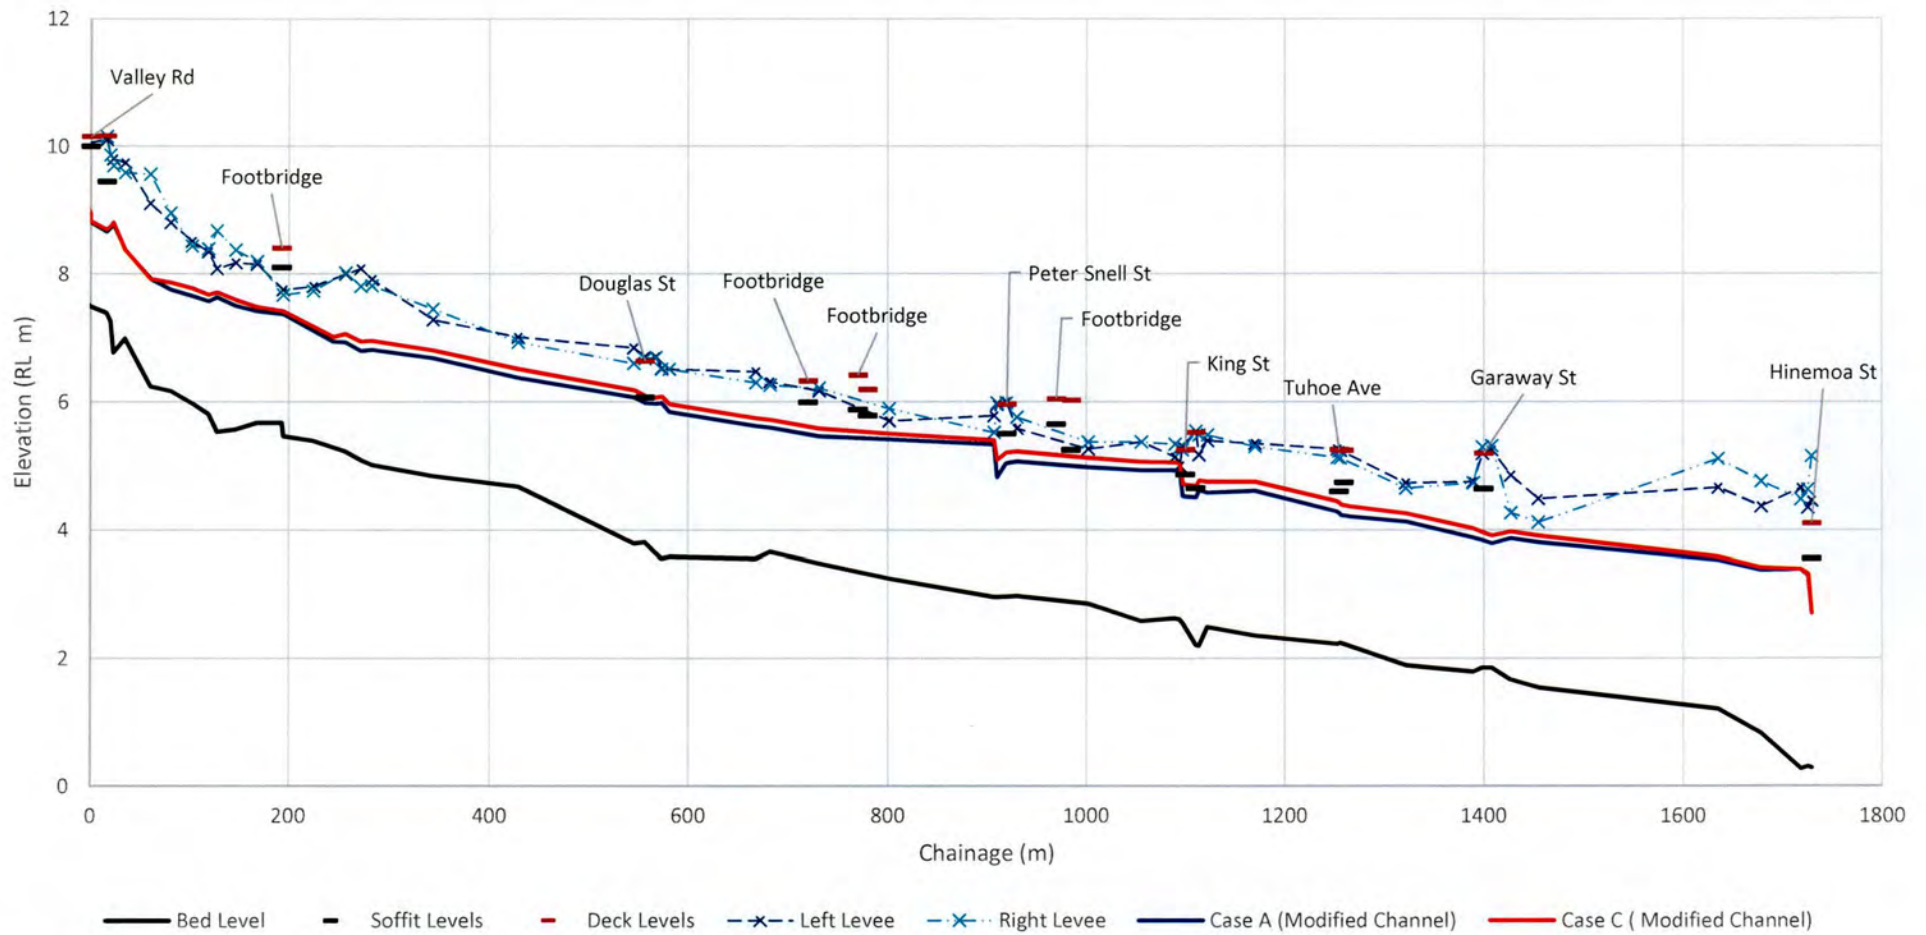
Figure 13 Profile of the modified Wainui Te Whara Stream showing the effect of increasing the base Manning's n channel roughness values by 0.005 for a flow of 25 m³/s (Cases A and C)

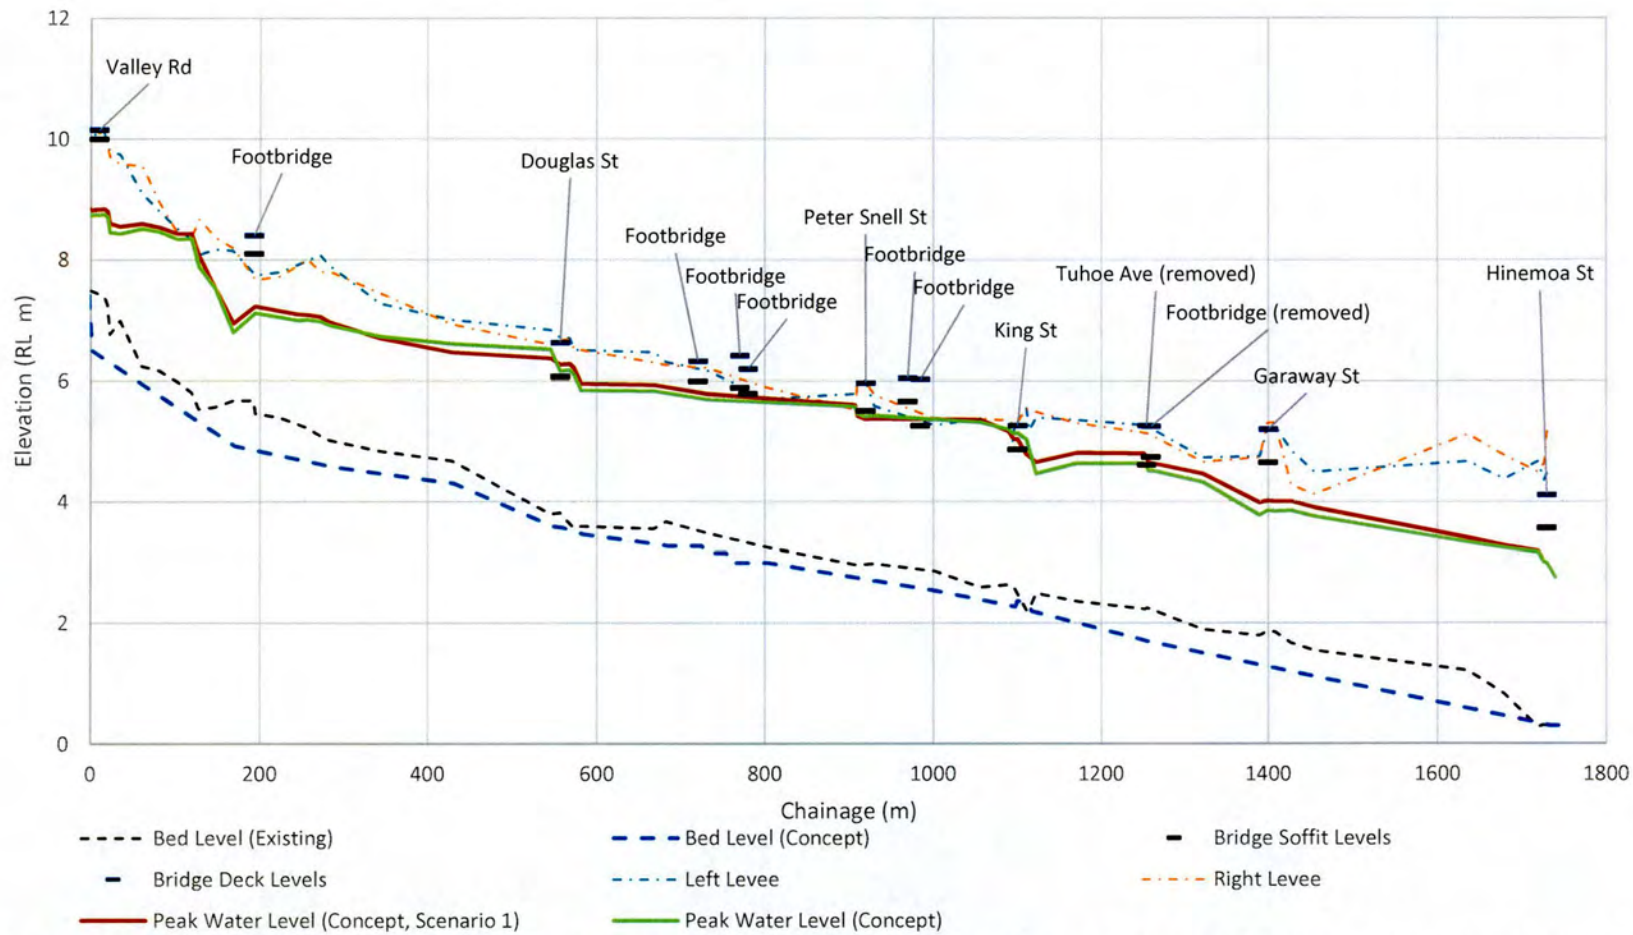
Figure A-3 Profile of the modified Wainui TeWhara Stream, for a discharge of 32 m³/s, comparing sensitivity test between original results and scenario 1 (to further 0.005 increase in n) based on concept bed (scenario 1).

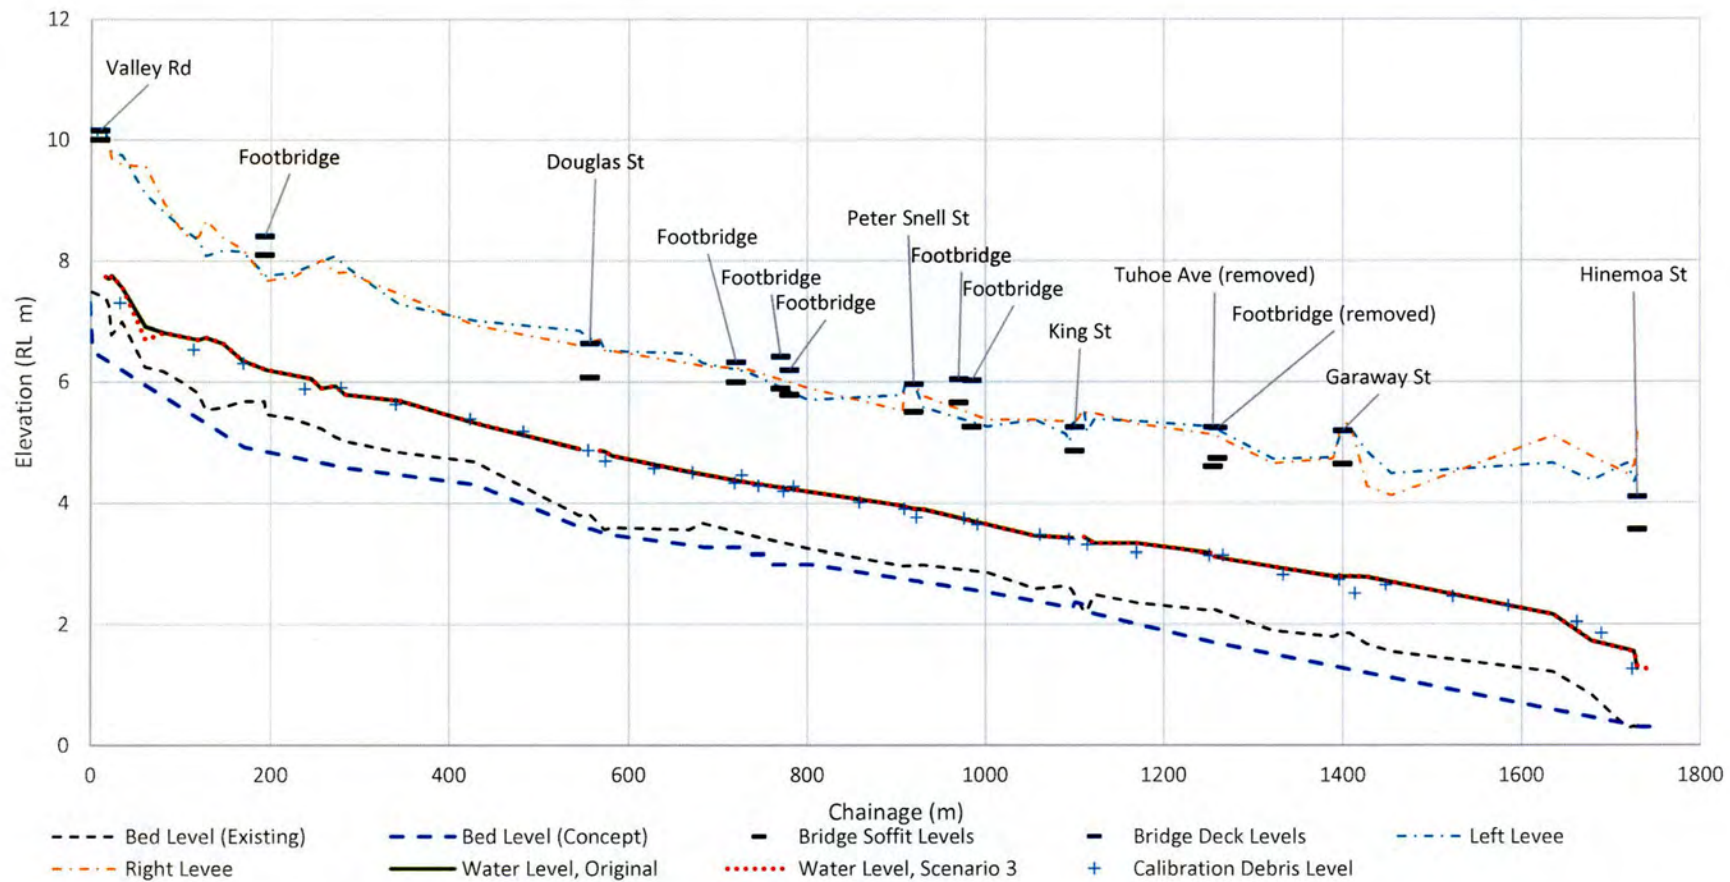
Figure A-5 Profile of the modified Wainui TeWhara Stream, for a discharge of 4.7 m³/s, comparing the original results with re-run scenario 3 (Hinemoa St culvert added).

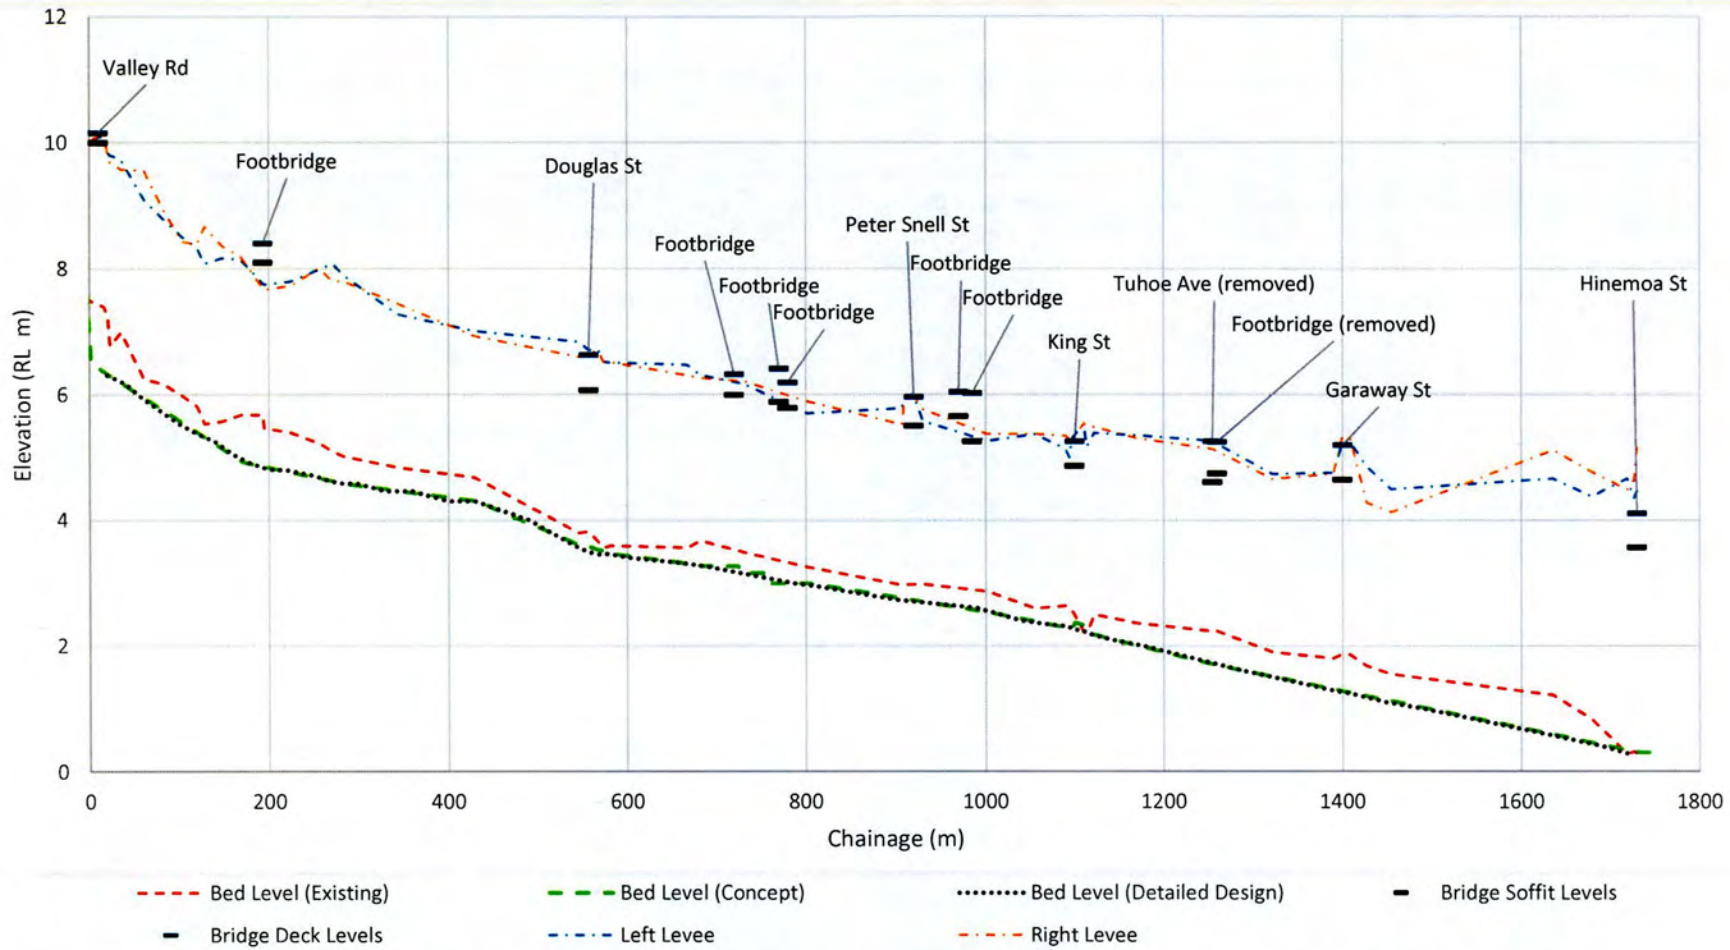
Figure A-6 Comparing minimum bed level between existing situation, concept design and detailed design.

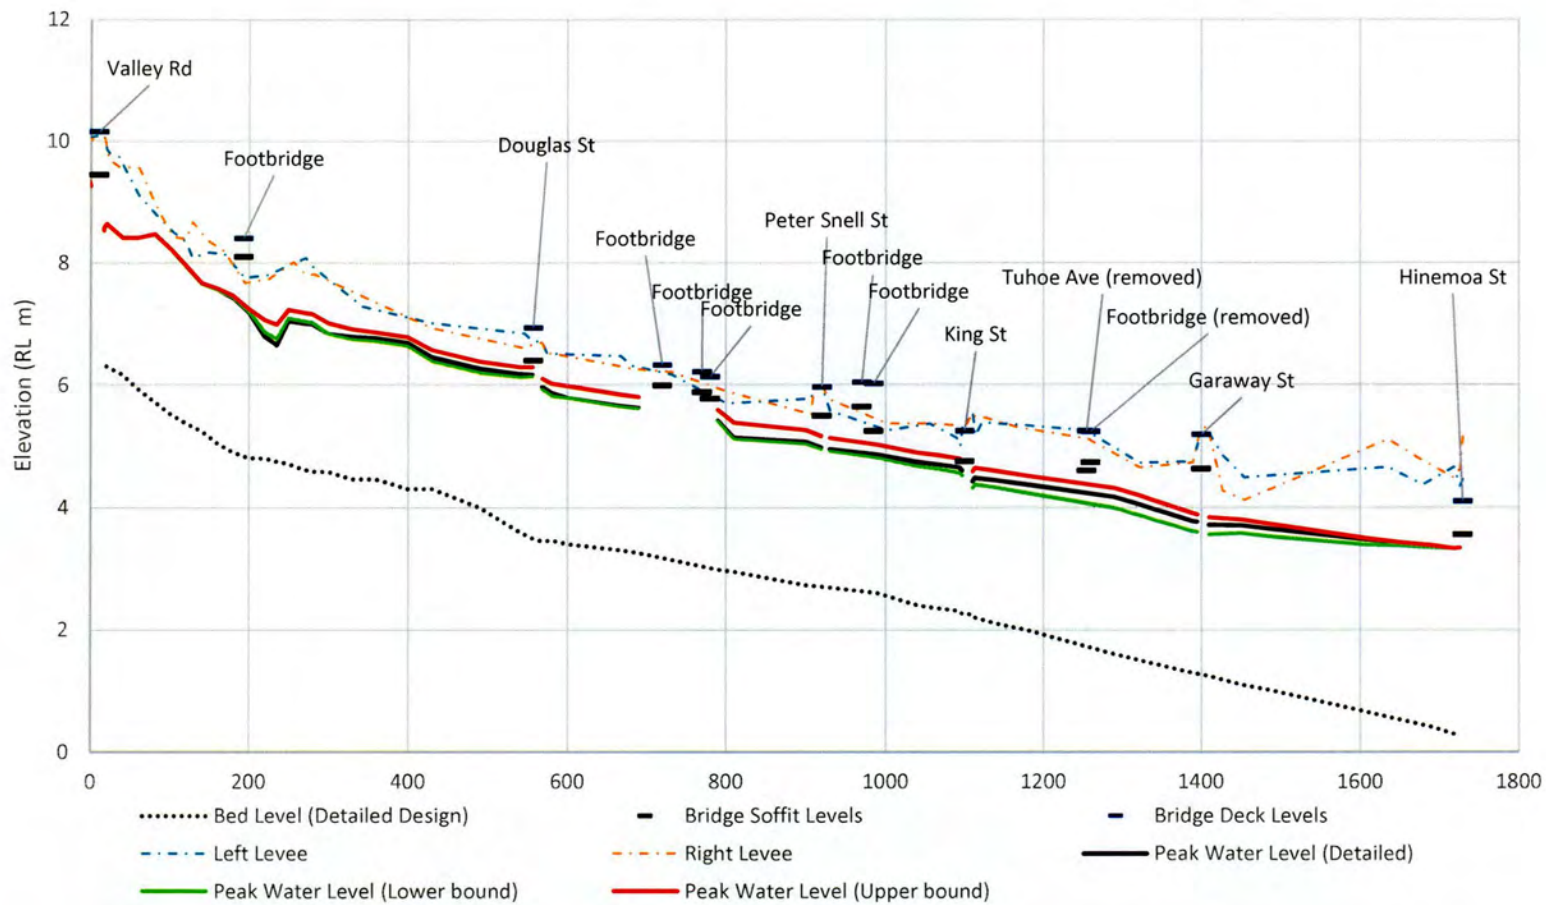
Figure A-9 Profile of the modified Wainui TeWhara Stream, $Q=32 \text{ m}^3/\text{s}$, comparing sensitivity test between original results and upper/Lower Manning bound (Cases b and c)
