Wainui Te Whara Stream:
Urban Channel improvement works

**Wainui Te Whara Stream:
Urban Channel Improvement Works**

Stage Two – Channel works

**Comprising Earthworks, erosion protection, channel reshaping, deepening
and stream realignment**

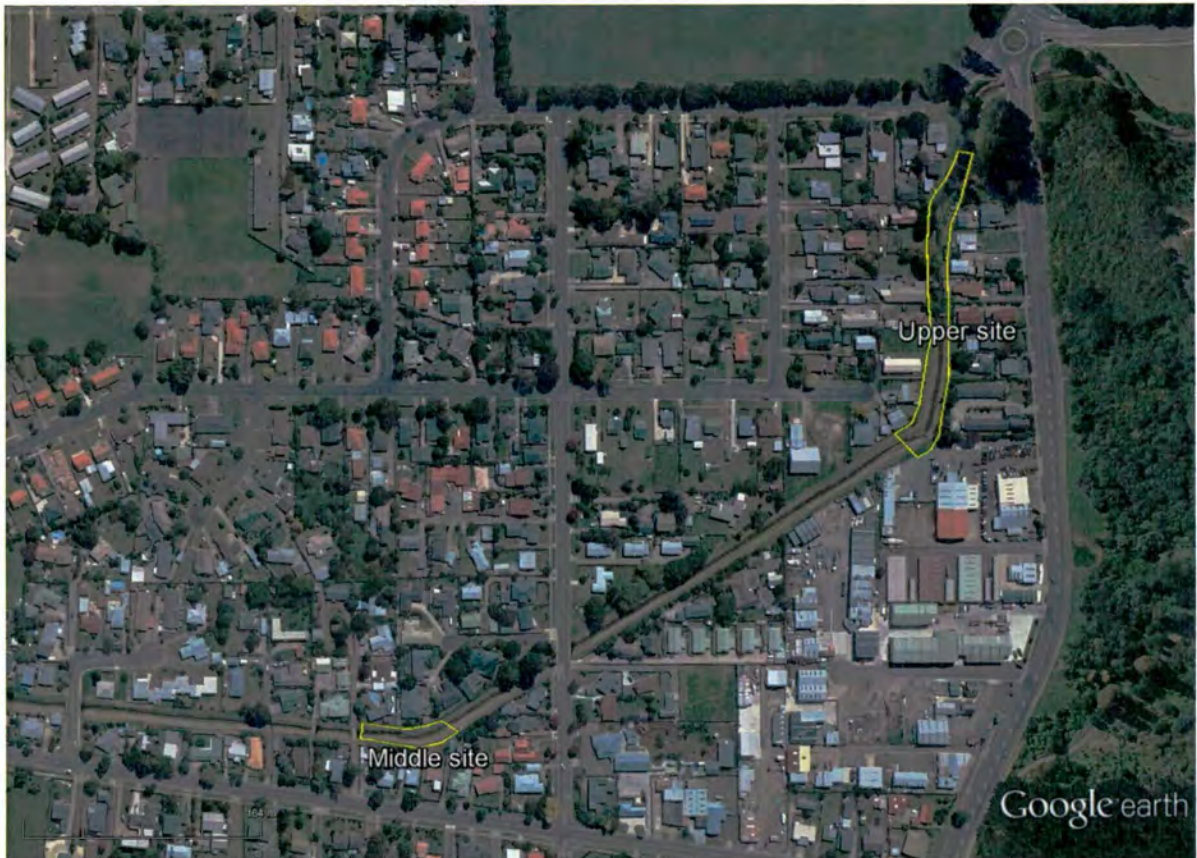
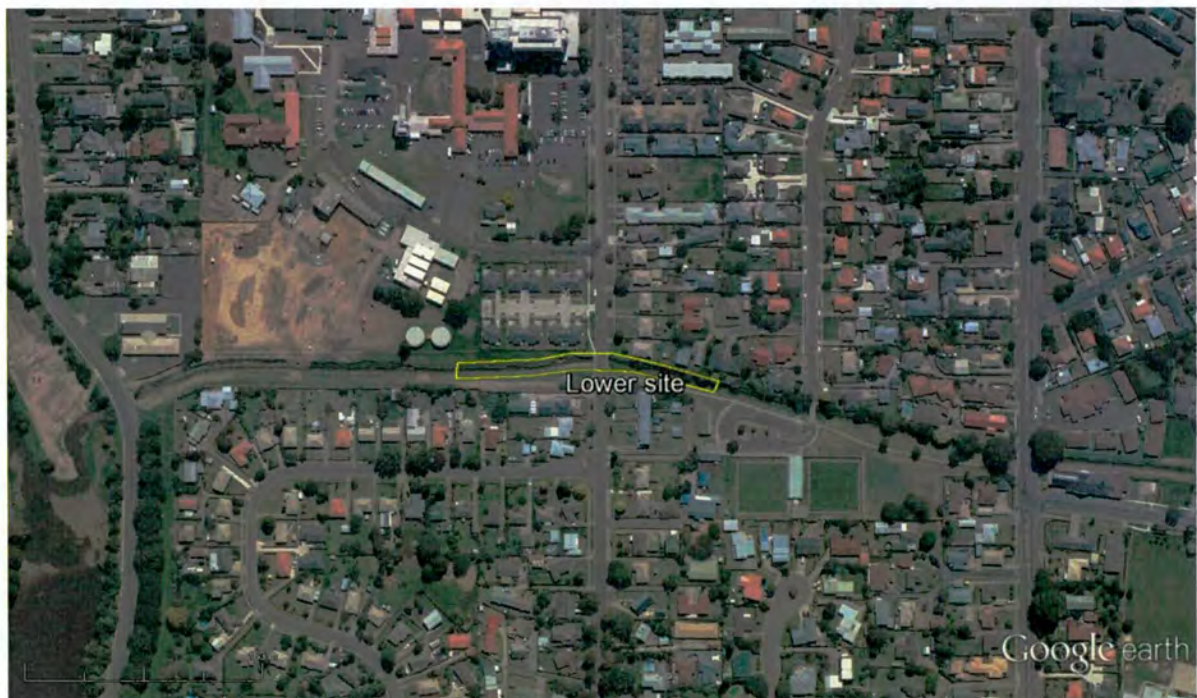
Figure 2.1: Location of sample sites on Wainui Te Whara Stream, Whakatāne. The upper site was located between Valley Road and Douglas Street, the middle site was between Douglas Street and a private bridge; the lower site was either site of Garaway Street.

Three sites were surveyed on the Wainui Te Whara Stream within its urban catchment: downstream of Valley Road (upper), downstream of Douglas Street (middle) and Garaway Street (lower) (see Table 2.1 and Figure 2.1). Aquatic macroinvertebrates were collected at all three sites; fish were surveyed using electric fishing at the Valley Road and Garaway Street sites. In total about 21% of the stream length between Valley Road and Awatapu Lagoon was fished using electric fishing.

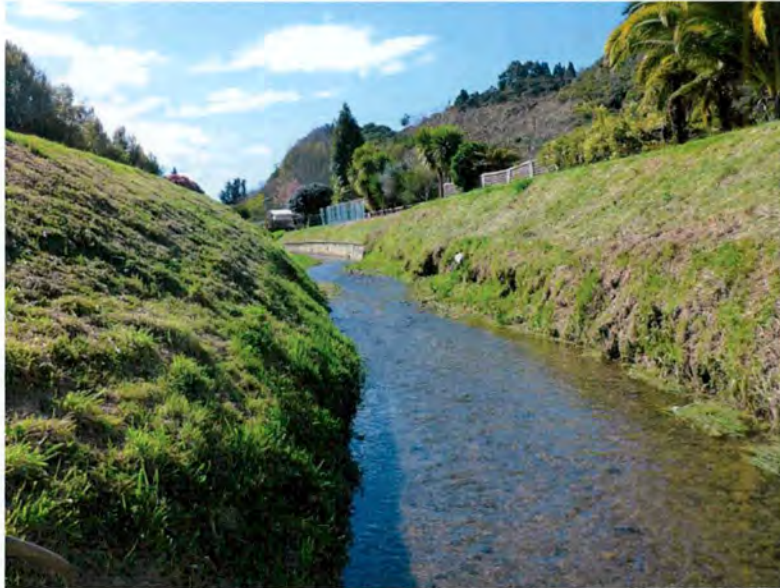
Photo A4.1: Wainui Te Whara upper site, downstream of Valley Road. Very few fish were caught in the section with the retaining wall seen in the top of this photo.

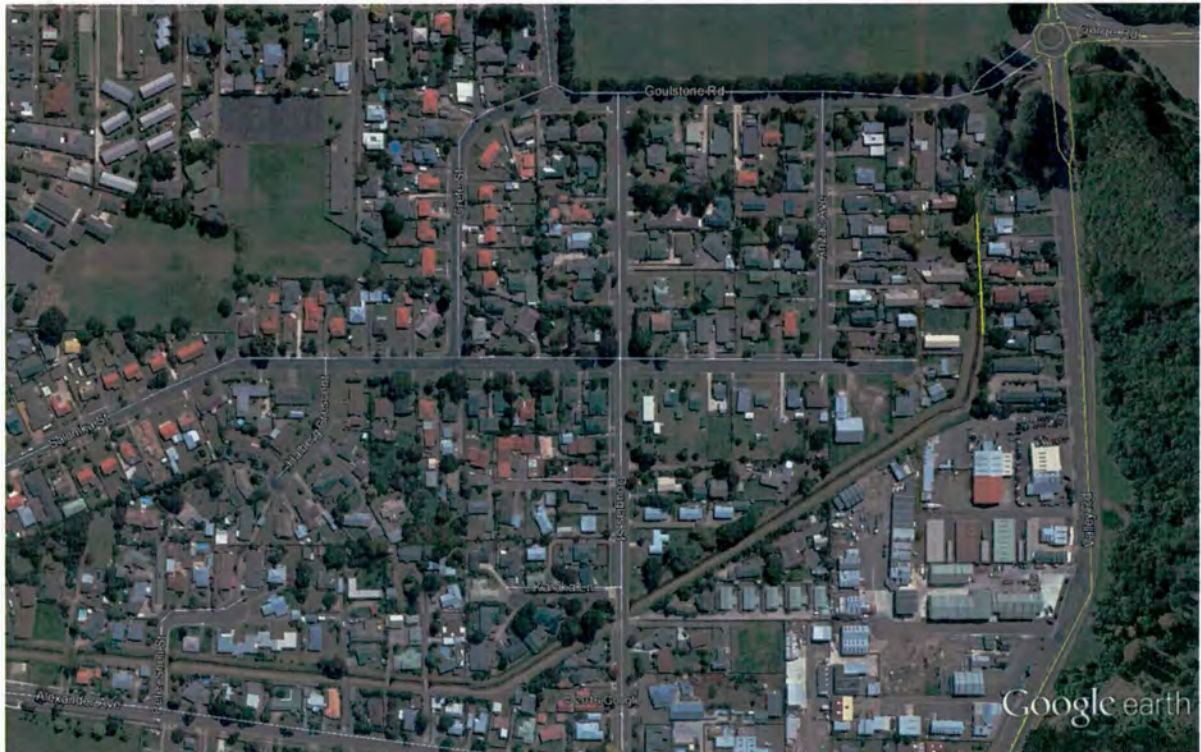
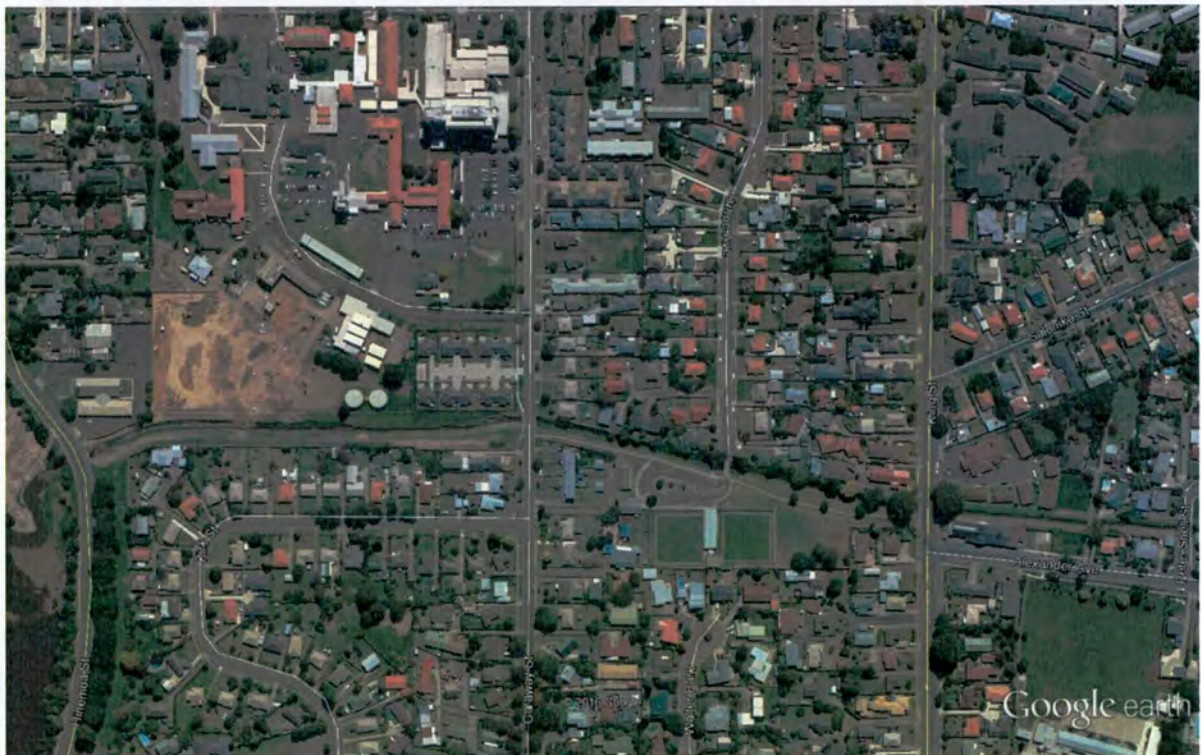
Figure 2.1: The lower Wainui Te Whara Stream between Hinemoa Street and Valley Road, Whakatāne. The current length of sheet piling downstream of Valley Road is indicated on the map by the yellow line.

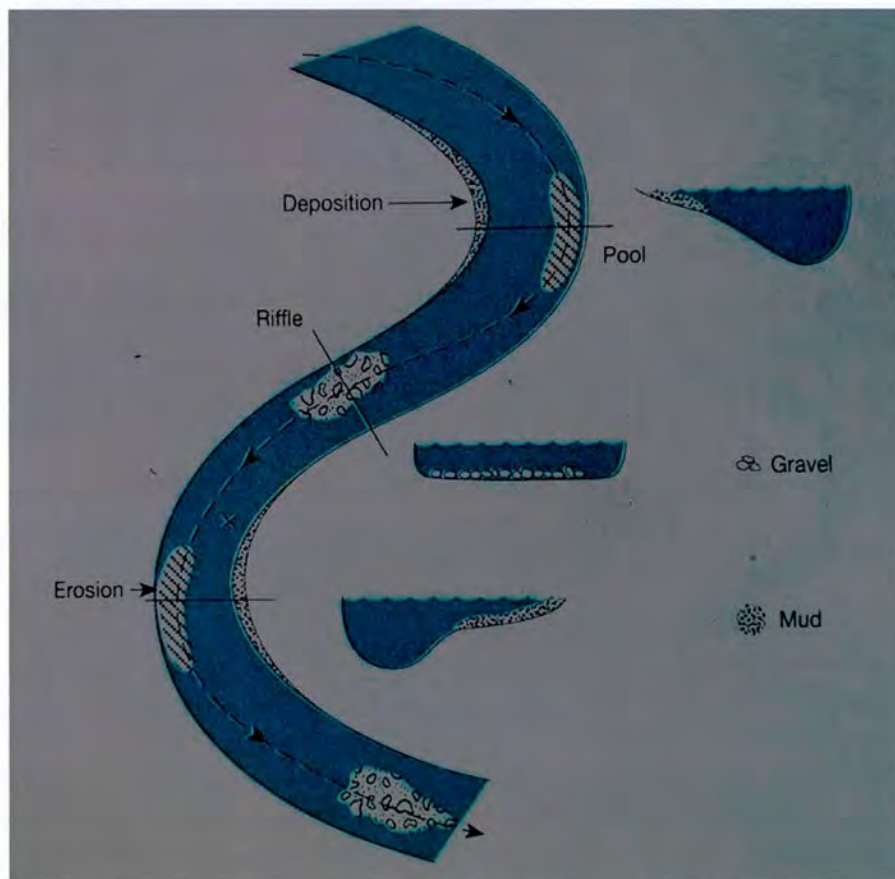
Figure 4.1: Formation of regular current, bend and depth conditions with a meander pattern (from Madsen 1995)

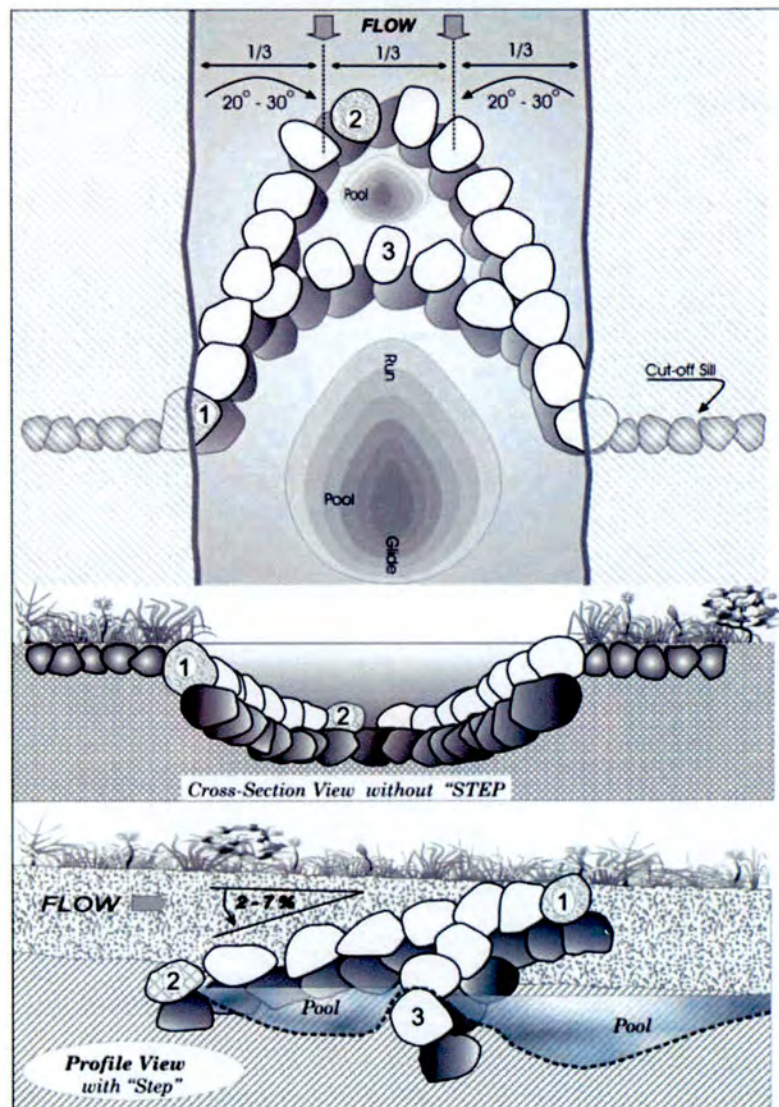
Figure 4.2: Cross Vanes in cross-section, profile and plan view (from Rosgen 2006)

Vanes provide fish habitat in their own right but also work very well in combination with fish habitat structures placed adjacent to pools created on the downstream end of the structures.

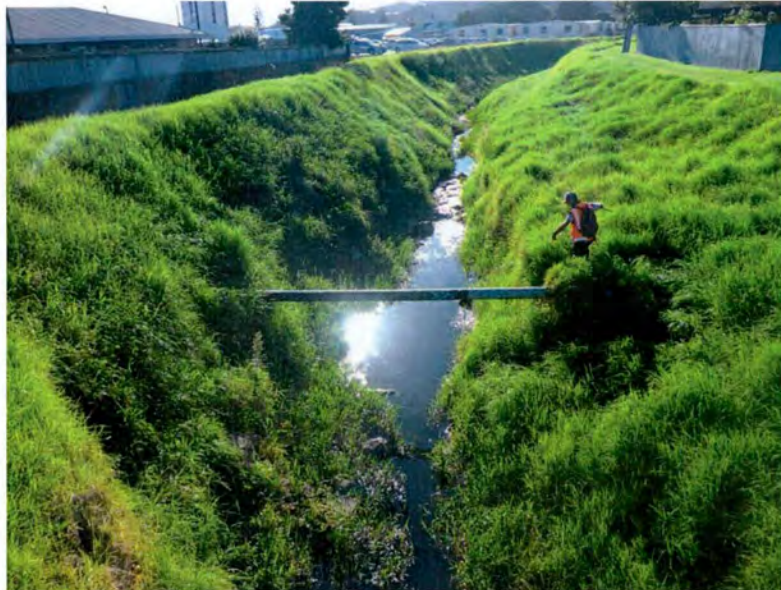
Photo A1: Wainui Te Whara Stream upstream of Hinemoa Street (facing upstream 14 April 2016). The stream section is relatively steep with potential fish cover amongst boulders.

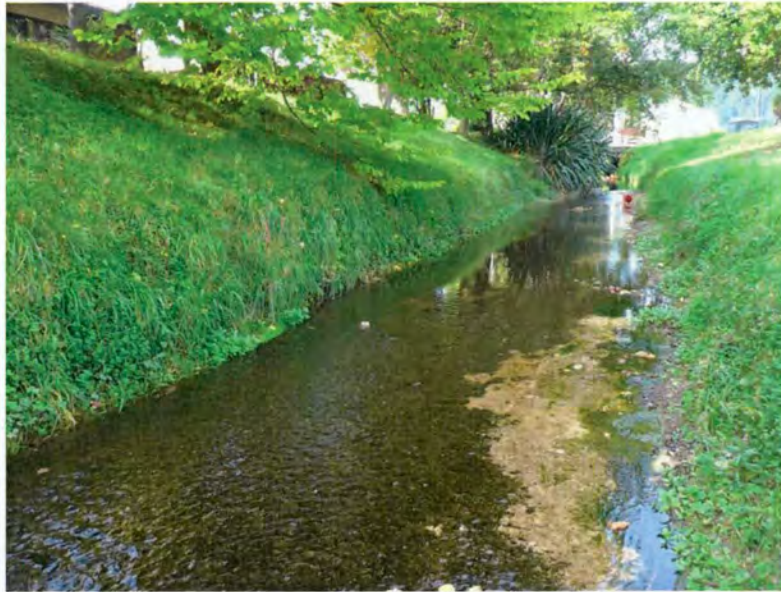
Photo A3: Wainui Te Whara Stream downstream of King Street (facing upstream 14 April 2016). In this section the stream is wide and shallow.

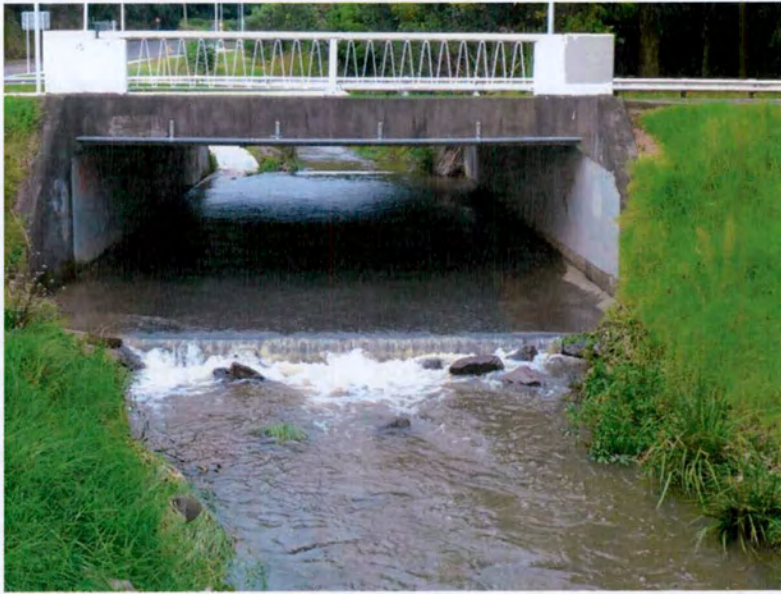
Photo A7: Wainui Te Whara Stream downstream of Valley Road during a small flood (18 April 2016).

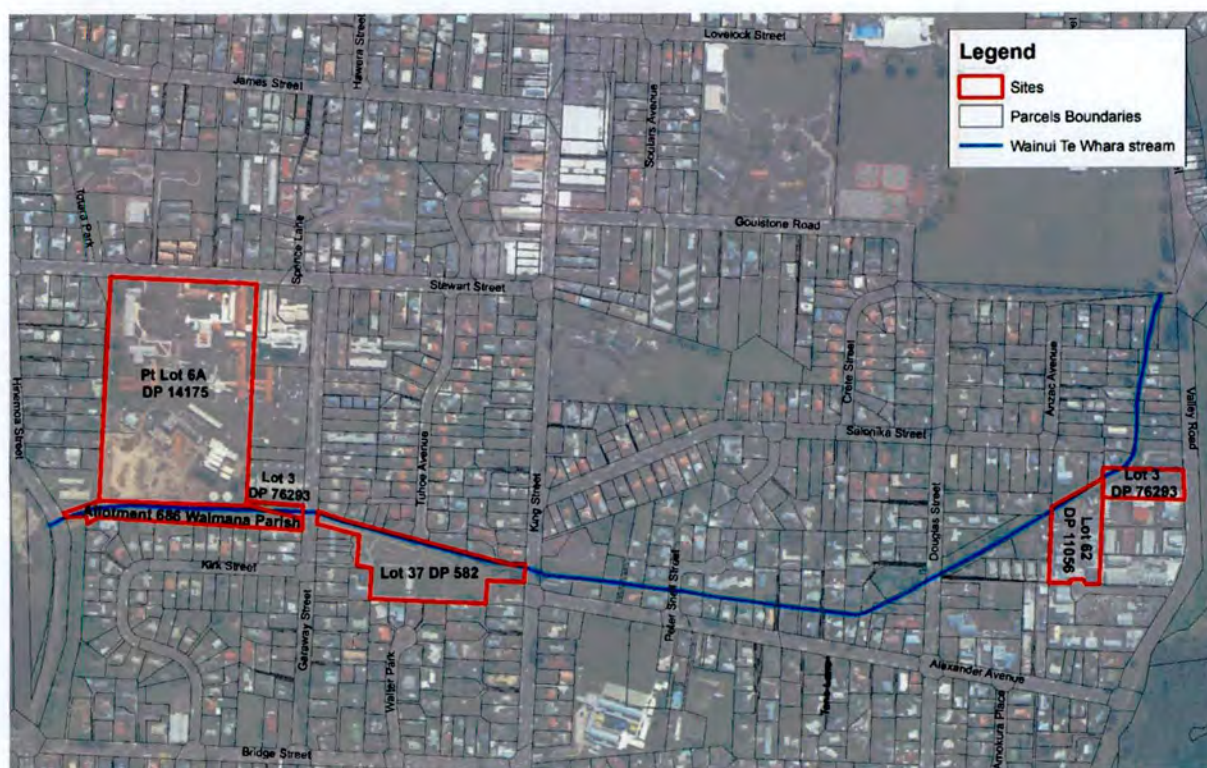
Figure 1 - Investigated sites

Investigations were completed on the following land parcels. Each site is depicted in Figure 1:

The proposed development is to improve flood defence by raising the stopbanks. The development fits the NES Commercial / industrial outdoor worker (unpaved) scenario during development and Parks/ recreational once works are completed.

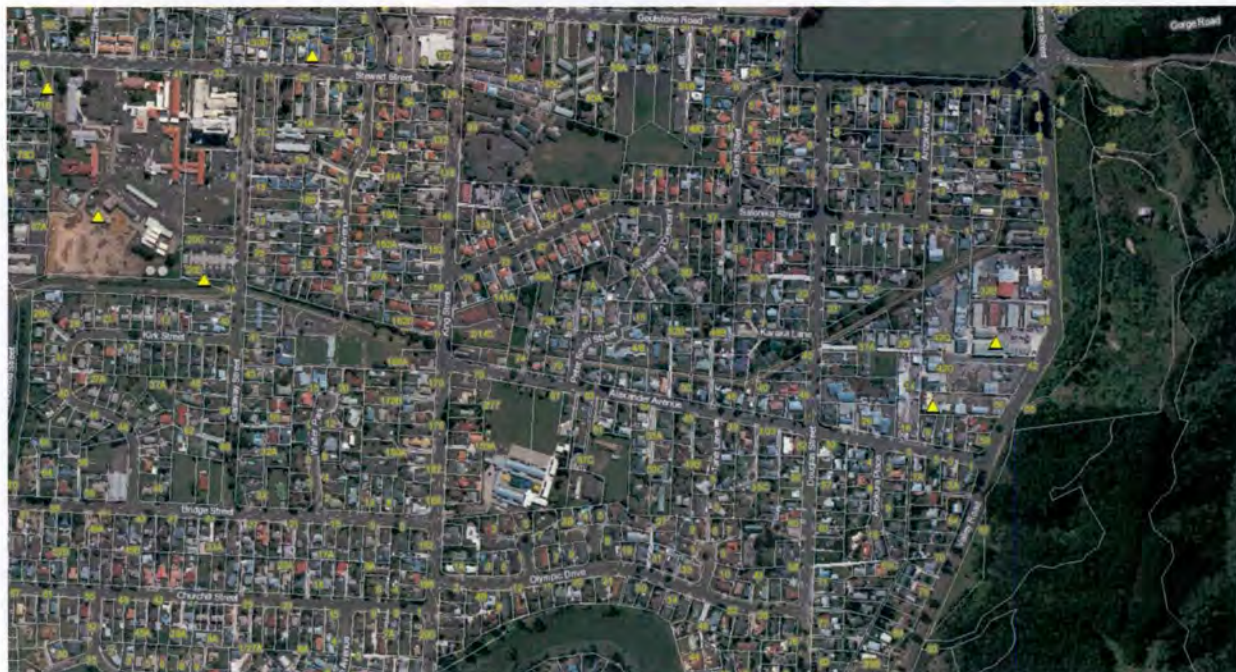
Figure 2 - Registered HAIL sites near the Wainui Te Whara (source BOPRC Bay eXplorer website).

Two HAIL sites located on the western end of the Wainui Te Whara are registered as “Contamination Managed” and “Waste disposal to land (excluding where biosolids have been used as soil conditioners)”.

The BOPRC online maps service indicates that there are two land parcels adjacent to the Wainui Te Whara that meet the classification of the Hazardous Activities and Industries List (HAIL). These are commonly referred to as HAIL sites and are shown as yellow triangles in figure 2.

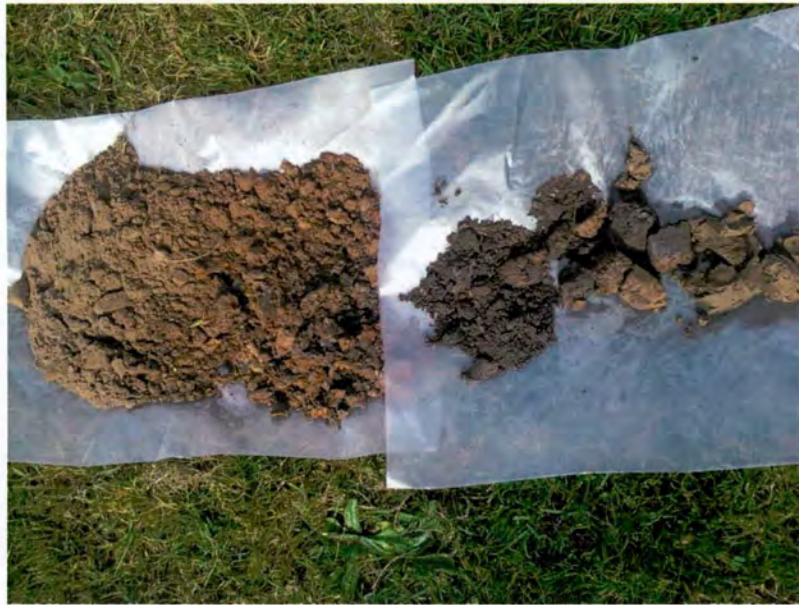
0-90 Sandy silt
90-120 Sand w/ silty clay
120-150 Silty clay
150-165 Sand
165-180 Silty clay
180-200 Clay

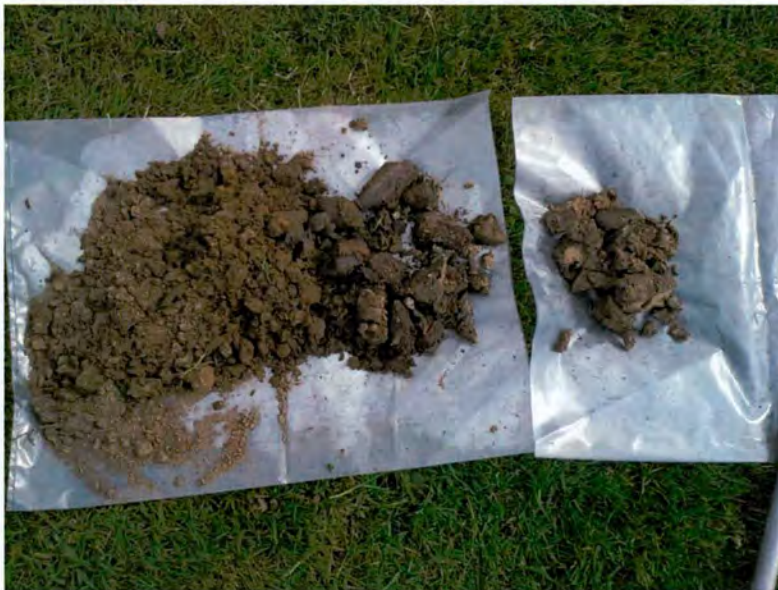
0-60 Sandy silt
60-110 Sand w/ clay
110-170 Silty clay
170-200 Clay

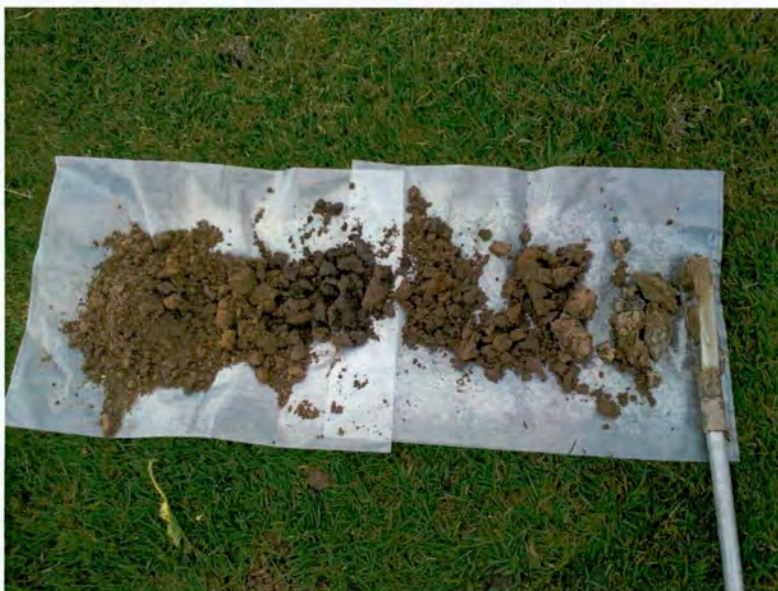
0-55 Sandy silt
55-100 Sand w/ clay
100-115 Silty clay
115-130 Sand
130-170 Sandy silt
170-200 Pumice, sandy silt

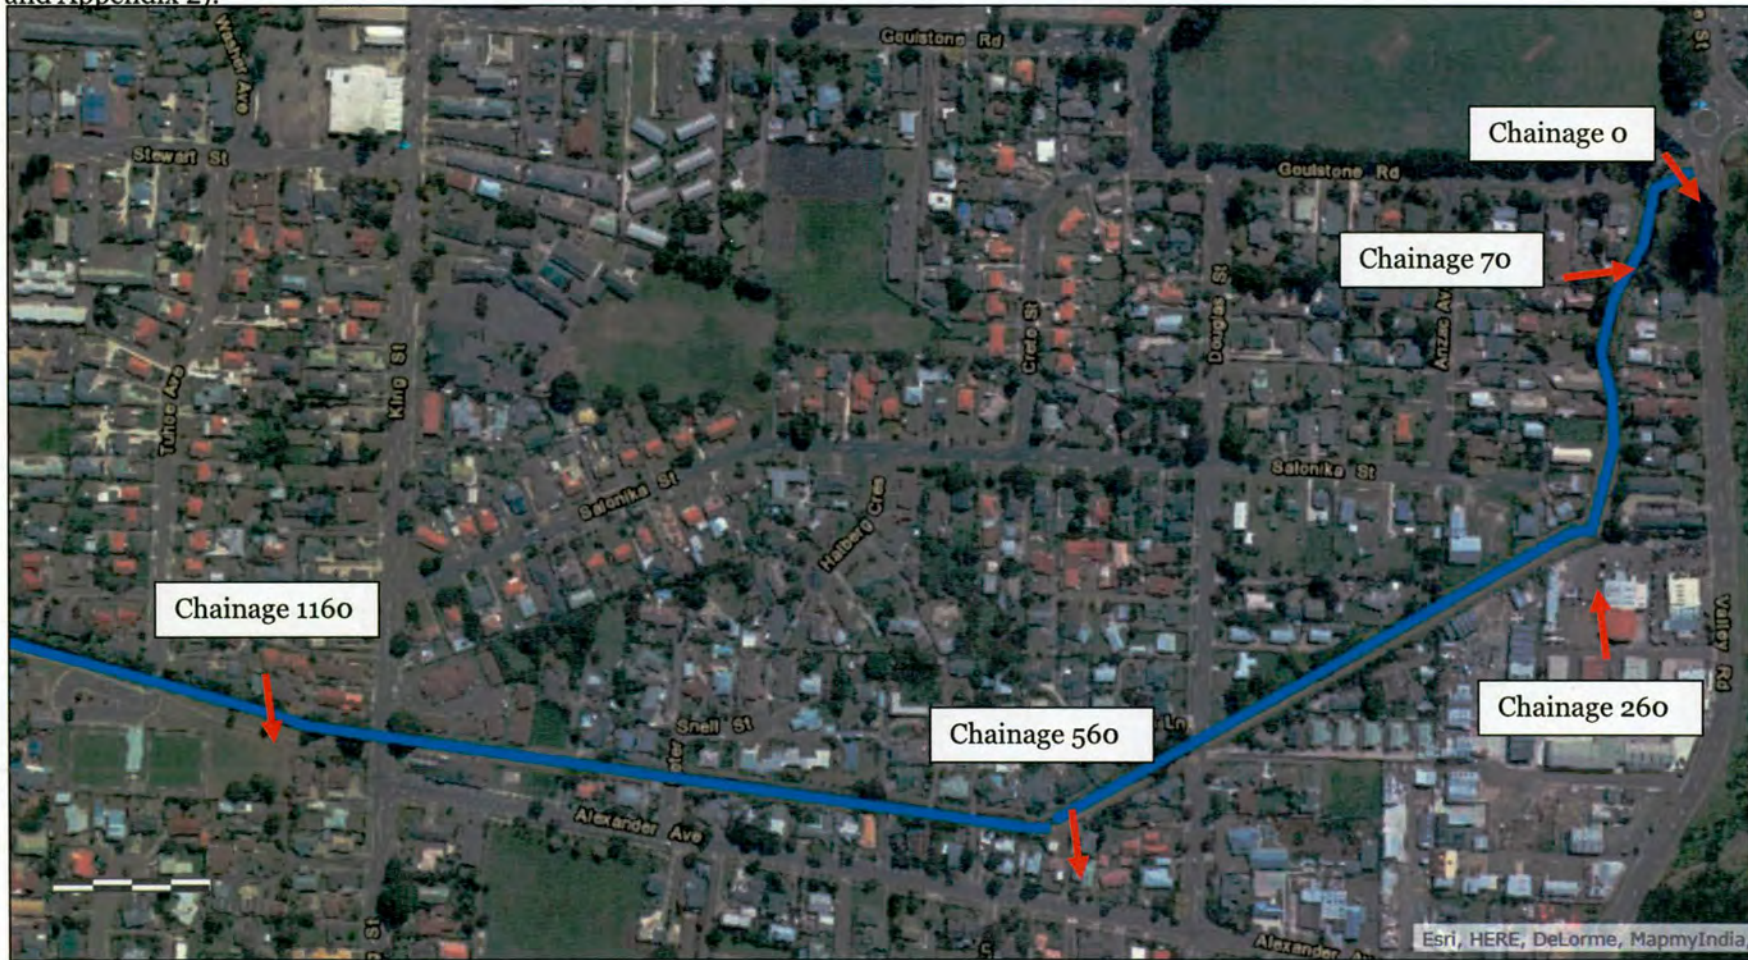
Figure 14: Chainage relevant to fieldwork in the eastern portion of the project footprint

Locations will be referred to in terms of Chainage (metres) from the start of works at Valley Road as per the plans (see Figure 15, Figure 16 and Appendix 2).

Table 1 outlines that the proposed works include widening and deepening the stream channel so the banks are between 35 and 42 degrees in slope (see for Figure 14 and Figure 15 Chainage locations). This equates to up to 2 m of bank removal on both sides in any one place.

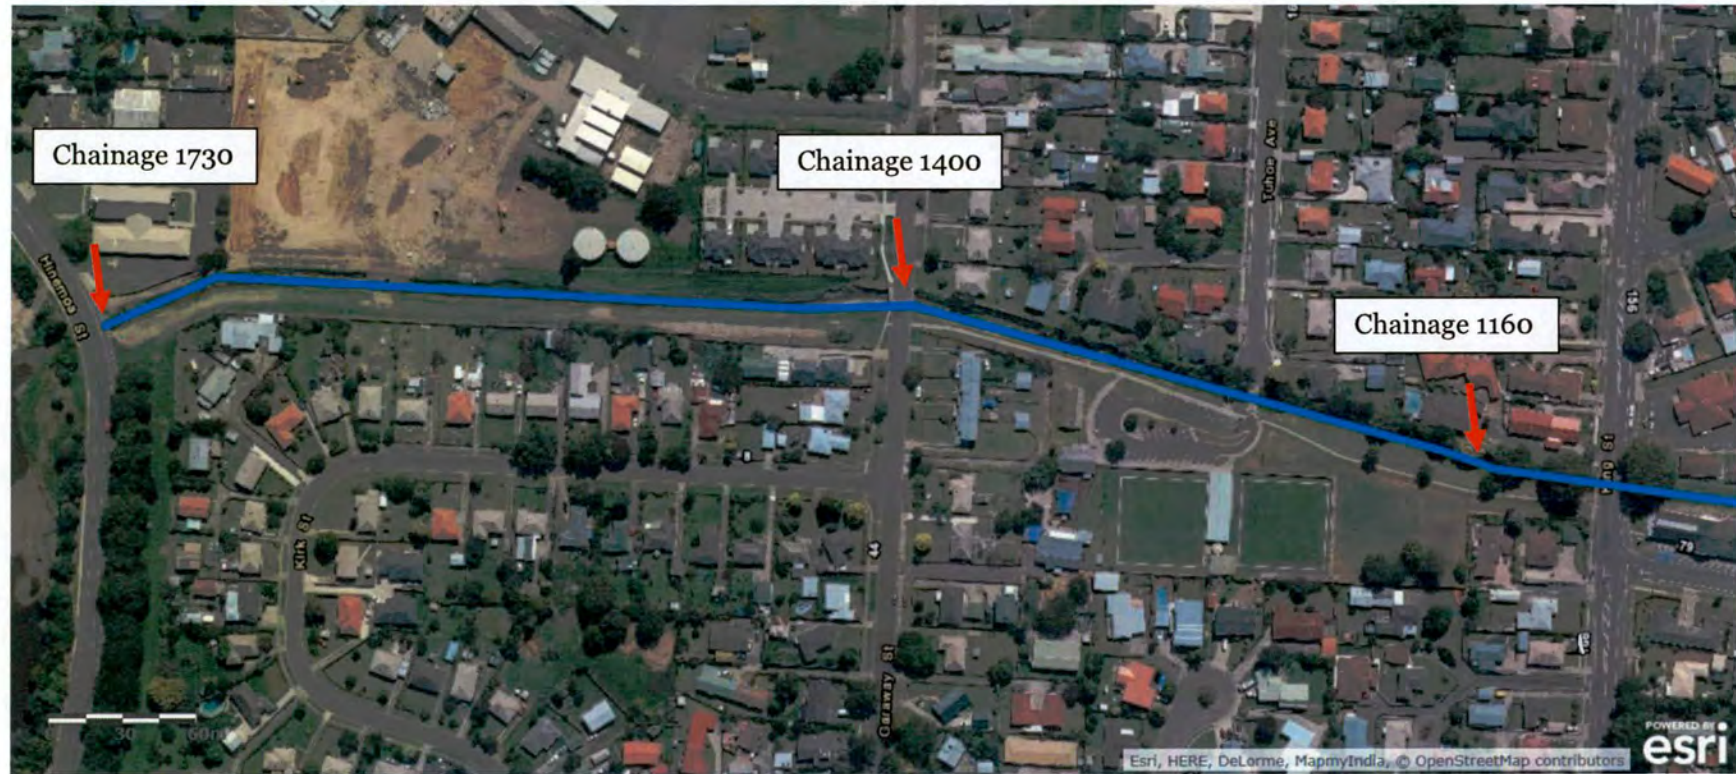
Figure 15: Chainage relevant to fieldwork in the eastern portion of the project footprint

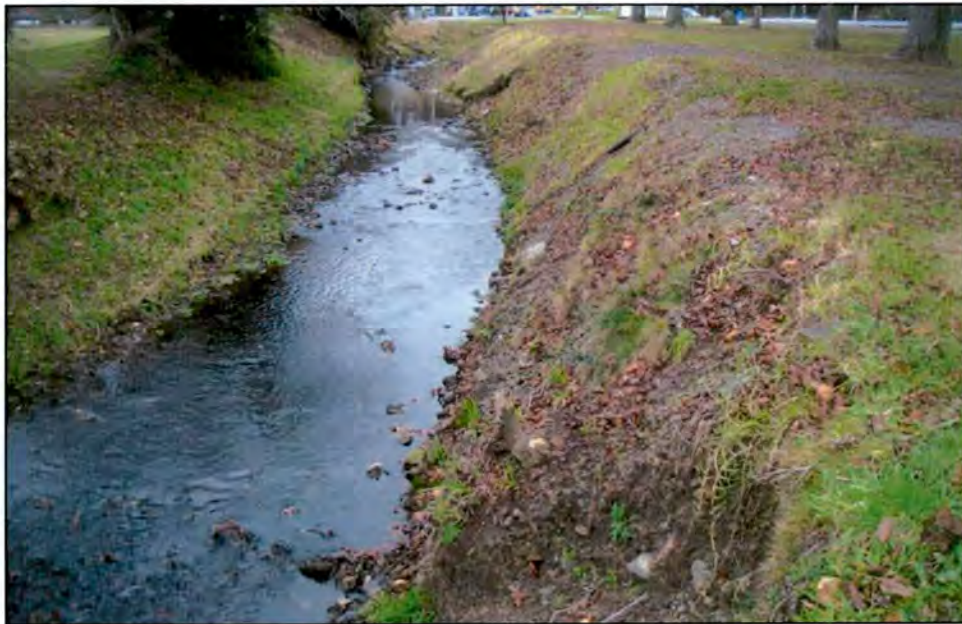
The east bank at this point is bounded by a small reserve and on the west, residential properties (see Figure 17). The reserve is planted in c.35 year old trees and has c.1200 mm subsurface of roading metal. It is likely this metal has been introduced to build up the area as part of the channel modification and subsequent roading development.

Figure 16: View north of Chainage 0-70m - note depth of roading material.

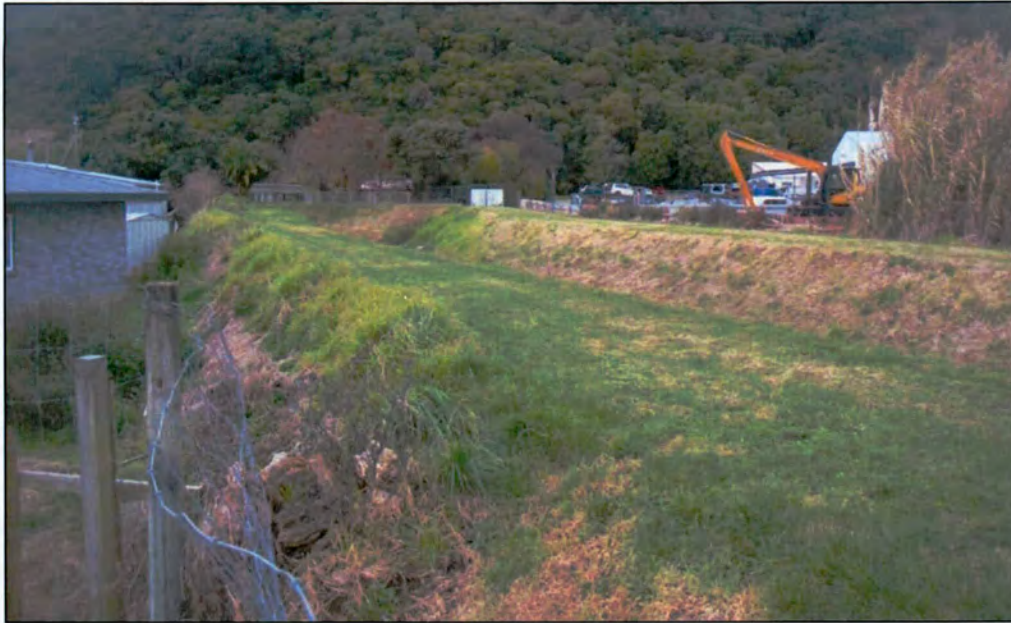
Figure 17: View east of Chainage 260- 360m.

A substantial stop bank c.1200 mm high has been built along the entire length of this section (see Figure 18). The stop bank and stream banks are covered in mown grass. Access to this area was gained from the Assembly of God church carpark in Salonika Street.

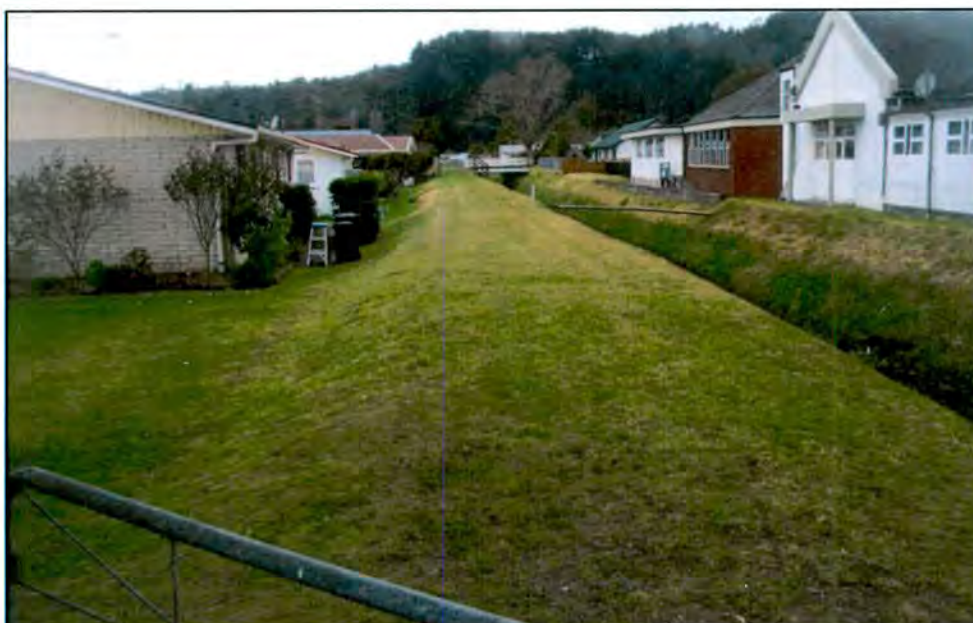
Figure 19: View east from King St of Chainage 900- 1100m – note the Baptist Church on the far right.

Prior to the field visit, NZAA site record forms were examined to indicate possible archaeological activity in the area. A map included in Site Record Form W15/418 (reported by Bristow in 1986) shows the position of a Māori village (not W15/418), reported to be at the present location of the Baptist Church on the corner of King Street and Alexander Avenue (see Figure 20 - Coates 1956).

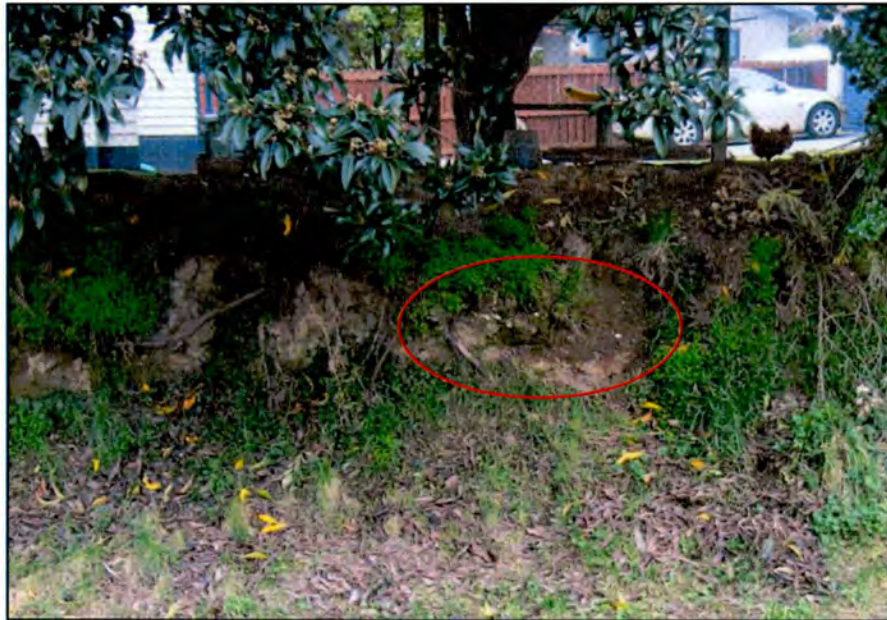
Figure 20: View north of Chainage 1225m. Cockle and pipi shell deposit in channel bank indicated by the red oval.

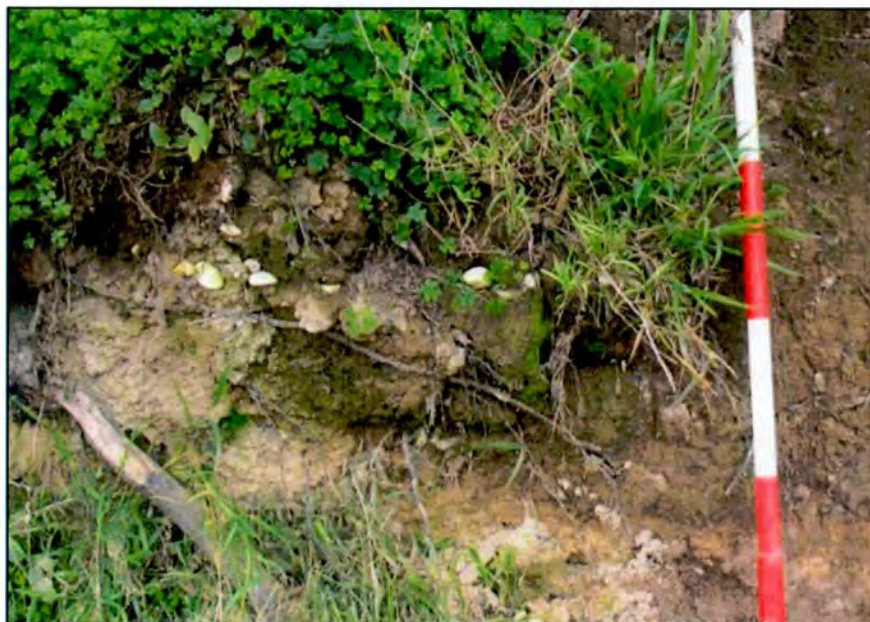
At Chainage 1225 a small in-situ cockle and pipi midden deposit was observed c.700 mm below the present ground surface (see Figure 21 and Figure 22). The shell may be in a buried topsoil context but no charcoal was observed. The condition and position of the shell suggests it may indicate more substantial archaeological remains in the vicinity. The shell midden was entered into ArchSite as W15/1206.

Figure 21: View north of Chainage 1225. Close up of cockle and pipi shell deposit.

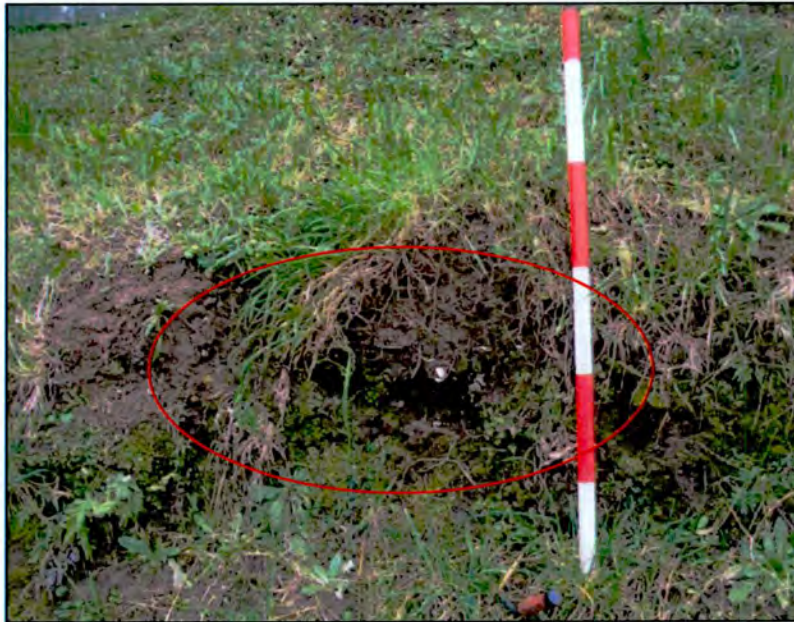
Figure 22: View north of Chainage 1285. Shell midden indicated with red oval.

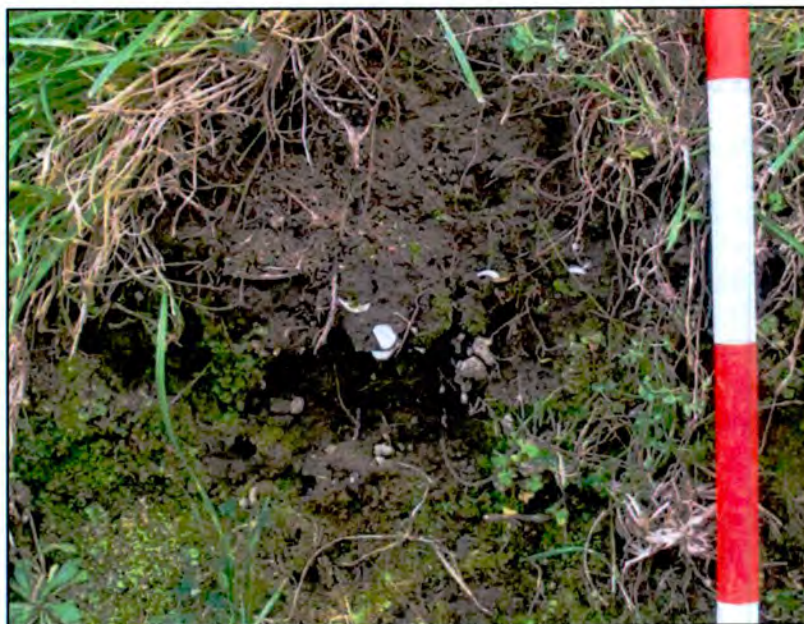
Figure 23: View north of Chainage 1285. Close up of shell deposit.
