Site 68	Karewa Island	Risk ranking: 1
<p><b>DESCRIPTION</b></p> <p>Karewa Island is a small 3.5 ha island situated approximately 6 km off the coast of Matakana Island. It is covered in Taupata Forest. The island is administered by the Department of Conservation (DoC) in close co-operation with tangata whenua, in recognition of its important cultural values. It is a pest free Wildlife Sanctuary, landing is prohibited without DoC permit.</p>		
<p><b>Foreshore type/environmental value</b></p>	<p>Primarily vertical and sloping bedrock, rocky reef, rock pools, sandy beaches</p> <p>Habitat (shoreline), contact, amenity (dive site).</p> <p>All shore segments have "habitat value".</p> <p>All intertidal areas are identified in the Regional Coastal Plan as areas of significant conservation/cultural value.</p>	
<p><b>Map sheets</b></p>	<p><b>NZ Topo 50</b> BD37 Tauranga</p>	<p><b>Chart Number</b> NZ541; NZ542</p>

# SITE 68 Karewa Island

## Oil Spill Management Plan

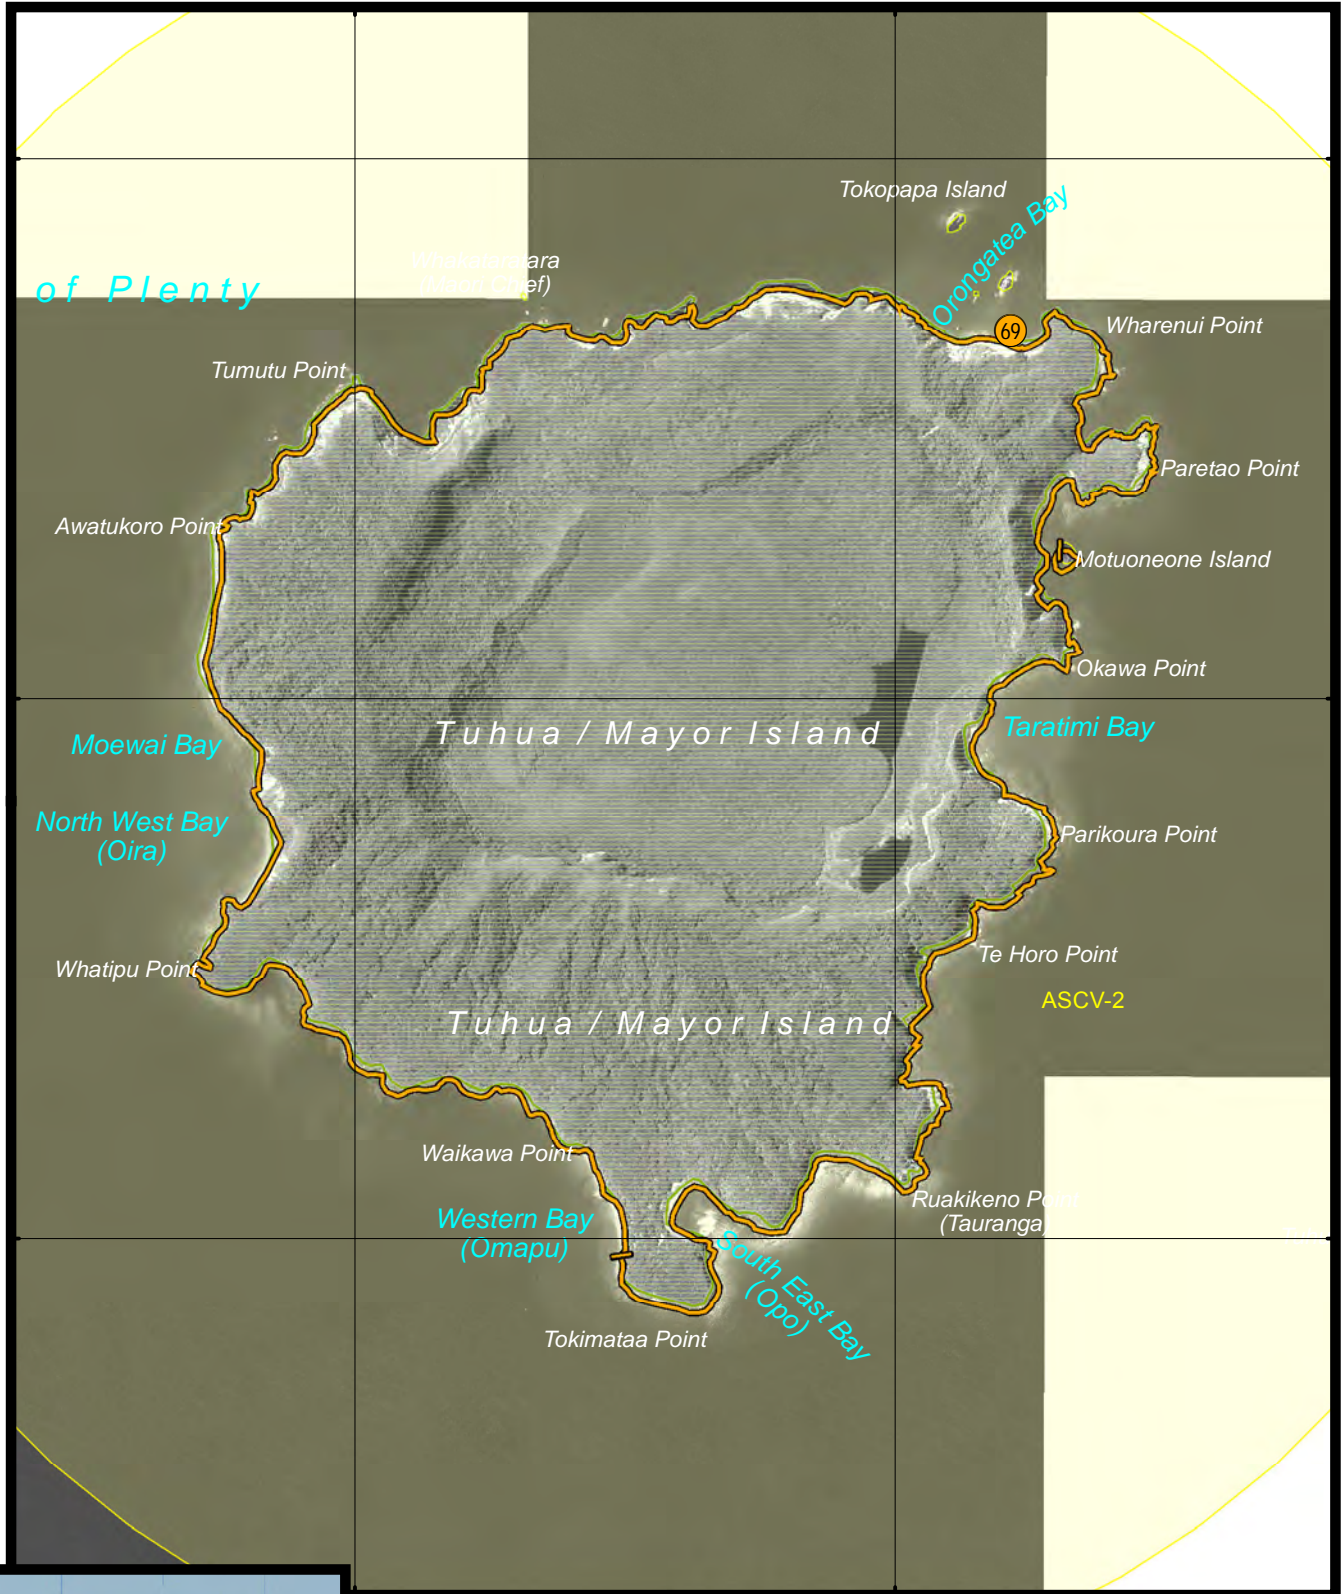
## SITE 69 Tuhua (Mayor Island)

Site 69	Tuhua (Mayor Island)	Risk ranking: 1
<b>DESCRIPTION</b>		
The island includes a marine reserve with regionally significant marine ecosystems in the intertidal and sub tidal habitats. See map attached. These include diverse rocky reef habitats. Large populations of seabirds, mostly threatened or at risk. Marine mammal (fur seal) resting sites.		
<b>Foreshore type/environmental value</b>	The coast of this Island is predominantly cliff face or high relief rocky reef. There are five sandy shores displayed in the attached map marked in blue in South East Bay, Western Bay, North West Bay and Moewai Bay.  All shore segments have habitat value.	
<b>Map sheets</b>	<b>NZ Topo 50</b> BC37 Mayor Island (Tuhua)	<b>Chart Number</b> NZ 541
<b>Segments</b>	<b>MAYO-</b> 00010, 20, by 10s to 180, 185, 190, 200, 210, 220, 230, 240 <b>SANDY BEACHES MAYO-</b> 00230 (SE Bay), 10, 40, 70, 90	
<b>At Risk Resources</b>

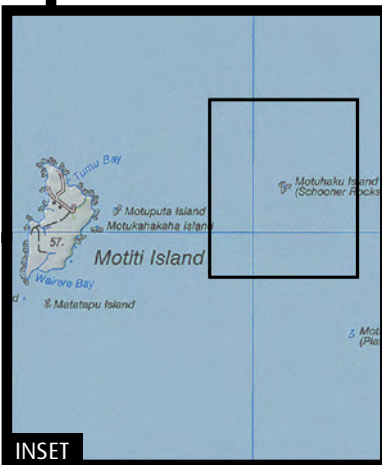
# SITE 74 Motuhaku Island (Schooner Rocks) Oil Spill Management Plan

<b>Site 74</b>	<b>Motuhaku Schooner Rocks</b>	<b>Risk ranking: 2</b>
<b>DESCRIPTION</b> Motuhaku is a rocky outcrop to the north east of Motiti Island. Schooner Rocks has a shallow rock shelf that breaks the water then drops steeply away to about 60 m to the sandy sea floor.		
<b>Foreshore type/environmental value</b>	Rocky cliffs, intertidal platform. Shore segments have “contact value” and “cultural value”.	
<b>Map sheets</b>	<b>NZ Topo 50</b> BD38 Maketu	<b>Chart Number</b> NZ541; NZ5413
<b>Segments</b>	<b>No segments assigned</b>	
<b>At Risk Resources</b>		
<ul style="list-style-type: none"> <li>• Of cultural importance as a fishing area</li> <li>• Of cultural importance as a historic navigational marker and of cultural significance to Motiti Island Iwi</li> <li>• Numerous fur seals – haul out and feeding area.</li> </ul>		
<b>Notes</b>		
<b>Actions</b>		
<ul style="list-style-type: none"> <li>• Natural cleaning may be most likely option due to nature of the shoreline</li> <li>• Notify wildlife of potential oiling for their independent planning for wildlife assessments</li> </ul>
