SITE 11 Maheka Point Oil Spill Management Plan

SITE 12 Matakana South Oil Spill Management Plan

SITE 13 Aongatete Oil Spill Management Plan

SITE 14 Wainui Oil Spill Management Plan

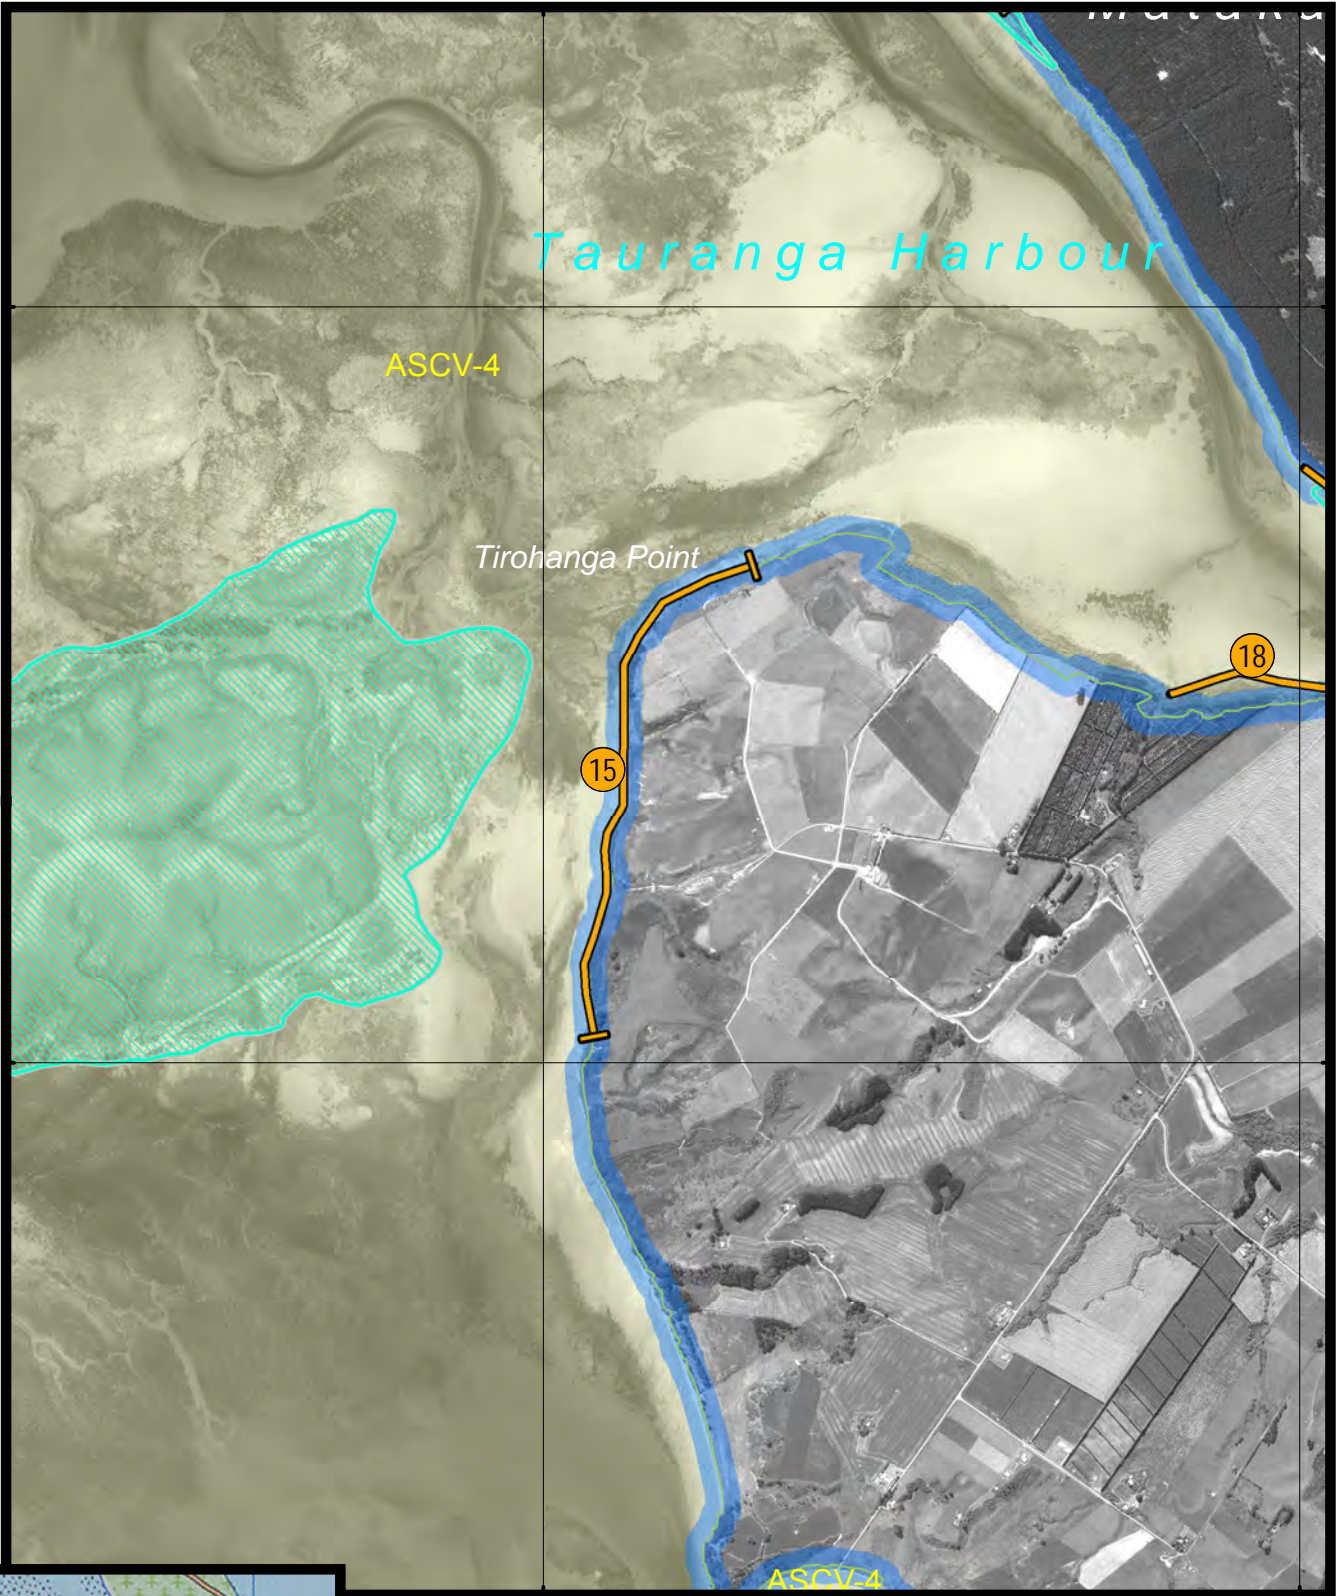
SITE 15 Central Mangroves

Site 15	Central Mangroves	Risk ranking: 3
<p>DESCRIPTION</p> <p>Largest area of mangroves in harbour, with some manuka shrub lands in centre. Situated in central middle of harbour on western side of Matakana Island.</p> <p>Moderate energy tidal flow.</p>		
<p>Foreshore type/environmental value</p>	<p>Sandy/muddy shores, riparian vegetation, transitional ecosystem (island in the making).</p> <p>All shore segments have "habitat value".</p> <p>All intertidal areas are identified in the Regional Coastal Plan as areas of significant conservation/ cultural value.</p>	
<p>Map sheets</p>	<p>TOPO 50</p> <p>BD36 Lower Kaimai</p>	<p>Chart Number</p> <p>NZ541</p>
<p>Segments</p>	<p>TAU-00830</p>	
<p>At Risk Resources</p> <ul style="list-style-type: none"> • Fernbird (kataitai), Banded Rail (kataitai) • Heron and shags • Canada goose and black swan nesting area • High value transitional ecosystem with fish spawning and invertebrate values • Cultural values: Mahinga kai
