Site 48	Pikowai Stream	Risk ranking: 3
<b>DESCRIPTION</b>		
This site comprises a small fresh water stream that is tidal to where it is crossed by SH 2. A 500 m long lagoon sits behind the dune system. Stream may not be connected in normal flow conditions to the sea.		
<b>Foreshore type/environmental value</b>	Sand, lagoon. All shore segments have "habitat value".	
<b>Map sheets</b>	<b>NZTopo50</b> BD38 Maketu	<b>Chart Number</b> NZ542
<b>Segments</b>	<b>BOP-00308</b>	
<b>At Risk Resources</b>		
<ul style="list-style-type: none"> <li>• New Zealand dotterel (tuturiwhatu) nesting – two pairs</li> <li>• Whitebait (inanga)</li> <li>• Sand spit</li> <li>• Locally important recreational fisheries</li> <li>• Moderate public use by fishermen and white baiters. Pikowai Campground beside</li> </ul>		
<b>Notes</b>		
Oil that enters this system will be able to be cleaned up as there is no natural vegetation in the riparian areas.

## SITE 48 Pikowai Stream Oil Spill Management Plan

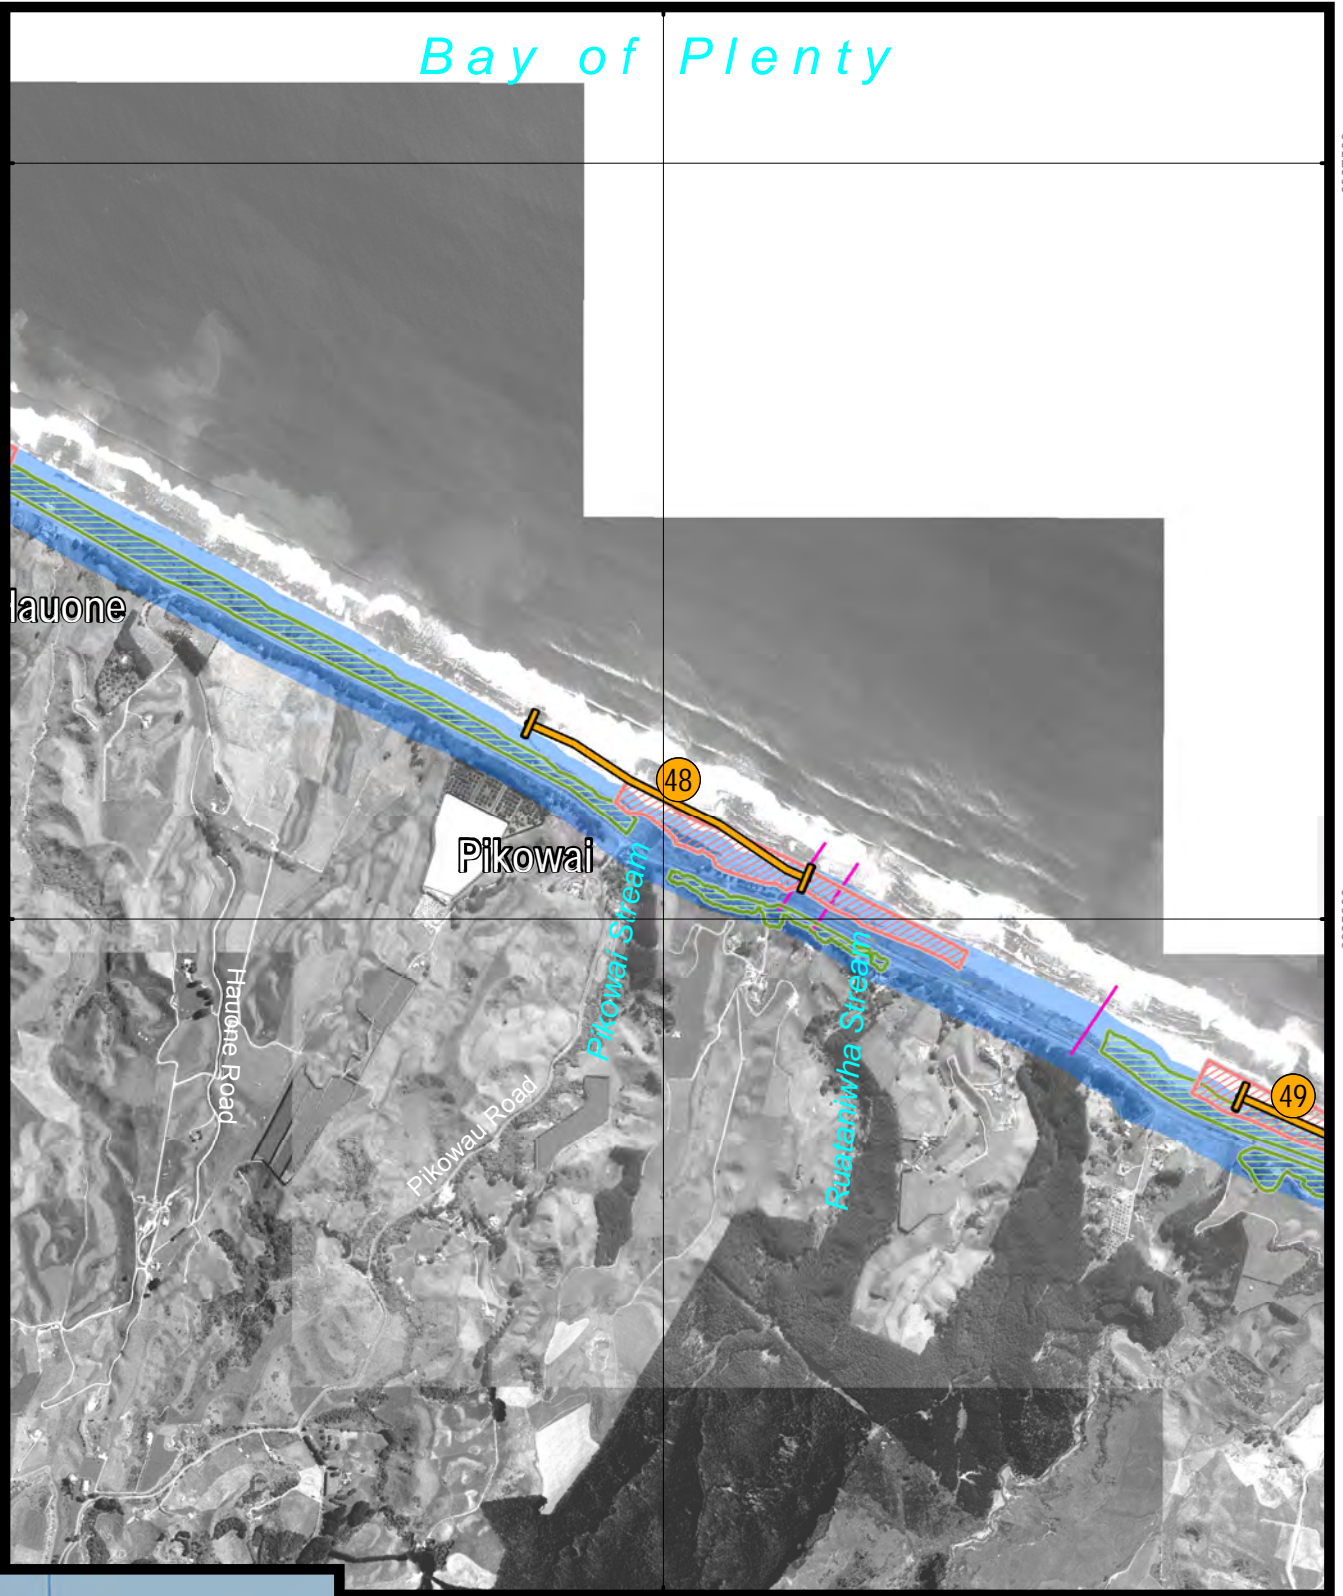
<b>Actions</b>		
<ul style="list-style-type: none"> <li>• Limit the amount of oil entering and moving through the estuary by placing a barrier across the entrance as oil approaches and monitor</li> <li>• Release built-up stream water from sand barrier during low tides as required, but close before high tide returns</li> <li>• Sand may form an effective barrier, but <b>only</b> after local cultural liaison and/or supervision</li> <li>• Shoreline clean-up – remove cleaned material from beaches daily (do not allow to remain over any high tidal period) and place at staging location to be agreed</li> <li>• Notify wildlife team of potential for oiling</li> <li>• Discuss pre-clean-up of intertidal debris - tidal range specific – with wildlife team</li> <li>• Consider pre capture New Zealand dotterels from the western spit</li> <li>• Consider pre-emptive capture of wildlife generally</li> <li>• Activation of oiled wildlife response collection teams if required</li> </ul>

Note that access is across a train line. Develop safety plan for safe access to this site in conjunction with KiwiRail.

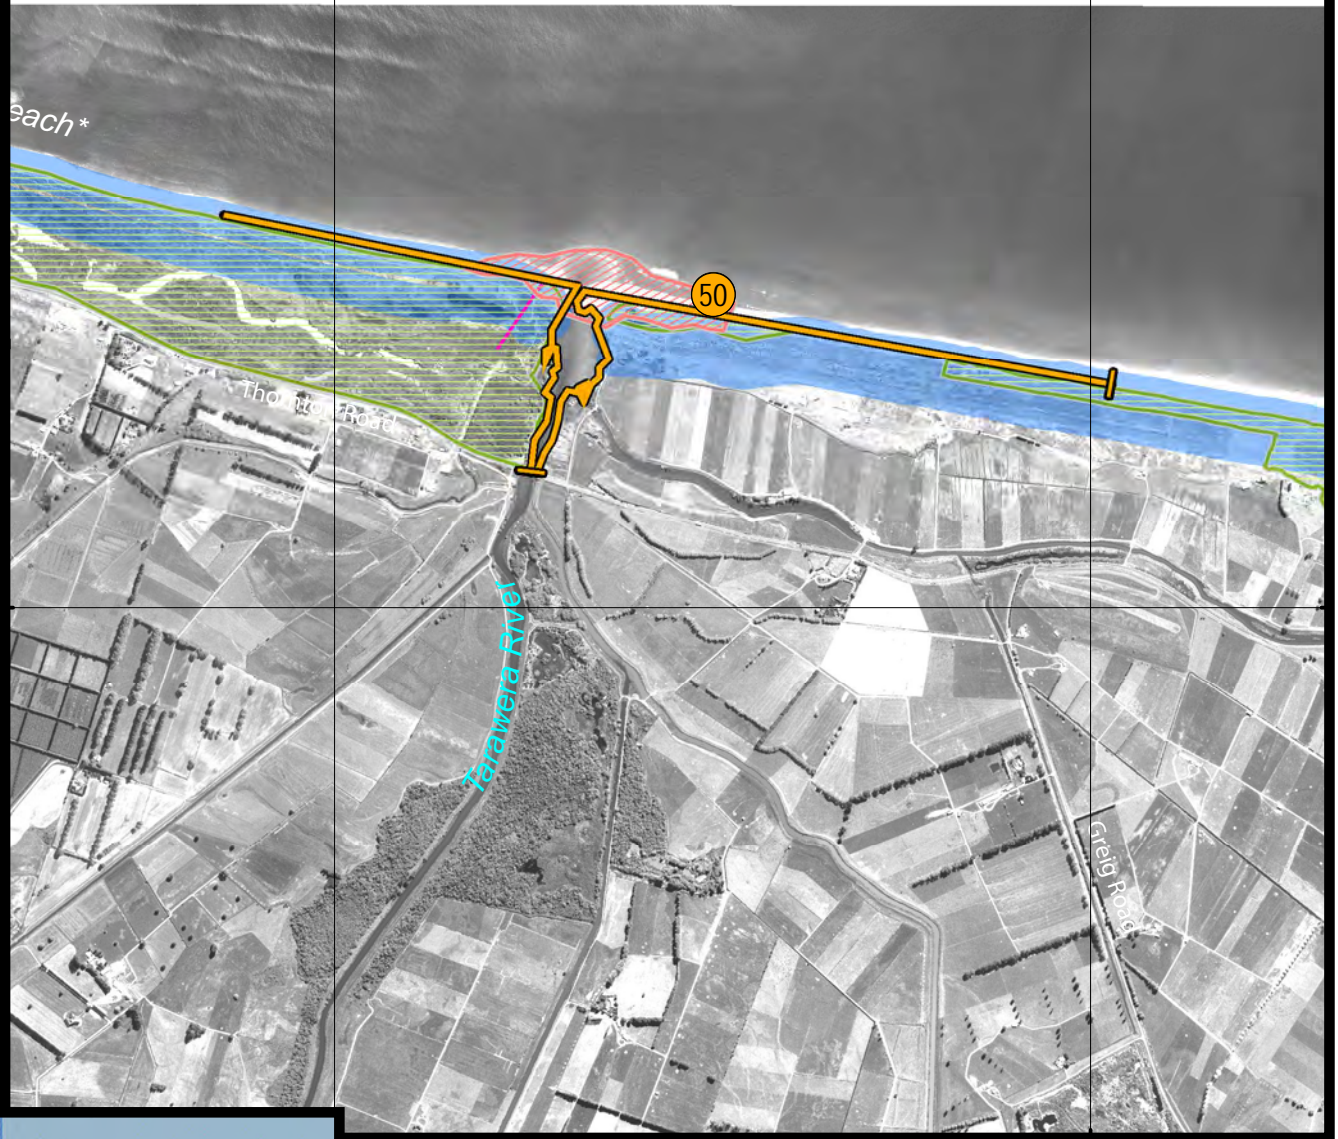
# SITE 50 Matata Lagoon

Site 50	Matata Lagoon	Risk ranking: 1
<p><b>DESCRIPTION</b></p> <p>This site comprises of the Matata River with associated wetland and stream confluence. A western fresh water side lagoon/wetland is connected only at high spring tides; the eastern side stream is connected through a flood gate.</p>		
<p><b>Foreshore type/environmental value</b></p>	<p>High dune protected from coastline, Mud substrate, lagoon/wetland, saltmarsh. Riparian vegetation. All shore segments have "habitat value".</p>	
<p><b>Map sheets</b></p>	<p><b>NZ Topo 50</b> BE 39 Edgecumbe</p>	<p><b>Chart Number</b> NZ 542</p>
<p><b>Segments</b></p>	<p><b>BOP-00490, BOP-00650, BOP- 00660, BOP- 00500</b></p>	
<p><b>At Risk Resources</b></p> <ul style="list-style-type: none"> <li>• Fresh water wetland lagoon, control by weir and one way flap gate. Raupo predominant</li> <li>• Recovering ecosystem</li> <li>• Channels and islands within the lagoon, although this is not directly connected to the sea</li> <li>• Numerous bird species including at risk and threatened bird species, e.g.: banded rail (kataitai), fern bird (kareni), bittern (matuku hūrepo), spotless crane (pūweto), white heron (kōtuku), New Zealand dotterel (tuturiwhatu)</li> <li>• Whitebait (inanga)</li> <li>• Very high cultural values</li> <li>• Motor camp beside, high amenity use</li> </ul>

<p><b>Notes</b></p> <p>Oil that enters the low energy systems of this estuary will remain for some time. Oil will harm intertidal and sand flats habitat.</p> <p><b>Actions</b></p> <ul style="list-style-type: none"> <li>• Prevent/minimise oil ingress into this system</li> <li>• Establish collection and recovery on sandy areas on eastern side of estuary mouth</li> <li>• Lagoon will only receive water from the river estuary on an extreme spring tide through overtopping of the one way weir. Weir just serviced, if threat please call Peter Cavaner (harbour superintendent) 027 5708283 and will arrange a watch. Very minimal risk of oil reaching the lagoon</li> <li>• Notify wildlife team of potential for oiling</li> <li>• Discuss pre-clean-up of intertidal debris - tidal range specific – with wildlife team</li> <li>• Consider pre-emptive capture of New Zealand dotterels if present</li> <li>• Consider pre-emptive capture of wildlife generally</li> <li>• Activation of oiled wildlife response collection teams if required</li> </ul>

**Access**  
 Via SH 2, Matata.  
 Access track to eastern side arm.  
 Locked gate access to western wetland weir (BOPRC have key).

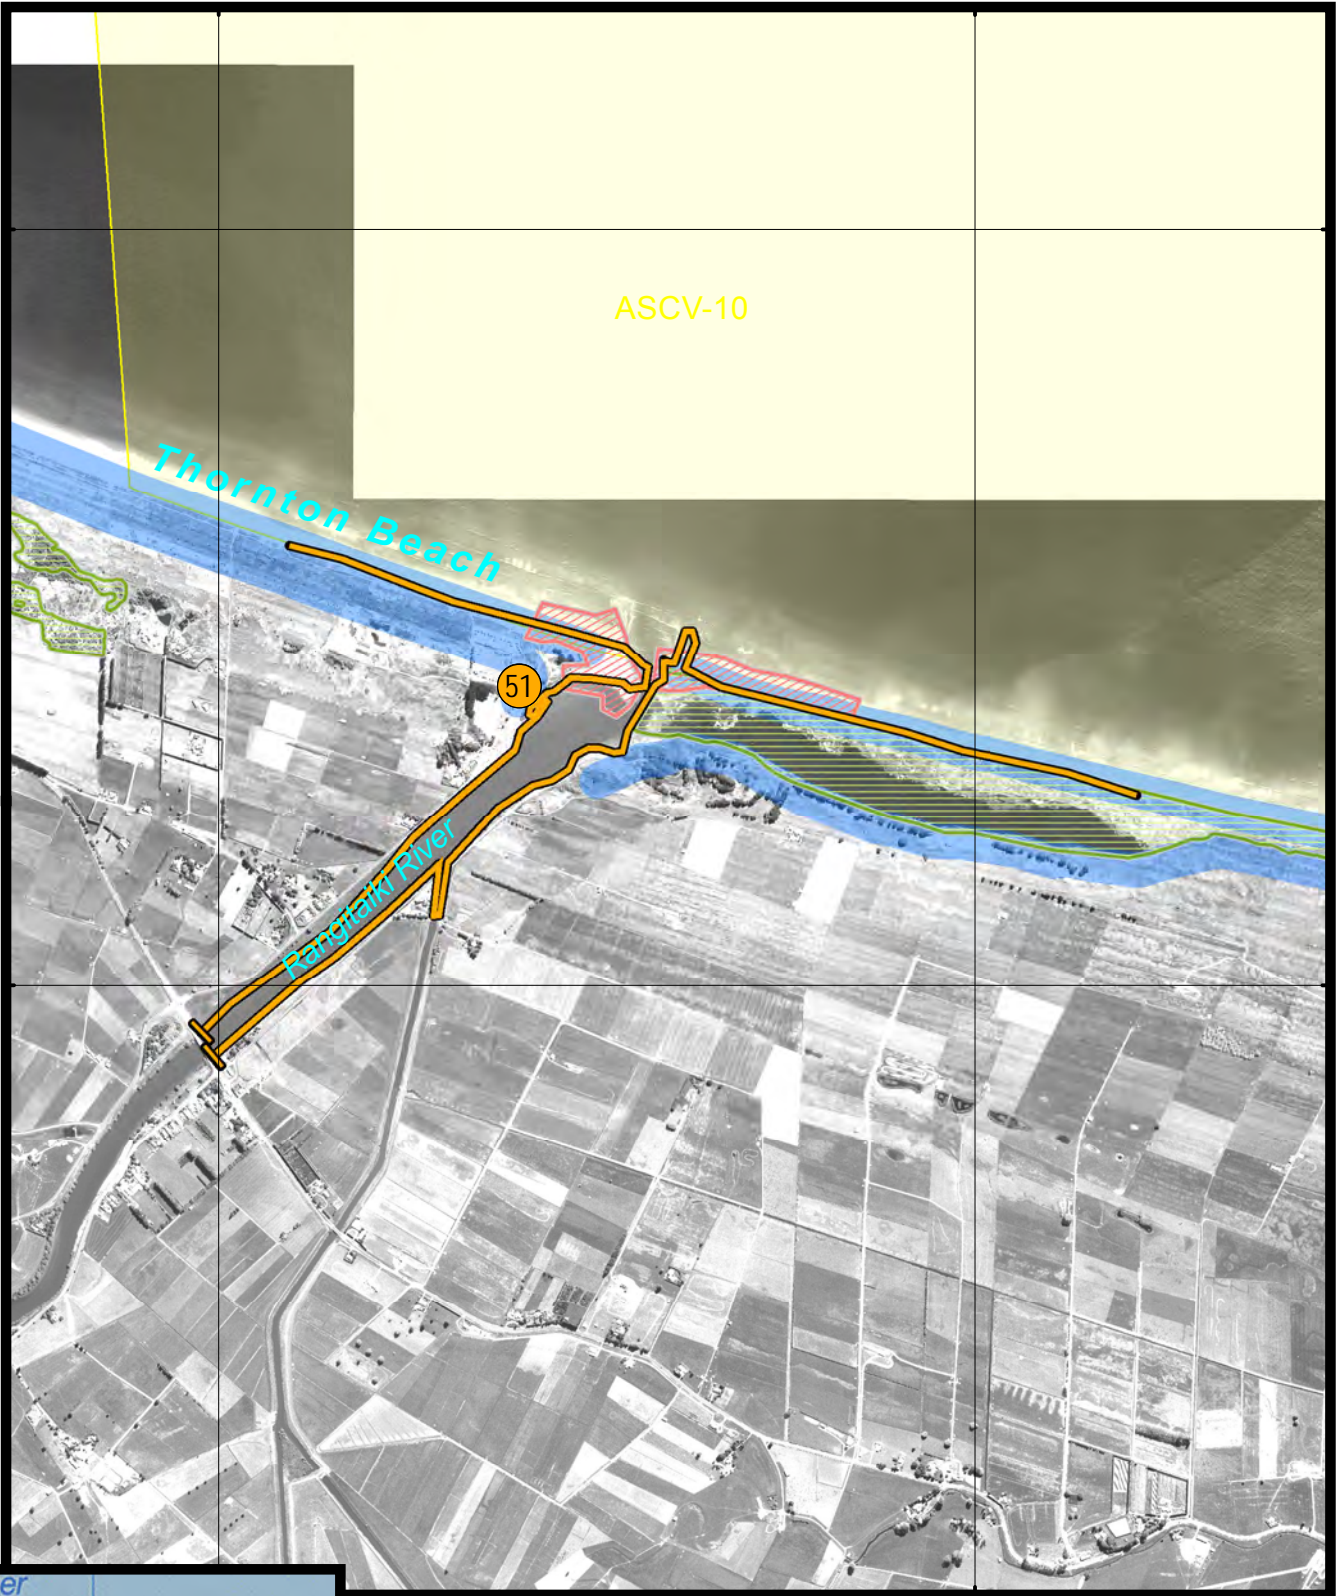
## SITE 51 Rangitaiki River East Oil Spill Management Plan

Site 51	Rangitaiki River East	Risk ranking: 1
<p><b>DESCRIPTION</b></p> <p>This site comprises the Rangitaiki river with a lagoon branching off to the east behind the dunes. This lagoon is connected to the river by a collapsed culvert with no flood gate protection, and is known as Thornton Wildlife Management Reserve.</p> <p>Within the gazetted rohe moana (area) of Ngāti Awa.</p>		
<p><b>Foreshore type/environmental value</b></p>	<p>Sand, riparian vegetation, saltmarsh, Lagoon</p> <p>All shore segments have "habitat value"</p>	
<p><b>Map sheets</b></p>	<p><b>NZ Topo 50</b></p> <p>BE 39 Edgecumbe</p>	<p><b>Chart Number</b></p> <p>NZ 542</p>
<p><b>Segments</b></p>	<p><b>BOP – 00550, 01480, 01490, 00580</b></p>	
<p><b>At Risk Resources</b></p> <ul style="list-style-type: none"> <li>• Numerous at risk bird species including: banded rail (kataitai), spotless crane (pūweto), bittern (matuku hūrepo), and fern bird (kareni). Also New Zealand dotterel (tuturiwhatu)</li> <li>• Freshwater fish - White bait (inunga)</li> <li>• Lagoon - Raupo dominant, predominantly fresh water wetland</li> <li>• Cultural sites: Nohonga (settlement) beside reserve</li> <li>• There are two archaeological sites in proximity to the river banks, W15/356 (Midden - lens of crushed tuatua) and W15/335 (no information). These should be noted when considering response options and avoided if possible or discussed with Iwi</li> <li>• Moderate public use including fishermen and White Baiters</li> </ul>

<p><b>Notes</b></p> <p>Oil that enters the low energy systems of this estuary will remain for some time. Oil will harm intertidal and sand flats habitat</p>		
<p><b>Actions</b></p> <ul style="list-style-type: none"> <li>• Limit the amount of oil entering and moving through the estuary by placing protection across the entrance culvert. Repair or fill collapsed culvert to prevent oil entering lagoon/ wetland – reopen when possible</li> <li>• Establish and maintain protective oil deflection at estuary entrance. Booming may be of assistance with oil directed to the SANDY western side for collection or snares may be sufficient. Note that current velocities on incoming tide may be over 2 kts</li> <li>• Notify wildlife team of potential for oiling</li> <li>• Discuss pre-clean-up of intertidal debris - tidal range specific – with wildlife team</li> <li>• Consider pre-emptive Capture Of New Zealand dotterels</li> <li>• Consider pre-emptive capture of wildlife generally</li> </ul>

<p><b>Access</b></p> <p>Via Thornton Hall Road, accessed from Thornton road on the south-east side of road bridge.</p>
