<b>Site 21</b>	<b>Tahunamanu Spit/Island</b>	<b>Risk ranking: 1</b>
<b>DESCRIPTION</b>		
Sand spit and sand island 1 km long, extensive tidal areas around island, tidal flows, low energy areas, wind predominantly westerly. Pampass and some other vegetation on island.		
<b>Foreshore type/environmental value</b>	Intertidal sand flats running up to sand island exposed at high tide. All shore segments have "habitat value". All intertidal areas are identified in the Regional Coastal Plan as areas of significant conservation/ cultural value.	
<b>Map sheets</b>	<b>NZ Topo 50</b> BD36 Lower Kaimai	<b>Chart Number</b> NZ 541
<b>Segments</b>	<b>TAU – 00880 to TAU – 00900</b>	
<b>At Risk resources</b>		
<ul style="list-style-type: none"> <li>• Extensive shellfish beds, surrounding sand flats support a wide range of wading birds (e.g. knots and godwits (kuaka))</li> <li>• Nesting New Zealand dotterel (tuturiwhatu) and caspian tern (taranui) on island and spit</li> <li>• Cultural resources: Mahinga kai</li> </ul>

## SITE 21 Tahunamanu Spit/Island

### Oil Spill Management Plan

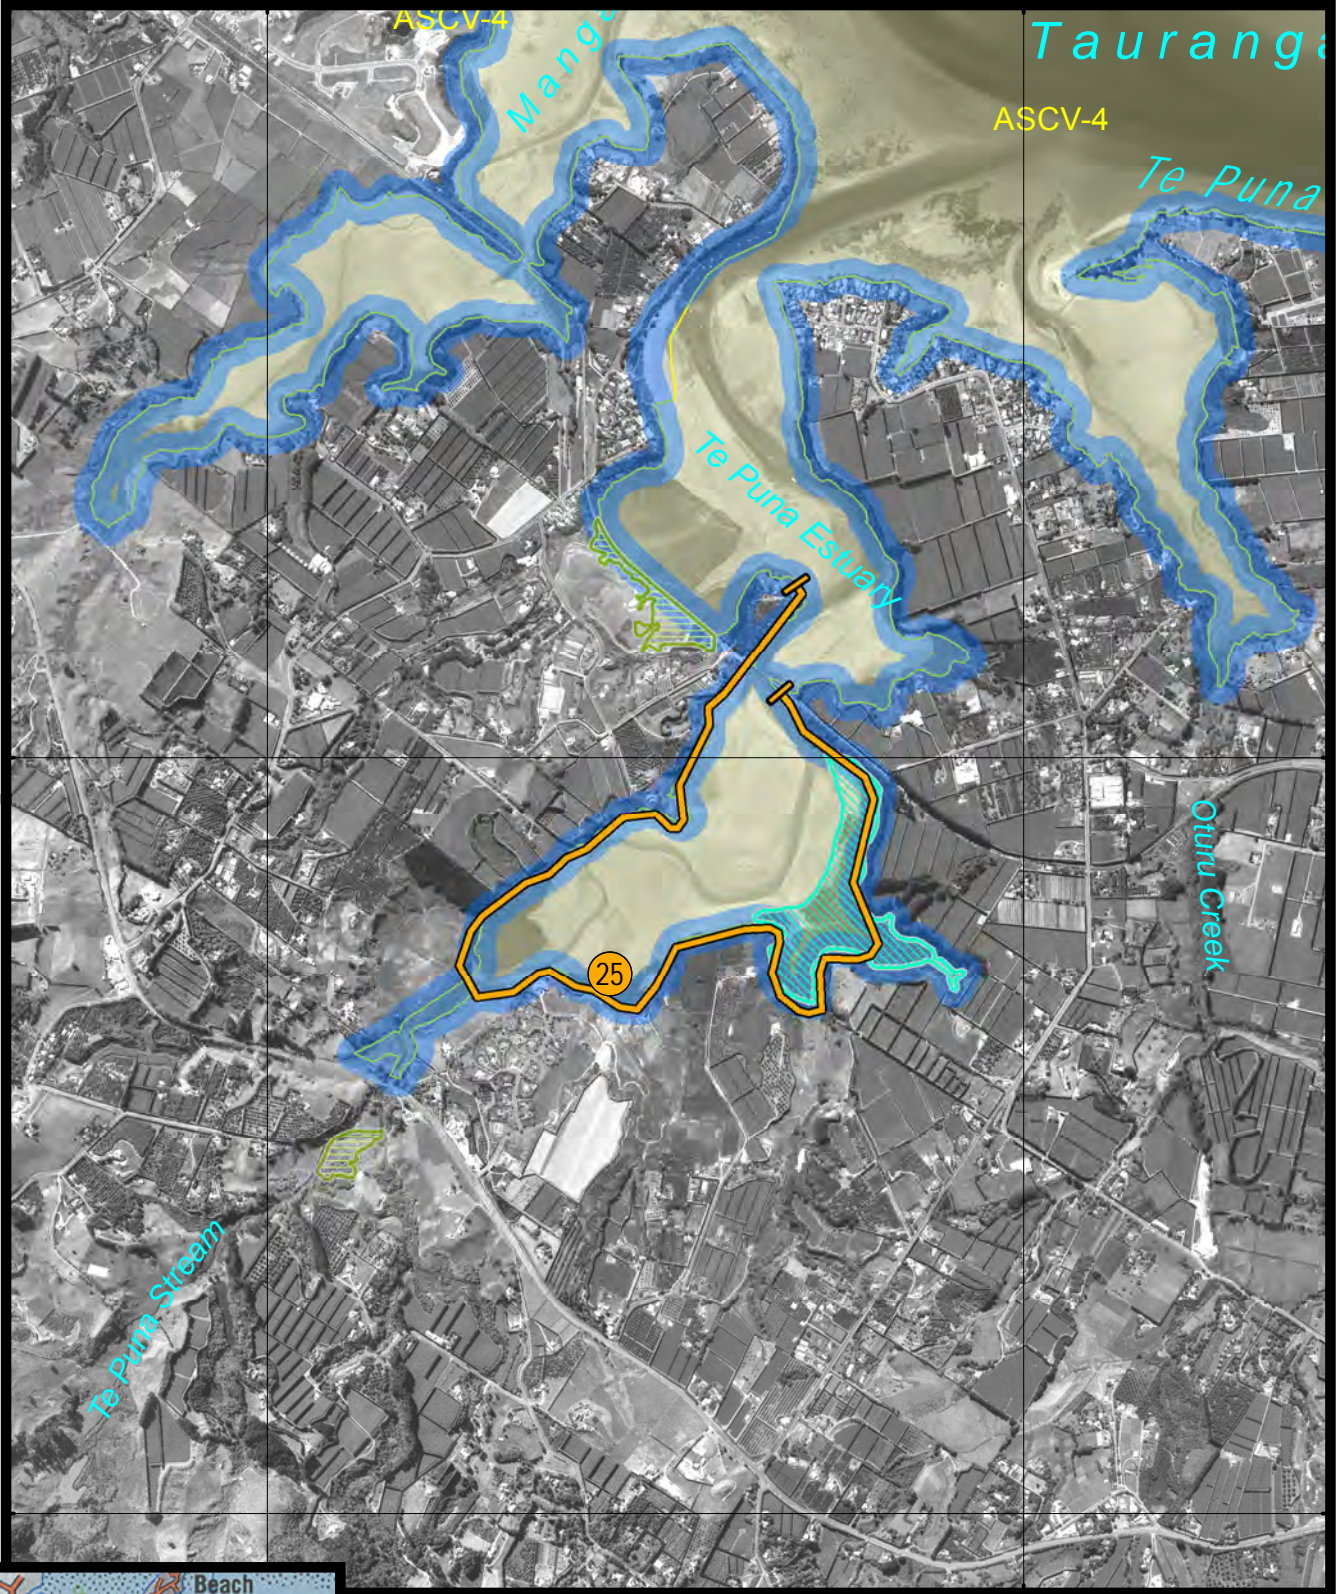
## SITE 25 Te Puna Oil Spill Management Plan

Site 25	Te Puna	Risk ranking: 3
<b>DESCRIPTION</b>		
Saltmarsh with strip of mangrove on harbour side, the manuka forest on the landward site is a good quality example of manuka forest. The intertidal shoreline is exposed from mid-tide.		
<b>Foreshore type/environmental value</b>	Sandy/muddy shores, mangroves, intertidal habitat. Habitat (intertidal), contact. All shore segments have "habitat value".	
<b>Map sheets</b>	<b>NZ Topo 50</b> BD36 Lower Kaimai	<b>Chart Number</b> NZ 541
<b>Segments</b>	<b>TAU-00390</b>	
<b>At Risk Resources</b>		
<ul style="list-style-type: none"> <li>• Bird species present include: banded rail (kataitai), fern bird (mātātā), NZ Dotterel</li> <li>• Jess Road wildlife management reserve, saltmarsh</li> <li>• Cultural resources: Pa sites</li> </ul>

<b>Notes</b>		
Where possible, oil should be prevented from entering the Tauranga Harbour.		
<b>Actions</b>		
<ul style="list-style-type: none"> <li>• Prevent/minimise oil ingress into this system</li> <li>• Notify wildlife team of potential for oiling</li> <li>• Consider pre-emptive capture of wildlife generally</li> </ul>		
<b>Access</b>		
Vehicle/foot access via Snodgrass Road or Jess Road

<b>Most preferred</b>	<b>Least preferred</b>	<b>Feasibility</b>
Containment and Recovery	High		Booming at railway bridge possible
On water Recovery	Medium		Only possible at railway bridge if booming successful
Dispersant Application	Low	Requires escalation to Tier 3 and MNZ approval	Water depth won't allow
Shoreline Clean-up	Low		Refer NEBA
Natural Recovery	Low		Cultural significance
