## SITE 16 Te Hopai Island

### Oil Spill Management Plan

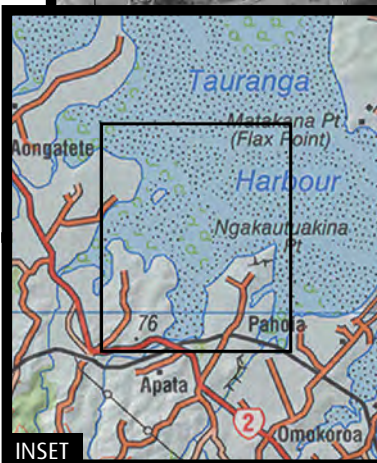
<b>Site 16</b>	<b>Te Hopai Island</b>	<b>Risk ranking: 3</b>
<b>DESCRIPTION</b>		
Large area of salt marsh and ribbon wood located approximately 1 km southeast of Te Hopai Island within the Tauranga Harbour.		
<b>Foreshore type/environmental value</b>	Sandy, muddy shores, riparian vegetation. Habitat, shoreline, contact.	
<b>Map sheets</b>	<b>TOPO 50</b> BD 36	<b>Chart Number</b> NZ 541
<b>Segments</b>	<b>TAU-00461</b>	
<b>At Risk Resources</b>		
<ul style="list-style-type: none"> <li>Banded rail (katakaitai), North Island fern bird (mātātā), variable oystercatcher (tōrea pango), white-faced heron (matuku-moana); southern black back gull nesting colony – low priority</li> <li>All intertidal areas are identified in the Regional Coastal Plan as areas of significant conservation/ cultural value.</li> <li>Cultural Values: Site of Significance</li> </ul>		
<b>Notes</b>		
Where possible, oil should be prevented from entering the Tauranga Harbour.

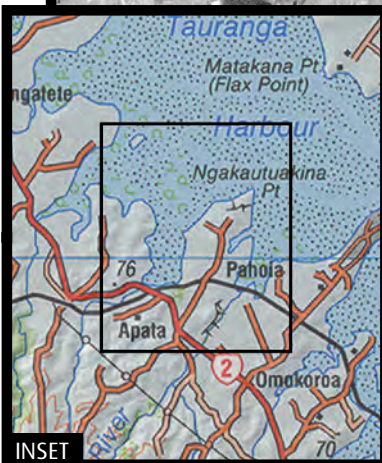
## SITE 17 Apata Estuary Oil Spill Management Plan

<b>Site 17</b>	<b>Apata Estuary</b>	<b>Risk ranking: 2</b>
<b>DESCRIPTION</b>		
Contains a large, good quality stand of mangroves, with relatively narrow strips of saltmarsh along the margins.		
<b>Foreshore type/environmental value</b>	Sandy/muddy shores. Habitat (intertidal), contact.	
<b>Map sheets</b>	<b>NZ Topo 50</b> BD36 Lower Kaimai	<b>Chart Number</b> NZ541; NZ5411
<b>Segments</b>	<b>TAU-00450, TAU-00460</b>	
<b>At Risk Resources</b>		
<ul style="list-style-type: none"> <li>Local birds include: Australasian bittern (matuku hūrepo), banded rail (kataitai), North Island fernbird (mātātā)</li> <li>Whitebait (inanga)</li> </ul>		
<b>Notes</b>		
Where possible, oil should be prevented from entering the Tauranga Harbour.		
<b>Actions</b>		
<ul style="list-style-type: none"> <li>Notify wildlife team of potential for oiling</li> <li>Consider pre-emptive capture of wildlife generally</li> <li>Activation of oiled wildlife response collection teams if required</li> </ul>

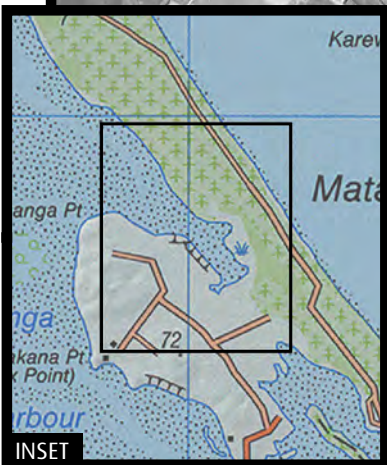
## SITE 18 Blue Gum Bay Oil Spill Management Plan

Site 18	Blue Gum Bay		Risk ranking: 1
<b>DESCRIPTION</b>			
Blue Gum Bay is an extensive wetland, much of which is a relatively unmodified, representative example of the estuarine and freshwater vegetation of Tauranga Harbour.			
Saltmarsh with mangrove edge, important feeding area for wide range of bird species.			
<b>Foreshore type/environmental value</b>	Saltmarsh with mangrove edge. All shore segments have "habitat value".		
<b>Map sheets</b>	<b>TOPO 50</b> BC36 Katikati BD36 Lower Kaimai	<b>Chart Number</b> NZ 541	
<b>Segments</b>	<b>TAU-00790, TAU-00810</b>		
<b>At Risk Resources</b>			
<ul style="list-style-type: none"> <li>• Banded rail (kataitai), bittern (matuku hūrepo), spotless crake (pūweto), marsh crake (koitareke) and North Island fernbird (matata)</li> <li>• Range of duck species</li> <li>• Wetland margin, intertidal habitats, mudflats, saltmarsh</li> <li>• Flounder (Patiki) breeding</li> <li>• Mud snail (Titiko)</li> <li>• Cultural values: Mahinga Kai</li> </ul>

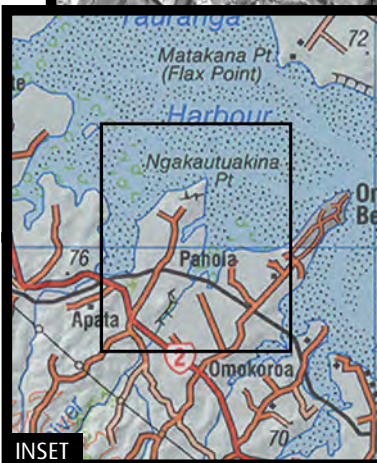
## SITE 19 Pahoa North Oil Spill Management Plan

<b>Site 19</b>	<b>Pahoia North</b>	<b>Risk ranking: 2</b>
<b>DESCRIPTION</b> Low energy estuary tidal lower reaches, small area of salt marsh with manuka in behind		
<b>Foreshore type/environmental value</b>	Sand, Mud flats Habitat (intertidal) All shore segments have "habitat value"	
<b>Map sheets</b>	<b>NZ Topo 50</b> BD36 Lower Kaimai	<b>Chart Number</b> NZ541; NZ5411
<b>Segments</b>	<b>Northern part of TAU- 00440</b>	
<b>At Risk Resources</b>		
<ul style="list-style-type: none"> <li>Local birds include: Australasian bittern (matuku hūrepo), banded rail (kataitai), North Island fernbird (mātātā)</li> <li>White bait (inanga)</li> <li>All intertidal areas are identified in the Regional Coastal Plan as areas of significant conservation/ cultural value</li> </ul>		
<b>Cultural Sites/Resources:</b>		
<ul style="list-style-type: none"> <li>U14/1206</li> </ul>		
<b>Notes and Preferred protection and clean-up options</b>

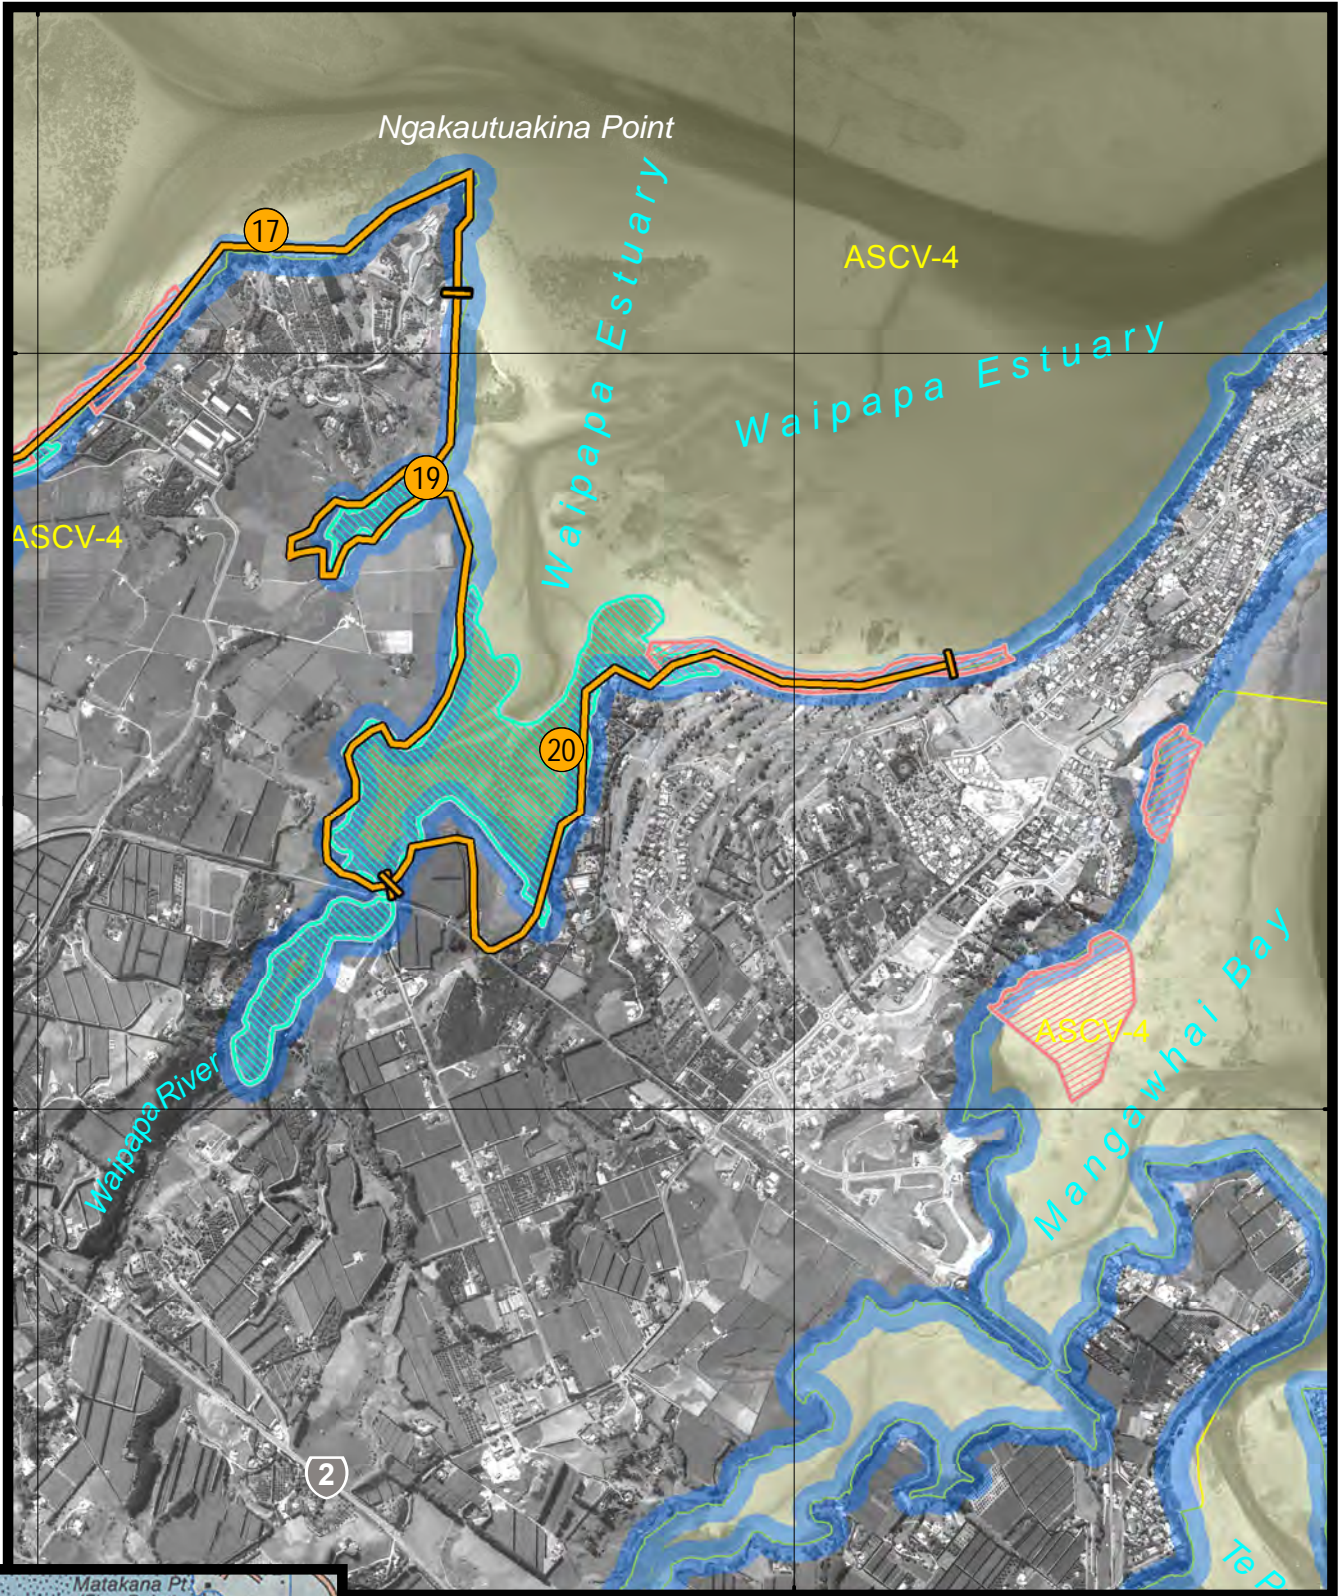
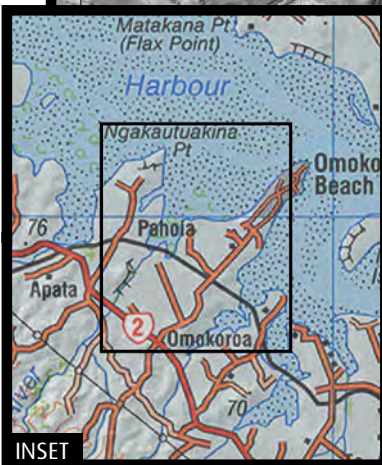
# SITE 20 Pahola South Oil Spill Management Plan

<b>Site 20</b>	<b>Pahoia South</b>	<b>Risk ranking: 2</b>
<b>DESCRIPTION</b>		
This site contains a representative, relatively large area of high quality oioi sedgeland inland from the main harbour adjacent to a tidal stream. Waipapa Estuary is a relatively large, good quality example of mangrove stands and saltmarsh. Mangrove scrub and shrublands form the cover over much of this area.		
<b>Foreshore type/environmental value</b>	Sandy/muddy shores. Habitat (intertidal) contact.	
<b>Map sheets</b>	<b>NZ Topo 50</b> BD36 Lower Kaimai	<b>Chart Number</b> NZ541; NZ5411
<b>Segments</b>	<b>Southern part of TAU-00440</b>	
<b>At Risk Resources</b>		
<ul style="list-style-type: none"> <li>Local birds include: Australasian bittern (matuku hūrepo), banded rail (kataitai), North Island fernbird (mātātā)</li> <li>Whitebait (inanga)</li> </ul>		
<b>Notes</b>		
Where possible, oil should be prevented from entering the Tauranga Harbour.
