<b>Site 01</b>	<b>Waiau/Athenree</b>	<b>Risk ranking: 1</b>
<p><b>DESCRIPTION</b></p> <p>Athenree is a large nationally ranked wetland, much of which is relatively unmodified, comprising a representative example of the estuarine vegetation of Tauranga Harbour. Much of this site is in the Athenree Wildlife Management Reserve.</p> <p><b>This site has the highest ecological values of whole harbour and wildlife refuge.</b></p>		
<b>Foreshore type/environmental value</b>	<p>Sand and mudflat Mangroves All intertidal areas are identified in the Regional Coastal Plan as areas of significant conservation/cultural value.</p>	
<b>Map sheets</b>	<b>NZ Topo 50</b> BC36 Katikati	<b>Chart number</b> NZ541
<b>Segments</b>	<b>TAU-00710 to TAU-00720</b>	
<p><b>At Risk resources</b></p> <ul style="list-style-type: none"> <li>• Wetland and intertidal habitat</li> <li>• Shellfish gathering site</li> <li>• Birds at risk include: Banded rail (kataitai), bittern (kataitai), spotless crake (pūweto), marsh crake (koitareke) and North Island fernbird (matata)</li> <li>• Cultural sites: U13/915 (Midden)</li> </ul>

## SITE 1 Waiau/Athenree Oil Spill Management Plan

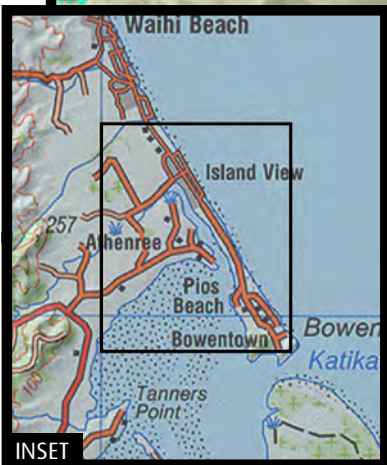
<p><b>Notes</b></p> <ul style="list-style-type: none"> <li>• Operations should consider booming the mouth of this site as it is approximately 100 m wide</li> <li>• Oil that enters the low energy systems of this estuary will remain for some time. Oil will harm intertidal and sand flats habitat</li> <li>• There is a low energy drain through middle of the wetland</li> </ul> <p><b>Actions</b></p> <ul style="list-style-type: none"> <li>• Prevent/minimise oil ingress into this system</li> <li>• Clean sandy areas according to STM</li> <li>• Discuss pre-clean-up of intertidal debris - tidal range specific</li> <li>• If oil enters low energy, sensitive areas, clean-up to be informed by SCAT/Environment</li> <li>• Notify wildlife team of potential for oiling</li> <li>• Consider pre-emptive capture of wildlife generally</li> <li>• Activation of oiled wildlife response collection teams if required</li> </ul>

<b>Most preferred</b>	<b>Least preferred</b>	<b>Feasibility</b>
Containment and recovery	High		Yes – can be boomed
On water recovery	Medium		Very shallow, dries out
Dispersant application	Low	Requires escalation to Tier 3 and MNZ approval	Water depth won't allow
Shoreline clean-up	High		Good access to shoreline
Natural recovery	Low		High public access

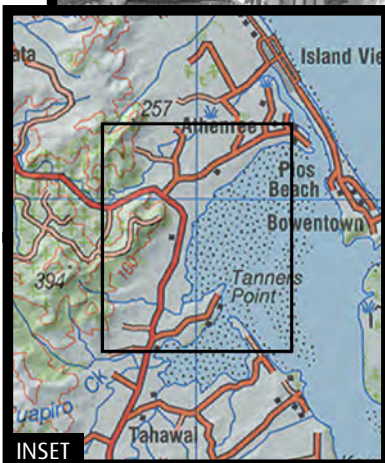
## SITE 2 North Tanners Point Oil Spill Management Plan

<b>Site 02</b>	<b>North Tanners Point</b>	<b>Risk ranking: 3</b>
<b>DESCRIPTION</b>		
Site is 1.5 km Northwest of Tanners Point, narrow salt marsh and mangrove strip. Low energy tidal flow.		
<b>Foreshore type/environmental value</b>	Sandy/muddy shores, riparian vegetation. All shore segments have "habitat value". All intertidal areas are identified in the Regional Coastal Plan as areas of significant conservation/cultural value.	
<b>Map sheets</b>	<b>TOPO 50</b> BC36 Katikati	<b>Chart Number</b> NZ 541
<b>Segments</b>	<b>TAU-00680</b>	
<b>At Risk resources</b>		
<ul style="list-style-type: none"> <li>• Fernbird (kataitai), Banded Rail (kataitai)</li> <li>• Cultural resources: mahinga kai (fishing)</li> </ul>		
<b>Notes</b>		
Where possible, oil should be prevented from entering the harbour		
<b>Actions</b>		
<ul style="list-style-type: none"> <li>• Prevent/minimise oil ingress into this system</li> <li>• If oil enters low energy, sensitive areas, clean-up to be determined in consultation with environmental advisors</li> </ul>

Most preferred	Least preferred	Feasibility
Containment and recovery	Medium		Large area dries at low tide
On water recovery	Medium		Possible but only in channels
Dispersant application	Low	Requires escalation to Tier 3 and MNZ approval	Water depth won't allow
Shoreline clean-up	Medium		NEBA – limited access – tidal/soft
Natural recovery	Medium		Ongoing monitoring

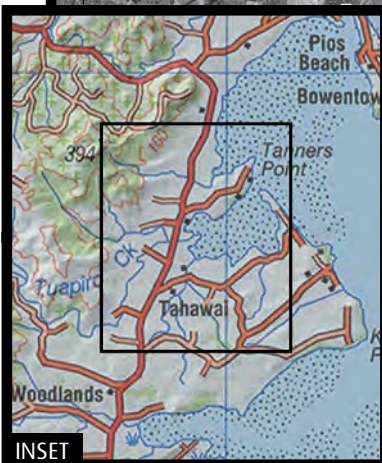
## SITE 3 Upper Tuapiro Estuary Oil Spill Management Plan

<b>Site 03</b>	<b>Upper Tuapiro Estuary</b>	<b>Risk ranking: 2</b>
<b>DESCRIPTION</b>		
This is a large, relatively good quality, diverse example of the estuarine vegetation of Tauranga Harbour. Saltmarsh with mangrove edge, there is a narrow fringe of freshwater wetland vegetation. Tuapiro Stream runs through middle of site. Intertidal shoreline dries below mid-tide.		
<b>Foreshore type/environmental value</b>	Sand, salt marsh, riparian vegetation. All shore segments have "habitat value".	
<b>Map sheets</b>	<b>TOPO 50</b> BC36 Katikati	<b>Chart Number</b> NZ 541
<b>Segments</b>	<b>TAU-00650</b>	
<b>At Risk Resources</b>		
<ul style="list-style-type: none"> <li>Banded rail (kataitai), Marsh crake (koitareke), North Island fernbird (mātātā), wading birds, shags</li> <li>Shellfish gathering</li> <li>Whitebait (inanga) spawning habitat</li> <li>Cultural sites: T13/657 (Midden - 3 x 7 m area of pipi; cockle (tuangi); mudsnail (Titiko); and turret shell)</li> <li>All intertidal areas are identified in the Regional Coastal Plan as areas of significant conservation/ cultural value</li> </ul>

<b>Notes</b>		
Booming may be effective in preventing oil ingress in intertidal area of Tuapiro Stream. Will need to be assessed by ops.		
<b>Actions</b>		
<ul style="list-style-type: none"> <li>Prevent/minimise oil ingress into this system</li> <li>Notify wildlife team of potential for oiling</li> <li>Consider pre-emptive capture of wildlife generally</li> <li>Activation of oiled wildlife response collection teams if required</li> </ul>		
<b>Access</b>		
Vehicle access SH 2 and Tanners Point Road.

<b>Most preferred</b>	<b>Least preferred</b>	<b>Feasibility</b>
Containment and Recovery	High		The stream entrance can be effectively boomed
On water Recovery	Low		Shallow area
Dispersant Application	Low	Requires escalation to Tier 3 and MNZ approval	Water depth won't allow
Shoreline Clean-up	Medium		Access via private property
Natural Recovery	High		Refer NEBA

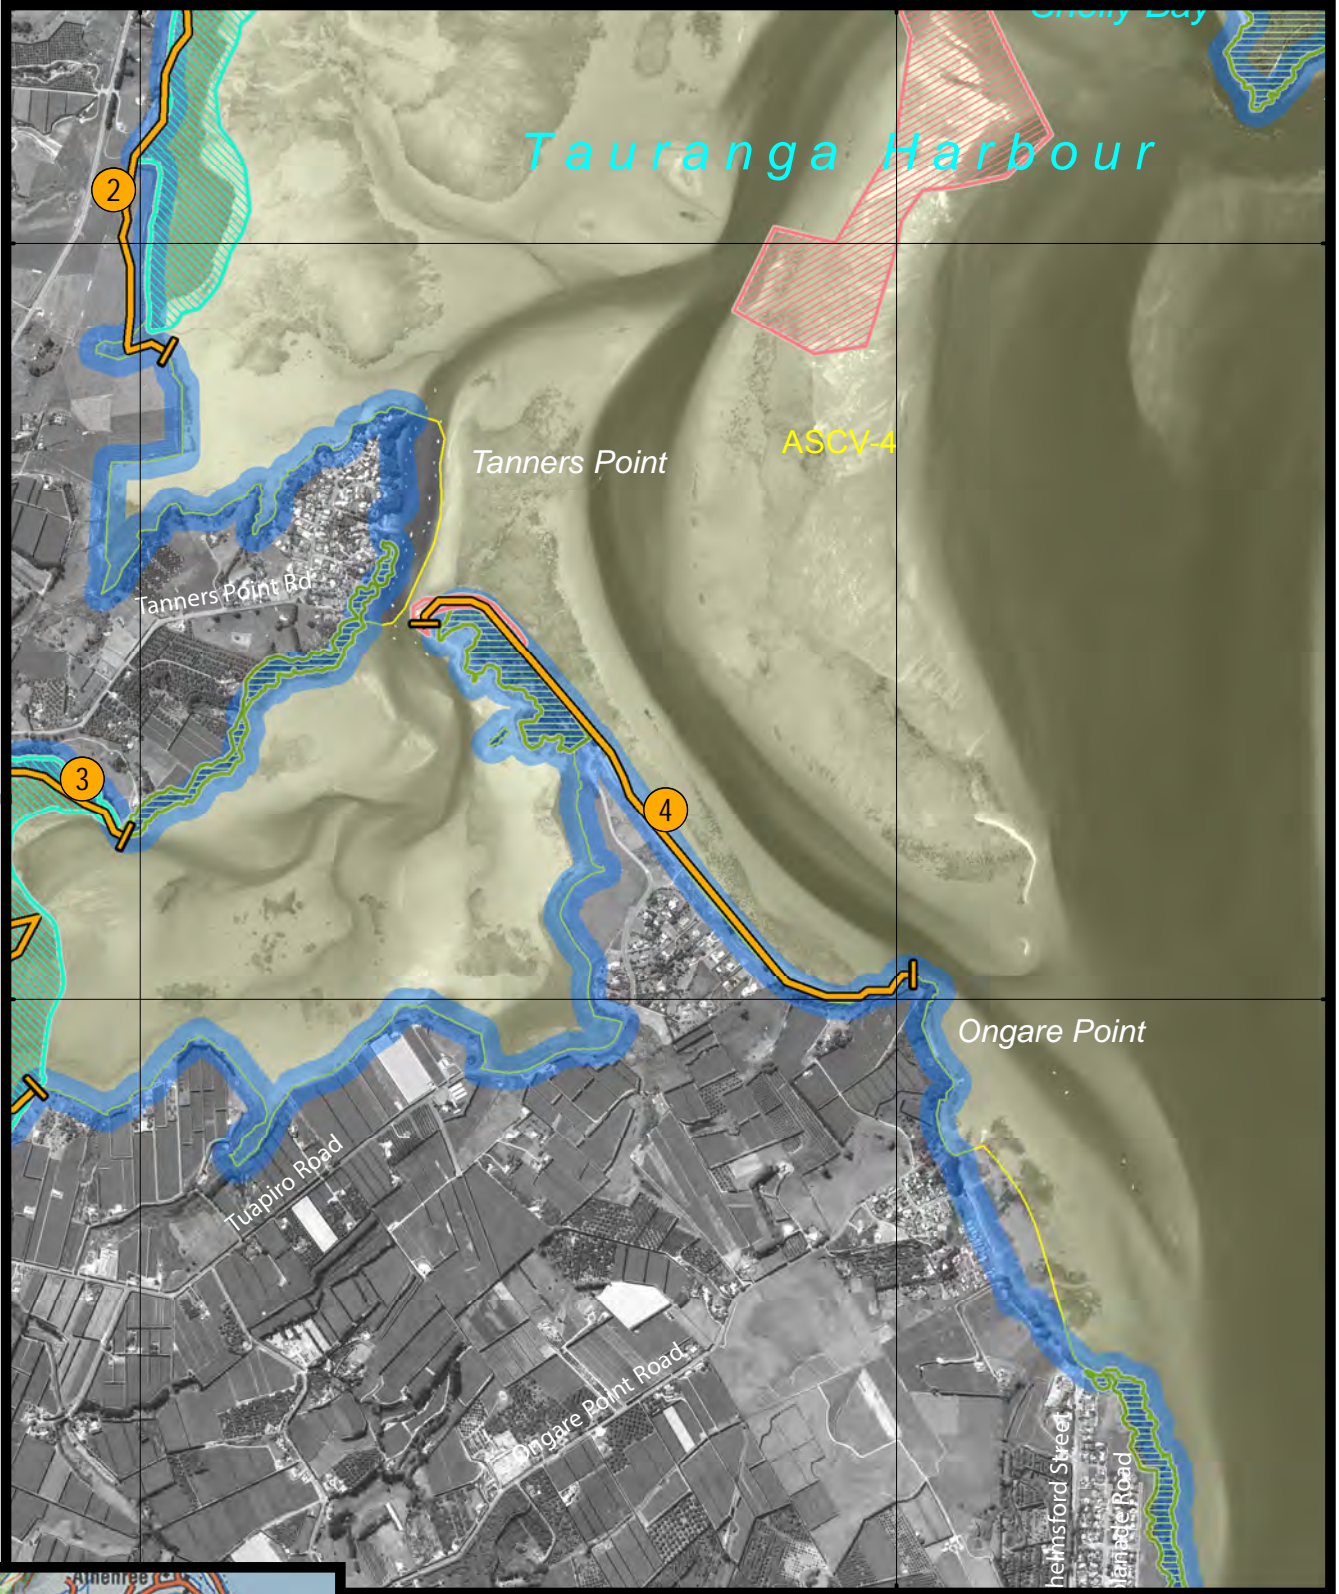
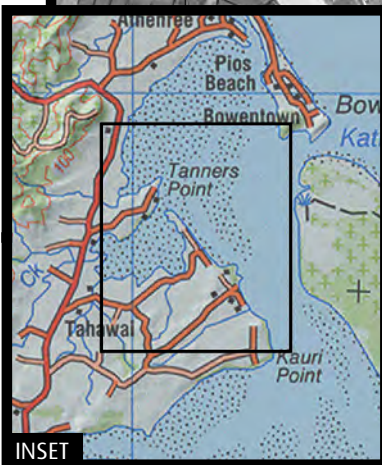
## SITE 4 Tuapiro Estuary Spit Oil Spill Management Plan

<b>Site 04</b>	<b>Tuapiro Estuary Spit</b>	<b>Risk ranking: 2</b>
<b>DESCRIPTION</b>		
Sand spit with pasture/development and scrub /trees at the furthest extent. No wetland areas have been identified.		
<b>Foreshore type/environmental Value</b>	Sand, mud flats, intertidal habitat. All shore segments have "habitat value". All intertidal areas are identified in the Regional Coastal Plan as areas of significant conservation/cultural value.	
<b>Map sheets</b>	<b>NZ Topo 50</b> BC36 Katikati	<b>Chart Number</b> NZ5411
<b>Segments</b>	<b>TAU-00620</b>	
<b>At Risk Resources</b>		
<ul style="list-style-type: none"> <li>Local birds include: godwit (kuaka), tern (taranui), white-faced heron (matuku-moana), oystercatcher (tōrea), shag (kawau), NZ Dotterel.</li> <li>Cultural sites/resources:</li> <li>There are several archeological sites close to shore in this section. The following sites are described as Midden: U13/766, U13/770, U13/716, U13/770, U13/716, U13/691. Site U13/773 is described as "x7 flakes of obsidian found over 50 m of beach".</li> </ul>

<b>Notes</b>		
Where possible, oil should be prevented from entering Tauranga Harbour.		
<b>Actions</b>		
<ul style="list-style-type: none"> <li>Clean-up of sensitive shorelines should be completed in line with the relevant Shoreline Treatment Methodology (See STMs for Sandy, saltmarsh and reeds Clean-up)</li> <li>The requirement for shoreline clean-up in sensitive areas is to be determined in consultation with environmental advisor</li> </ul>		
<b>Access</b>		
4WD Vehicle access via Ongare Point Road, foot access along spit.

Most preferred	Least preferred	Feasibility
Containment and recovery	High		Some deflection and entrance booming possible
On water recovery	High		Possible if ORV or similar available
Dispersant application	Low	Requires escalation to Tier 3 and MNZ approval	Water depth won't allow
Shoreline clean-up	Medium		Limited access, large mangrove area
Natural recovery	Medium		Limited access

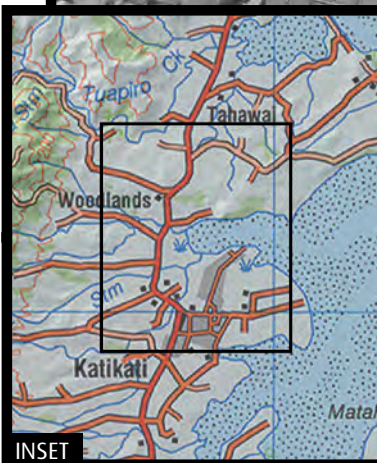
# SITE 5 Uretara Upper Oil Spill Management Plan

<b>Site 05</b>	<b>Uretara Upper</b>	<b>Risk ranking: 1</b>
<b>DESCRIPTION</b> Saltmarsh with mangrove edge, low energy, tidal up to Katikati.		
<b>Foreshore type/environmental value</b>	Sand and mudflat. Habitat (intertidal). All intertidal areas are identified in the Regional Coastal Plan as areas of significant conservation/ cultural value.	
<b>Map sheets</b>	<b>NZMS 260 Series</b> BC36 Katikati	<b>Chart Number</b> NZ 541
<b>Segments</b>	<b>TAU-000570, part TAU-00560</b>	
<b>At Risk Resources</b>		
<ul style="list-style-type: none"> <li>Banded rail (kataitai), bittern (matuku hūrepo), spotless crane (pūweto), marsh crane (koitareke) and North Island fernbird (matata). Pateke (brown teal) and scaup (pāpango)</li> <li>Whitebait (inanga) spawning areas</li> <li>Cultural sites: T13/528 (Midden - cockle and mudsnail (crushed and whole; sparse concentration))</li> </ul>		
<b>Notes</b>		
<ul style="list-style-type: none"> <li>Limited opportunity to protect the locality if oil threatens</li> <li>Notify wildlife team of potential for oiling</li> <li>Consider pre-emptive capture of wildlife generally</li> <li>Activation of oiled wildlife response collection teams if required</li> <li>Oil that enters the low energy systems of this estuary will remain for some time. Oil will harm intertidal and sand flats habitat</li> </ul>

<b>Most preferred</b>	<b>Least preferred</b>	<b>Feasibility</b>
Containment and Recovery	Medium		Unlikely
On water Recovery	Low		Unlikely, too shallow
Dispersant Application	Low	Requires escalation to Tier 3 and MNZ approval	Water depth won't allow
Shoreline Clean-up	Medium		Best access via private property
Natural Recovery	High		See NEBA
