Site 36	Waimapu –Windermere	Risk ranking: 3
DESCRIPTION Saltmarsh with mangrove edge. Low energy intertidal mudflat.		
Foreshore type/environmental value	Sandy, muddy shores, riparian vegetation. Habitat (shoreline), contact.	
Map sheets	NZMS 260 Series BD 37 Tauranga	Chart Number NZ 541
Segments	TAU-00180	
At Risk Resources		
<ul style="list-style-type: none"> • Banded rail (katakaitai), North Island fern bird (mātātā), pukeko Oi Oi – Jointed Sagebrush (Apodasmia similis) • Rimurehia/Zostera Species • Flounder (pātiki) • Cultural resources: mahinga kai 		
Notes Where possible, oil should be prevented from entering the Tauranga Harbour.		
Actions		
<ul style="list-style-type: none"> • Prevent/minimise oil ingress into this system • Booming may be an effective option across the mouth of Waiorohi Stream • Notify wildlife team of potential for oiling • Consider pre-emptive capture of wildlife generally • Activation of oiled wildlife response collection teams if required

Oil Spill Management Plan

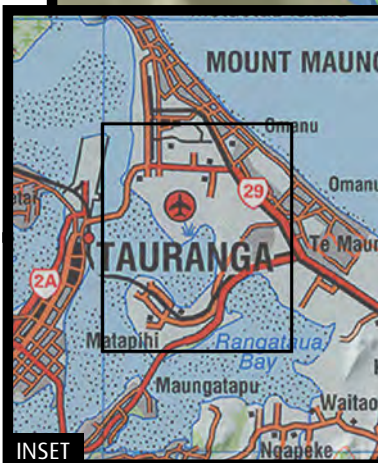
SITE 37 Waipu Bay/ Tauranga Airport Oil Spill Management Plan

Site 37	Waipu Bay/Tauranga Airport	Risk ranking: 3
DESCRIPTION Waipu Bay is adjacent to the Tauranga Airport.		
Foreshore type/environmental value	Sandy/muddy shores. Habitat (intertidal), contact. All shore segments have "habitat value".	
Map sheets	NZ Topo 50 BD37 Tauranga	Chart Number NZ 541
Segments	TAU-00050	
At Risk Resources		
<ul style="list-style-type: none"> • Birds on site include: banded rail (kataitai), North Island fern bird (mātātā), pukeko, variable oystercatcher (tōrea pango), turnstone, NZ Dotterel, migratory wader species. • Fish include: flounder (patiki), stingray (whai) • Cultural resources: Whareroa Marae and boat ramp

<ul style="list-style-type: none"> • All intertidal areas are identified in the Regional Coastal Plan as areas of significant conservation/cultural value 		
Notes		
<ul style="list-style-type: none"> • Where possible, oil should be prevented from entering the Tauranga Harbour • Booming possible from the boat ramp to the Tauranga Marina Bridge

Most preferred	Least preferred	Feasibility
Containment and Recovery	High		Booming of this area is possible but there are strong tidal flows
On water Recovery	High		Possible prior to entering bay area
Dispersant Application	Low	Requires escalation to Tier 3 and MNZ approval	Water depth won't allow in the bay area
Shoreline Clean-up	Medium		Sandy beach area at entrance easier to clean
Natural Recovery	Medium		No vehicle access along tidal area

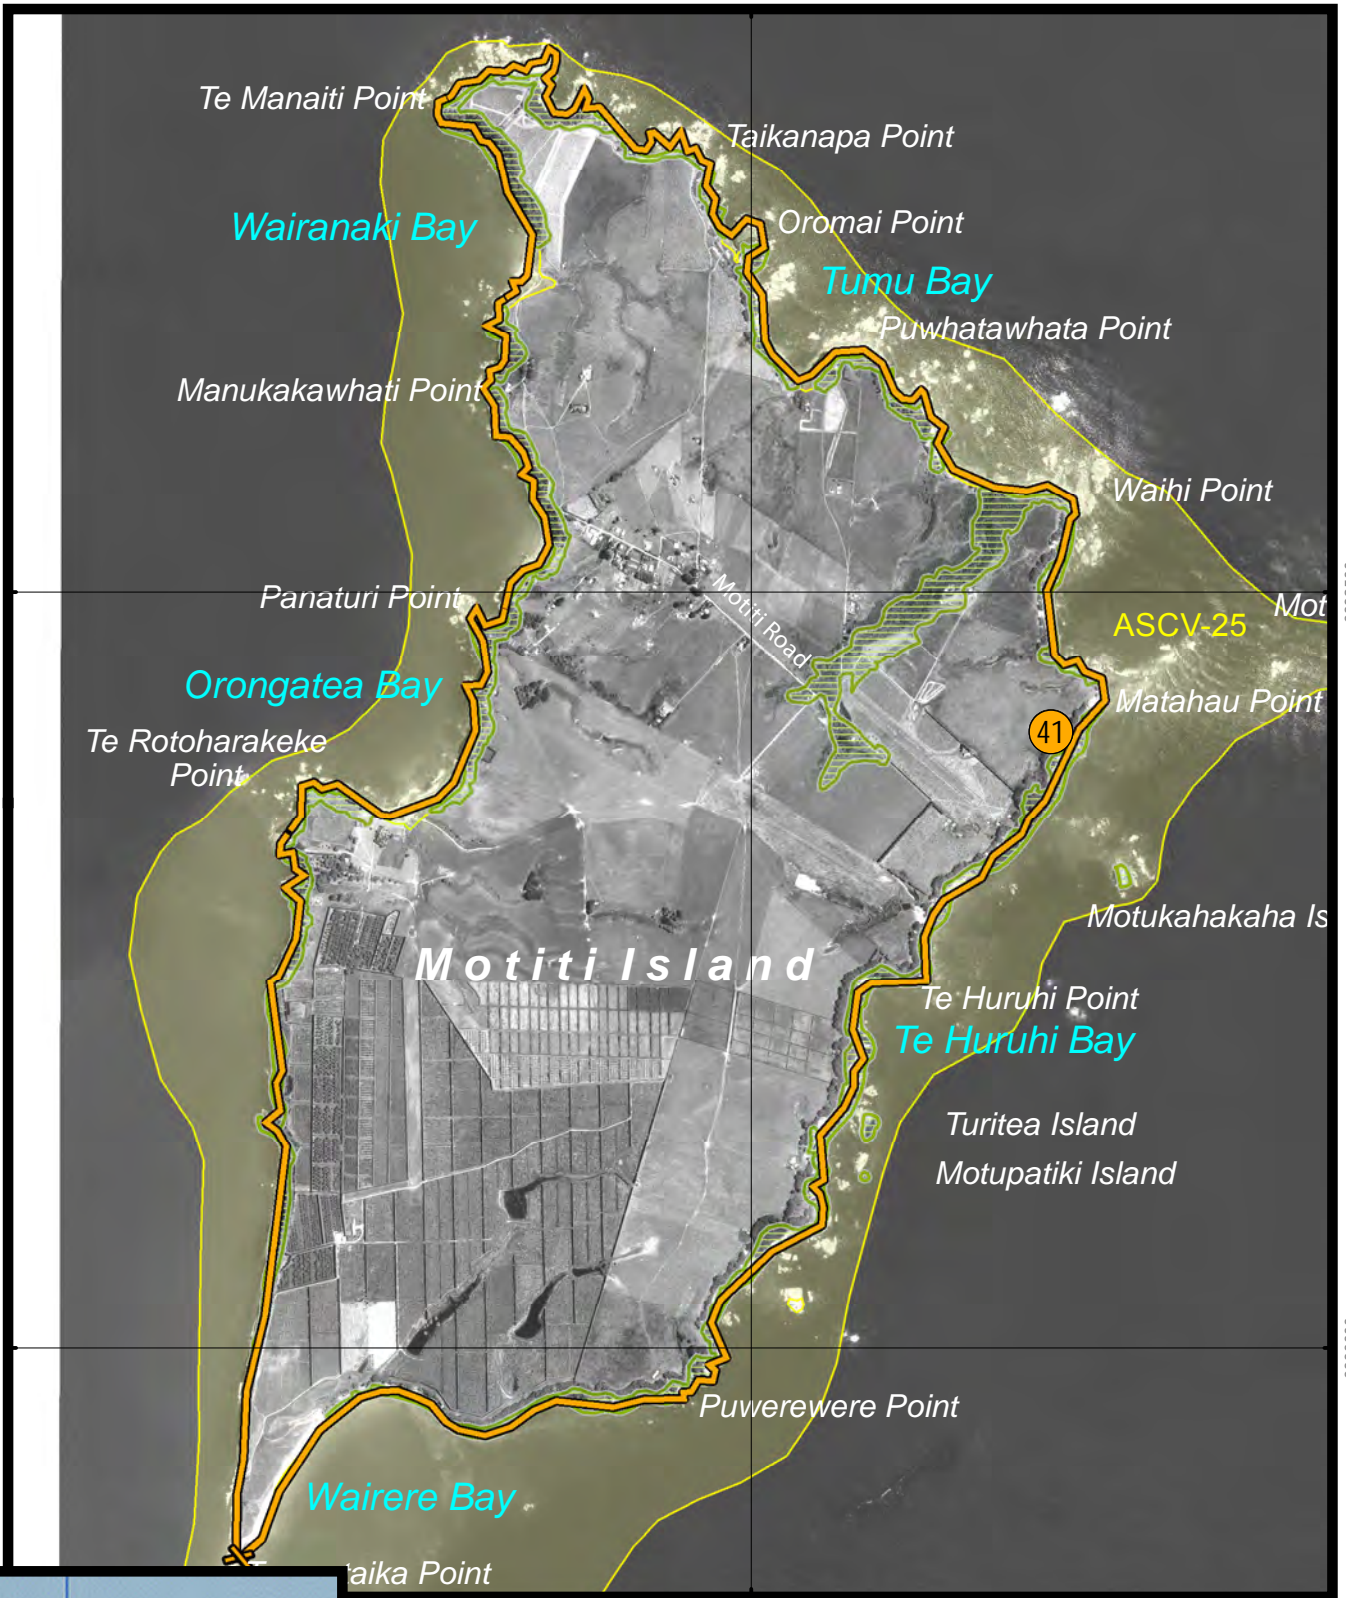
SITE 41 Motiti Island Oil Spill Management Plan

Site 41	Motiti Island	Risk ranking: 1
DESCRIPTION		
<p>Motiti Island is privately owned and approximately 10 km offshore of Papamoa Beach. Motiti is a relatively flat island covering approximately 10 km².</p>		
Foreshore type	<p>Primarily vertical and sloping bedrock with occasional sand beaches.</p> <p>The relatively protected waters of Wairanaki Bay on the north-western tip of the island have a popular and prominent sand beach, with other beaches located in Orongatea and Wairere Bays.</p> <p>The rest of the foreshore is rocky or cobble with offshore reefs and exposed rocks.</p> <p>All shore segments have “habitat value”.</p>	
Map sheets	NZ Topo 50 BD37 Tauranga	Chart Number NZ541; NZ542; NZ5413
Segments	MOT-00010;MOT-00020;MOT-00030;MOT-00035;MOT-00040;MOT-00050;MOT-00060;MOT-00070;MOT-00080;MOT-00090;MOT-00100;MOT-00034;MOT-00032;MOT-00105	
At Risk Resources		
<ul style="list-style-type: none"> • Blue penguins (kororā) in rocky burrows and where cobbles and rocks occur on beaches • Red-billed gulls (akiaki)- nationally vulnerable, pied shag (kāruhiruhi) colonies all around coast • Reef herons (matuku-moana), variable oystercatcher (tōrea pango) seen on island • Motuputa Rock (Cave Rock) on the north east corner of the island is recognised as a nesting area for fluttering shearwater (breeding September–February), fleshy footed shearwater (breeding November–May) and diving petrels • Fur seals (kekeno), multiple haul-out locations along the west coast • Motukahakaha Rock on the eastern side of the island contains a population of duvachell geckos and is the only known island in the Bay of Plenty containing this species, Little Blue penguins, grey face petrel and common diving petrel breeding. • Abundant kaimoana on almost all rocky reefs (paua, kina, kōura) • The whole island is of historic cultural significance to iwi. The following archaeological sites have been identified along the coast: V14/42, V14/182, V14/43, V14/44, V14/45, V14/46, V14/47, V14/171, V14/48, V14/183, V14/49, V14/50, V14/51, V14/53, V14/54 • Silent files

Most preferred	Least preferred	Feasibility
Containment and Recovery	High		Deflection booms may work in some locations but weather will dictate
On water Recovery	High		Requires appropriate large vessels
Dispersant Application	Low	Requires escalation to Tier 3 and MNZ approval	Possible off-shore
Shoreline Clean-up	High		Reasonable access to most areas at low tide
Natural Recovery	Medium		High energy coastline may lead to this option
