Aongatete

Sub-Catchment Action Plan 2012

The Aongatete Sub-Catchment Action Plan is one of a series about the sub-catchments surrounding Tauranga Harbour. This action plan provides an analysis of the current land management issues, a summary of the available physical resources in the Aongatete sub-catchment, and planned action for land and resource use in the sub-catchment.

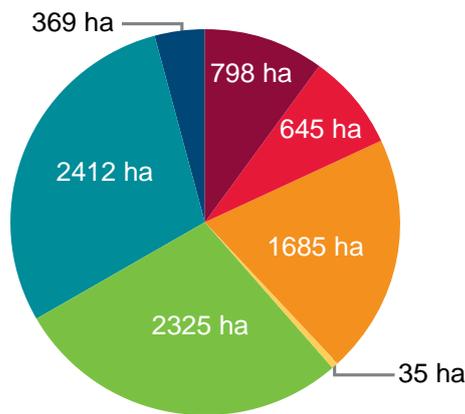
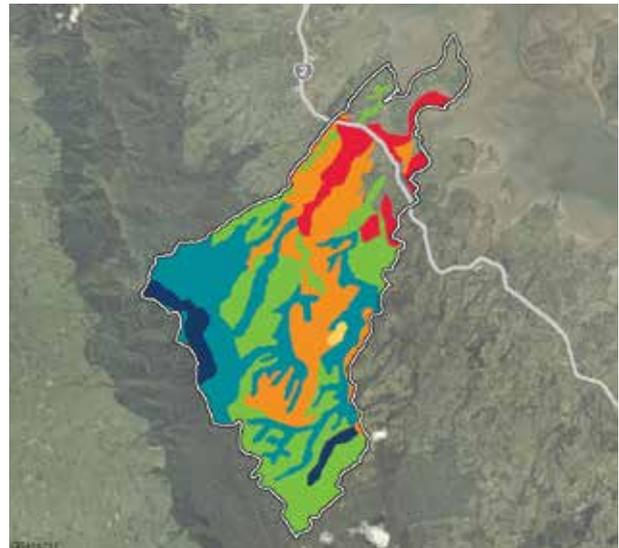
Land use capability classification in the Aongatete sub-catchment

The majority of land in this sub-catchment is Land Use Capability (LUC) Class 6 and 7 – strongly rolling and steep landscapes. Highly productive LUC Class 2, 3 and 4 - gentle to rolling lands - are also well represented across the sub-catchment.

LUC Class	LUC Units	Percent
2	2e 1, 2s 1	10
3	3e 1, 3e 2, 3e 8, 3w 1	8
4	4e 1, 4e 2, 4e 9	20
5	5c 1	0.4
6	6e 2, 6s 3, 6e 4, 6e 11, 6w 1	28
7	7e 1, 7e 2	29
8	8e 4, 8w 1	4

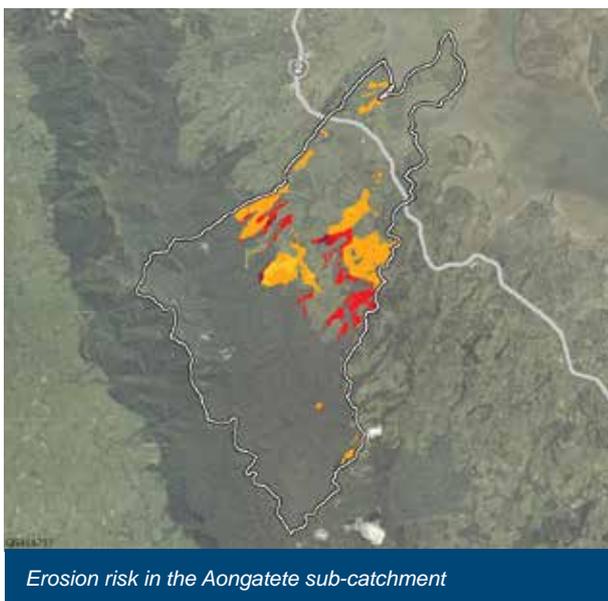
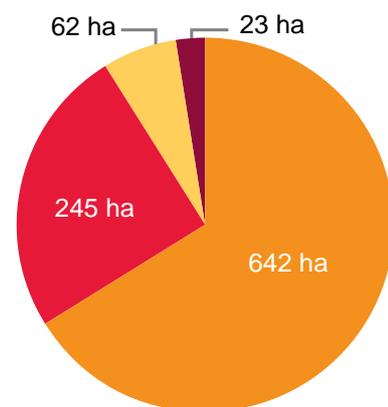
Erosion risk in the Aongatete sub-catchment

A moderate proportion of Land Use Capability Class 6 and 7 lands in the Aongatete sub-catchment have a medium-high risk of erosion occurring due to pastoral land use. Forestry located on this class of land has a medium-high risk of erosion during the post-harvest phase.

Land Use	Risk	Percent
Pasture	Medium	8
Pasture	High	3
Exotic forest	Medium	1
Exotic forest	High	0.3

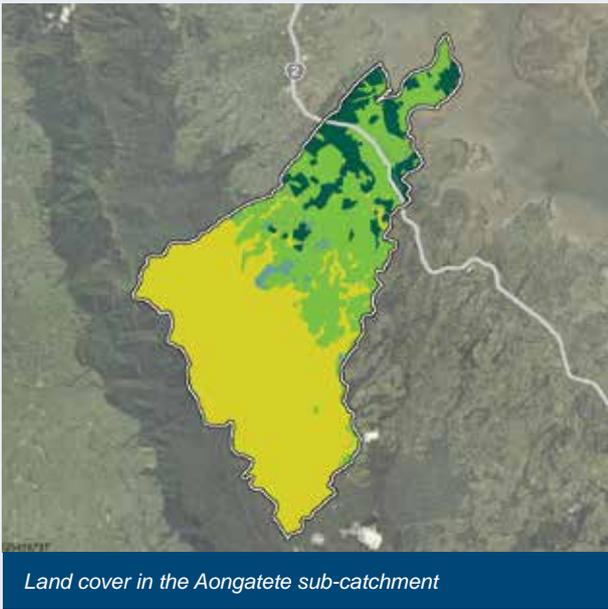
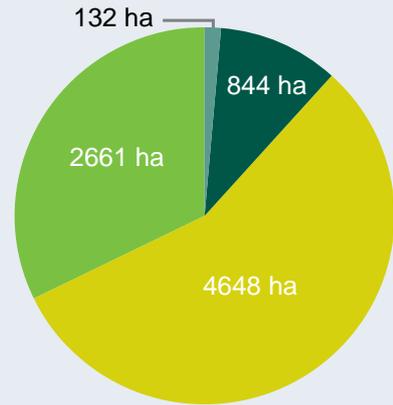
Land cover in the Aongatete sub-catchment

Vegetation	Percent
Exotic	2
Horticulture	10
Indigenous	56
Pasture	32

The most widely spread land cover in the sub-catchment is indigenous bush at 56 percent. Pasture covers 32 percent, horticultural 10 percent and exotic forest two percent. Large areas of estuarine wetlands surround the Aongatete estuary.

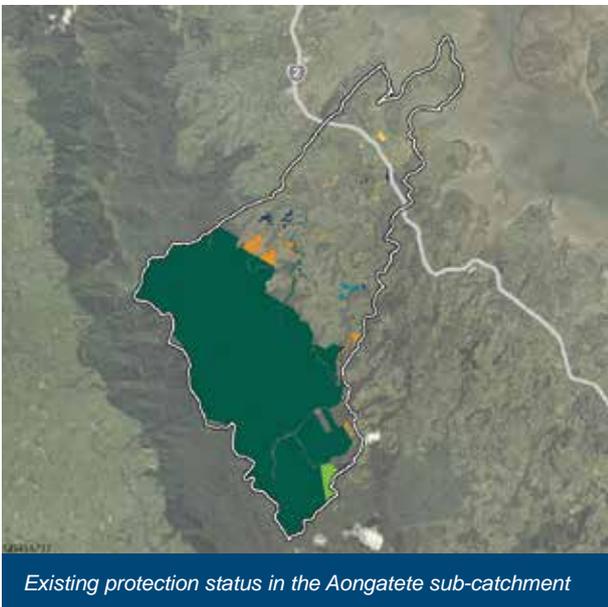
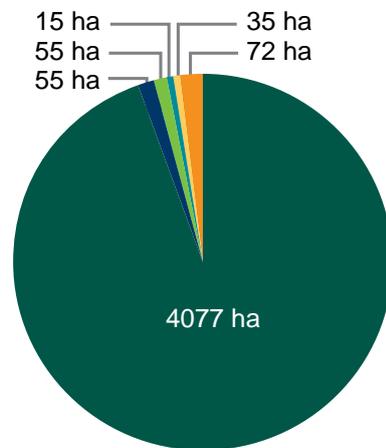
Existing protection status in the Aongatete sub-catchment

Class	Percent
DOC	49
BOPRC Covenant	1
Nga Whenua Rāhui	1
QEII	0.2
District Reserve	0.4
WBOPDC Covenant	1
