# Whakatane Waimana Floodplain Management Strategy - Stage 1

Review of the current flood hazard from the Whakatane and Waimana Rivers  
and existing responses

Prepared by Robbin Britton, Project Engineer  
Environment Bay of Plenty  
Operations Publication 2008/09  
June 2008 (updated from January 2007)

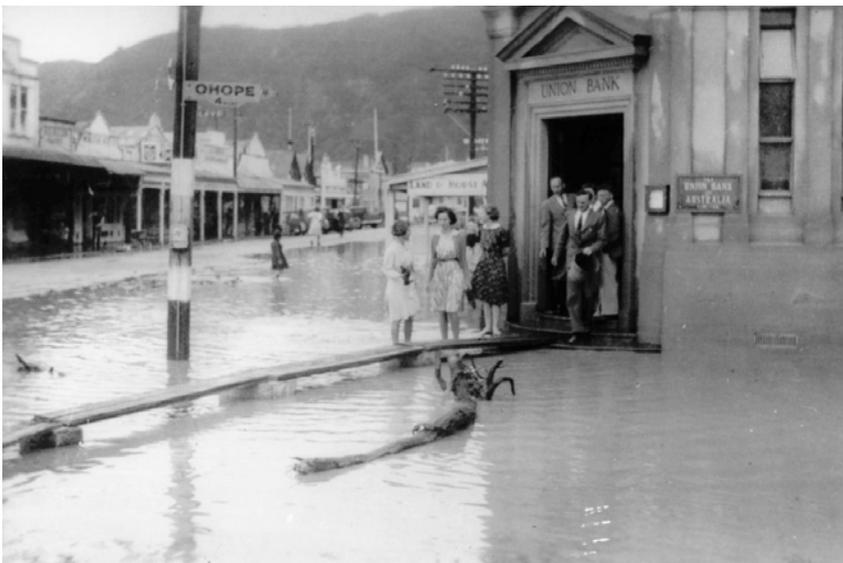
Figure 1.6 Flooding of The Strand during 1944. The Union Bank is now a car sales yard.

According to a report by Bay of Plenty Catchment Commission (BOPCC) a peak discharge of 55,000 cusecs (1557m<sup>3</sup>/s) was estimated for this 1944 event. The report added, “local residents on the upper river above the recording station state that this flood was not as high as the 1925 flood” (BOPCC, 1985, p12)

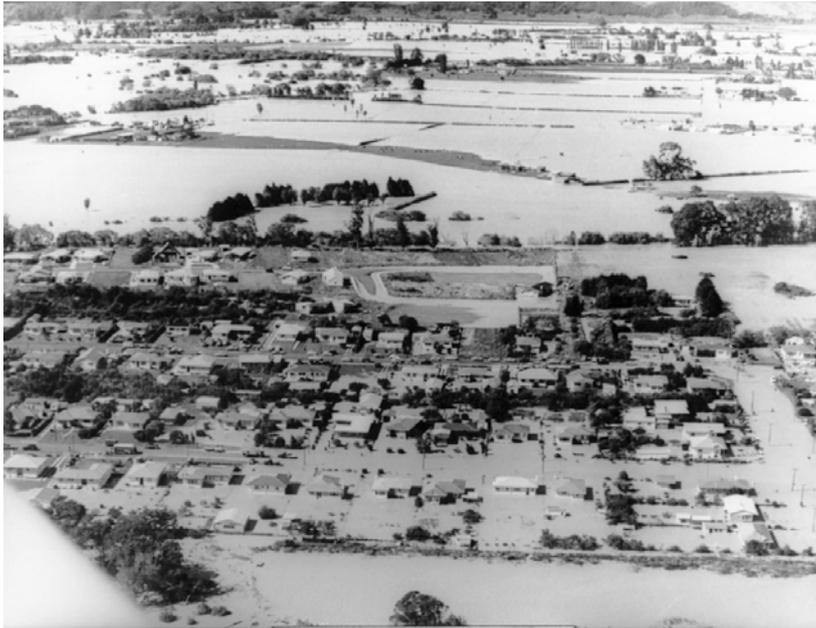
*Figure 1.7 Photo from over the Board Mills looking towards Whakatane West Station (i.e. the Rangitaiki Plains) (February 1965)*

A major flood occurred whereby the mean rainfall over the Whakatane catchment was 8.92 inches over 36 hours. This was equal to a peak discharge of 68,000 cumecs (1926m<sup>3</sup>/s).

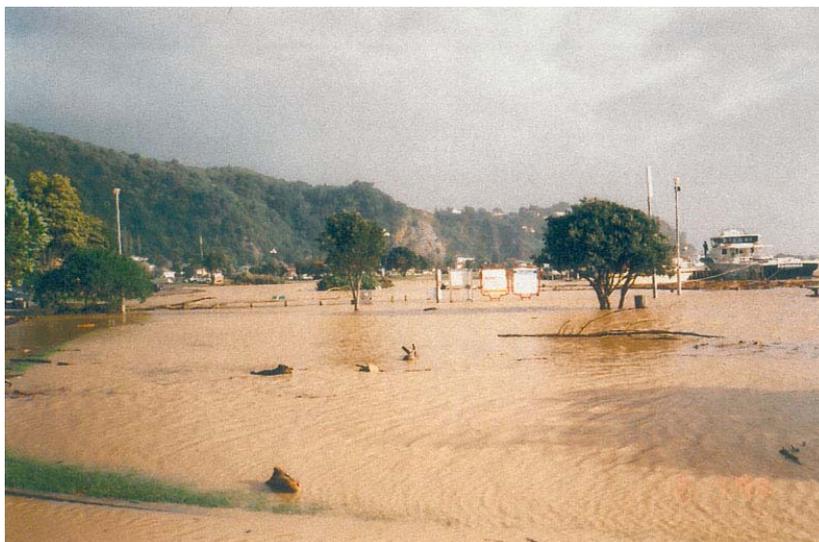
*Figure 1.8 Whakatane Heads at the boat ramp where the carpark is completely submerged (2 July 1998)*

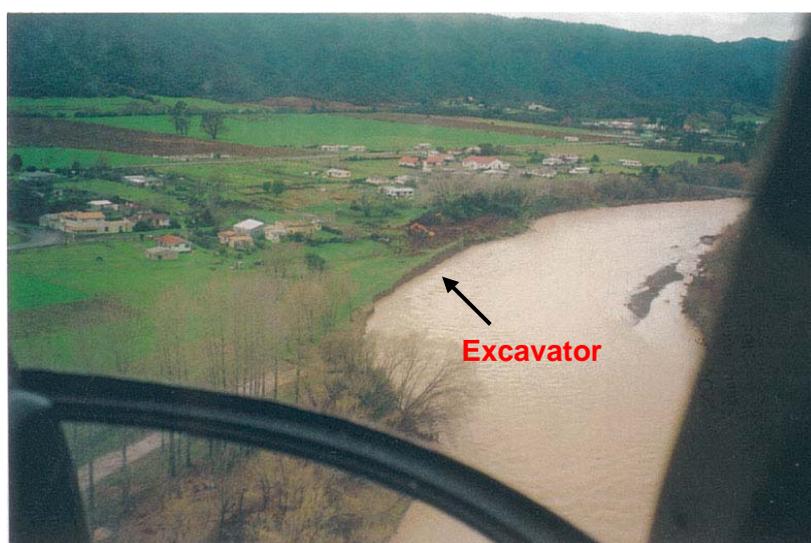
*Figure 1.9 Bank erosion at Ruatoki. Threatened stopbank being realigned by excavator (17 July 1998)*

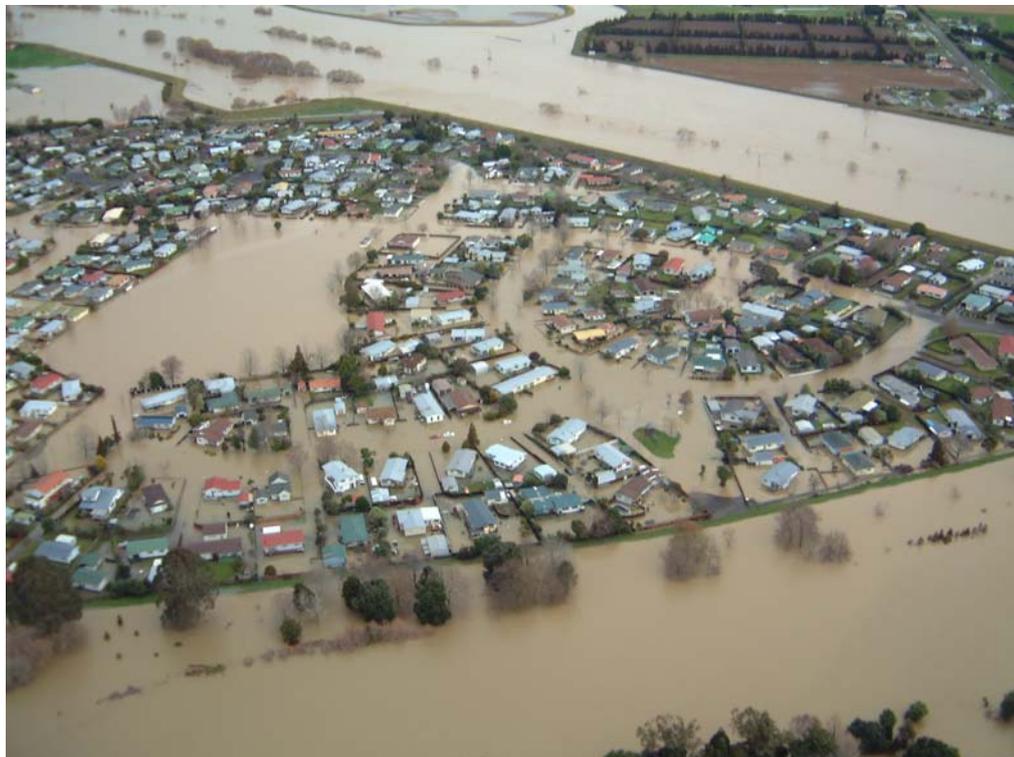
Figure 1.12 Suburb of Awatapu under floodwaters. The Whakatane River is in the background, Awatapu Lagoon in foreground (18 July 2004)

Unfortunately the suburb of Awatapu did flood owing to a malfunction of the main pump station. Flood waters resulted from Wainui Te Whara Stream run-off and overtopping of the internal stopbanks that surround the suburb.

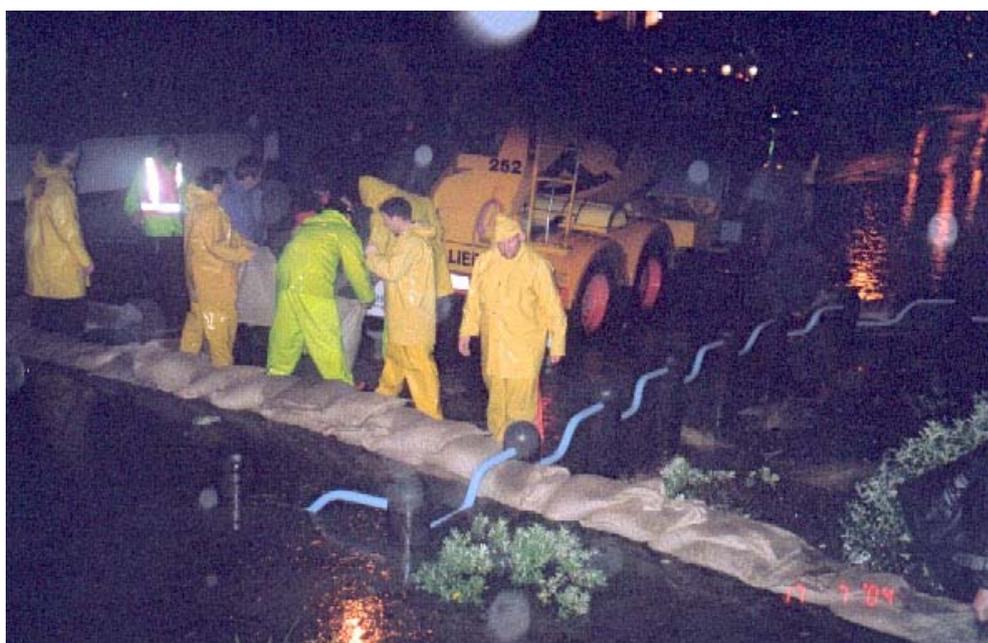
Figure 1.13 Sandbagging outside the Fishing Club on Muriwai Drive. This helped prevent floodwaters spreading to Whakatane township (17 July 2004)

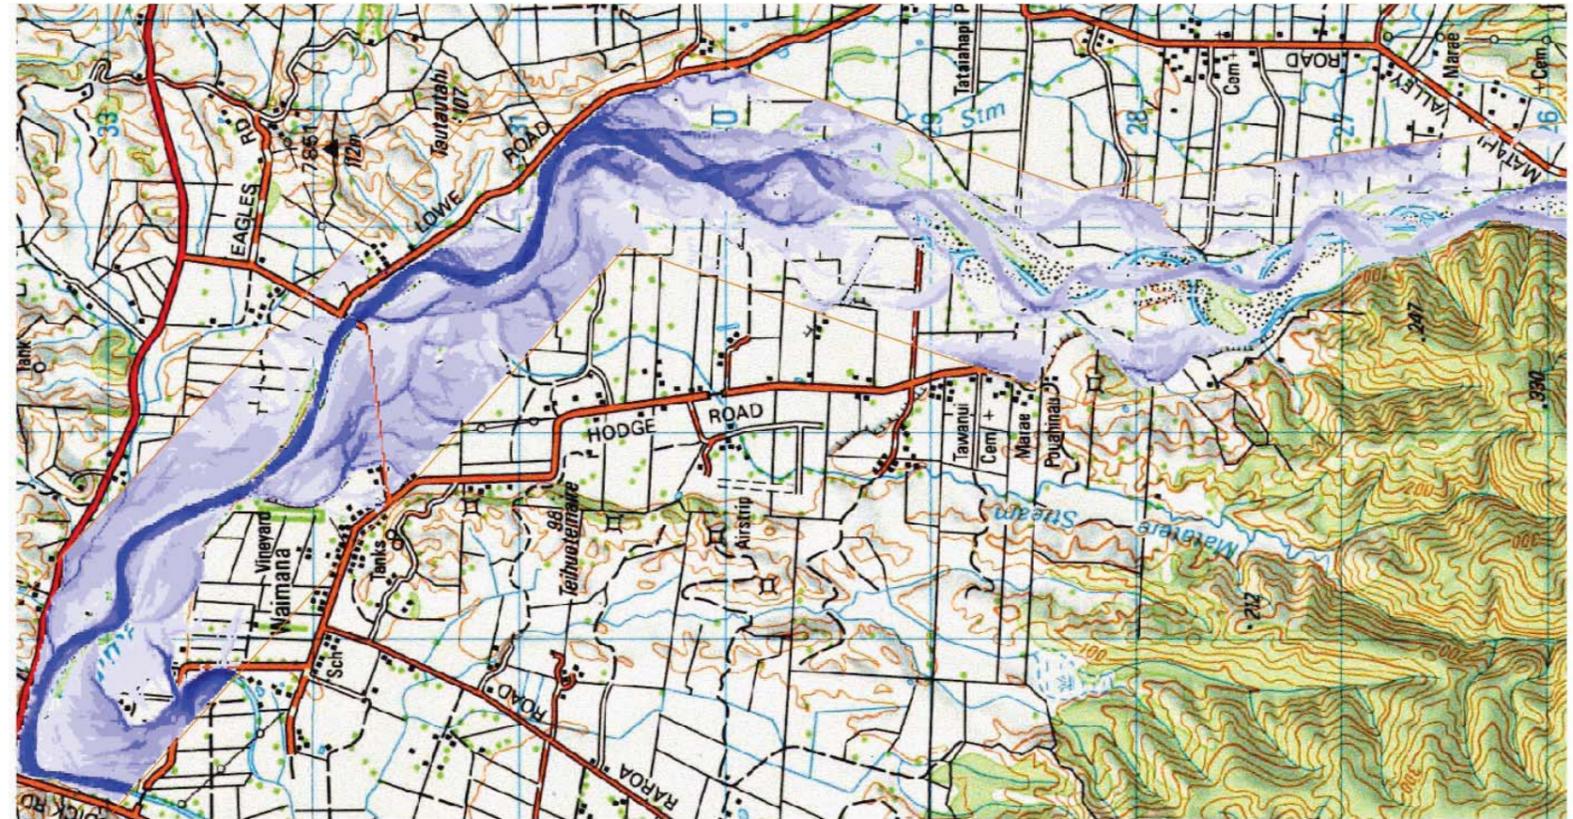
Figure A3.13 - Topography Map of flood extent in Waimana River floodplain during a 1 in a 50 year flood (excluding freeboard)

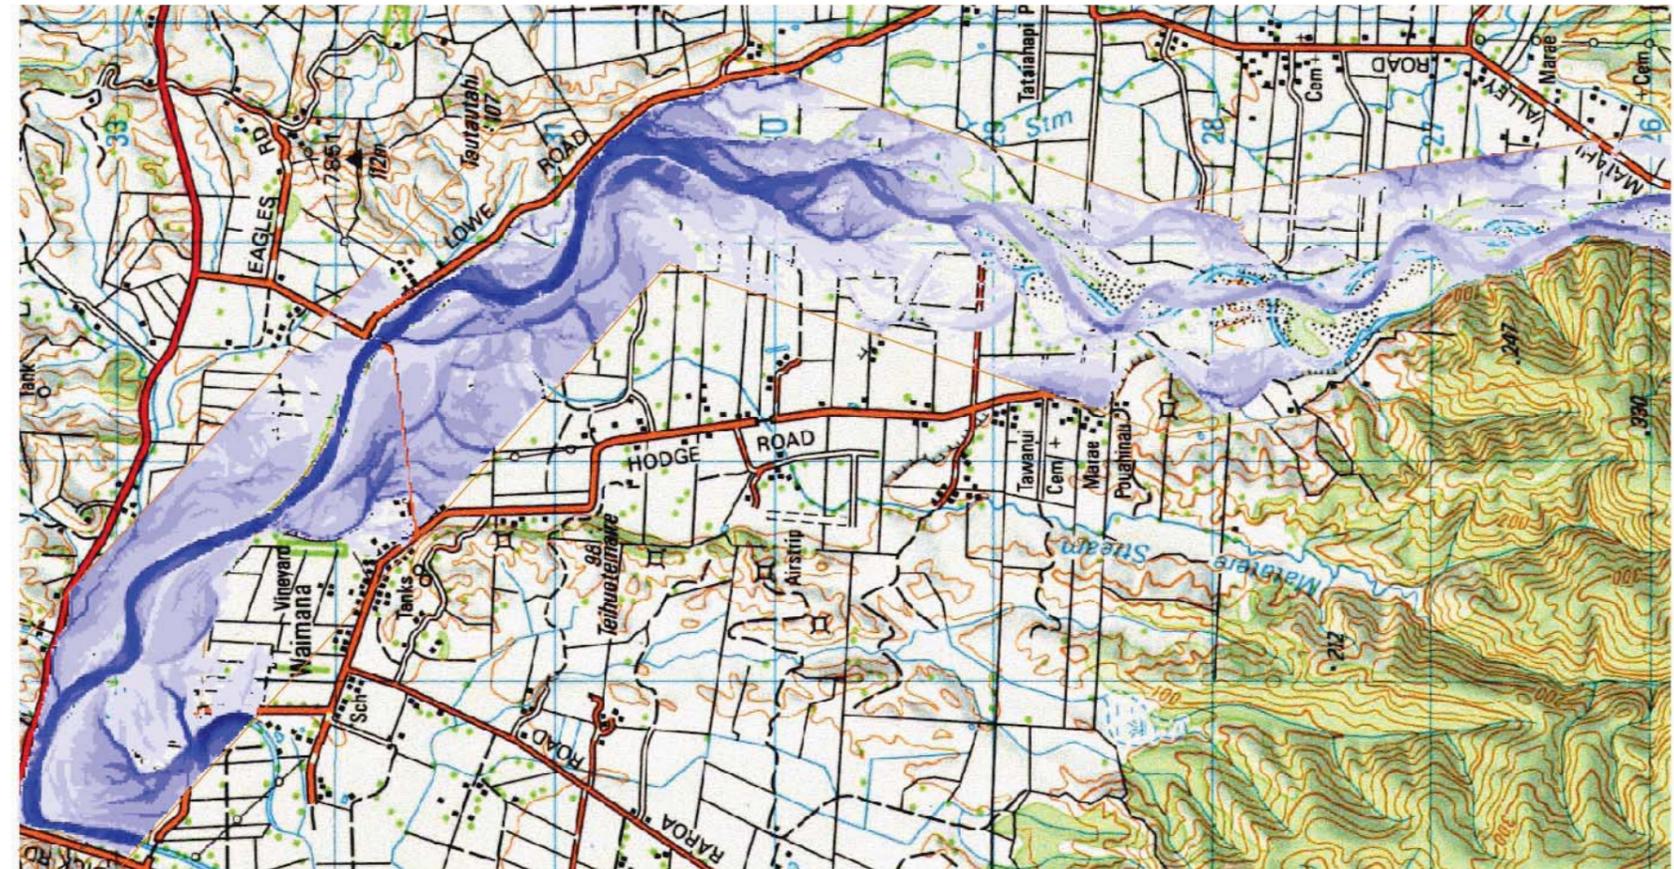
Figure A3.19 - Topography Map of flood extent in Waimana River floodplain during a 1 in a 200 year flood (excluding freeboard)
