**Submission on publicly notified Proposal for Policy Statement Change**  
*Clause 6 of Schedule 1, Resource Management Act 1991*

This is a submission on Proposed Change 2 (Natural Hazards) to the Bay of Plenty Regional Policy Statement:

# The 18 May 2005 debris flow disaster at Matata: Causes and mitigation suggestions

**DEBRIS FLOW EMERGENCY AT MATATA, NEW  
ZEALAND, 2005  
INEVITABLE EVENTS, PREDICTABLE DISASTER**

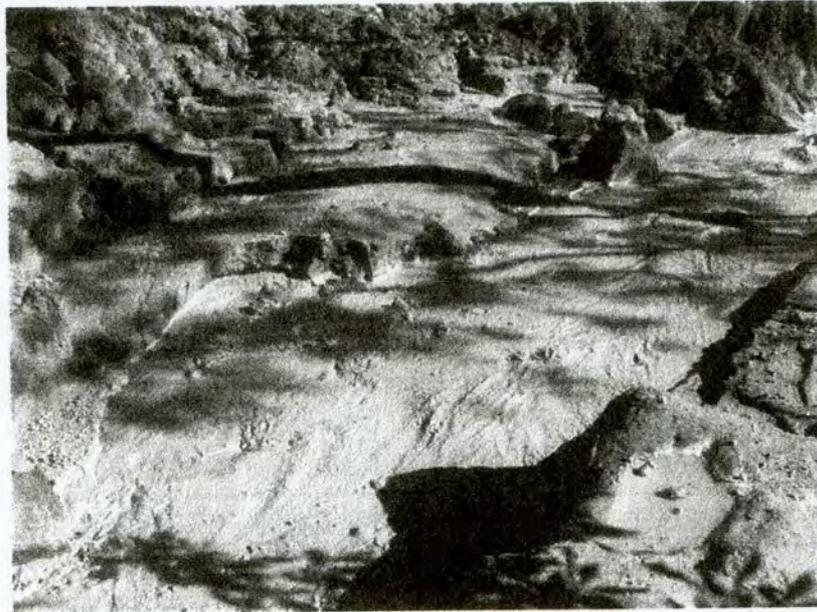
**Figure 1.3.7** A small stream west of Matata, beside SH2 photographed in hyperconcentrated flow on 23 May. The flow appears to be thick and oily. Much of the surface roughness usually seen on a clear stream is damped out because of the high density of the flow. Witnesses described and photographed<sup>7</sup> hyperconcentrated flows at Matata on 18 May.

floods as discussed earlier, are large, sediment-rich flow events, which may or may not involve hyperconcentrated flow. Hyperconcentrated flow is a distinct flow process that can occur at low as well as high discharges. A hyperconcentrated flow is a flow of water so highly charged with sand and silt that much of its turbulence is damped out and its flow appears to be smoothed and oily, though it may be moving faster than an equivalent depth of clean water. The normal small-scale surface choppiness and splashes of water are missing on hyperconcentrated flows. A dense, fast-moving hyperconcentrated flow is capable of moving larger boulders along the bed of the flow than is the equivalent normal flow of water. Some witness descriptions of the floodwater at Matata<sup>6</sup> fit hyperconcentrated flow from debris flows, and we saw one small stream west of Matata in hyperconcentrated flow on 23 May when it was far from being in flood (Figure 1.3.7).

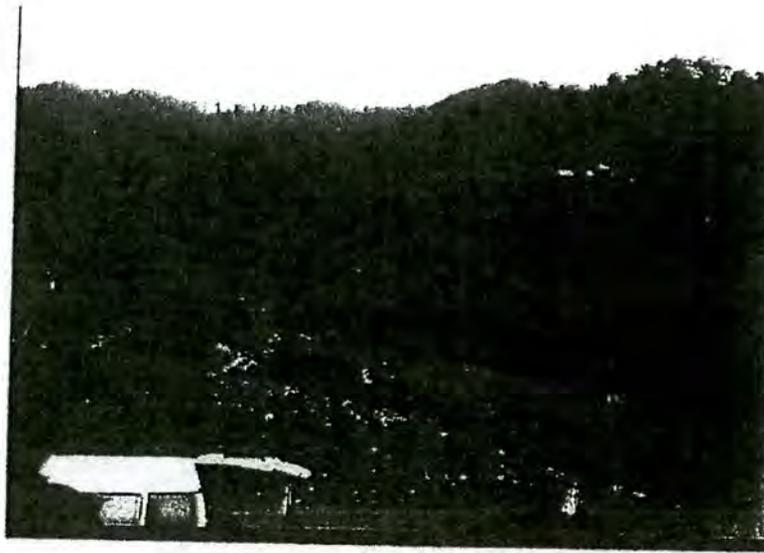
Fig. 2. Debris flow fan north of Westport, with clear evidence of the last debris flow event: note the steep fan slope, the large boulders, the deep, narrow channel, with levees, and the small, steep catchment. A new dwelling is just out of the picture to the right (arrowed).

Small fans also have incised fan heads (e.g. Fig. 2), but the land adjacent to the incised stream is not safe from flooding and sediment deposition. This is because, in small, steep catchments with erodible rock, a quite different erosion process can occasionally occur; this is a “debris flow”, and it was this phenomenon that devastated parts of Matata.

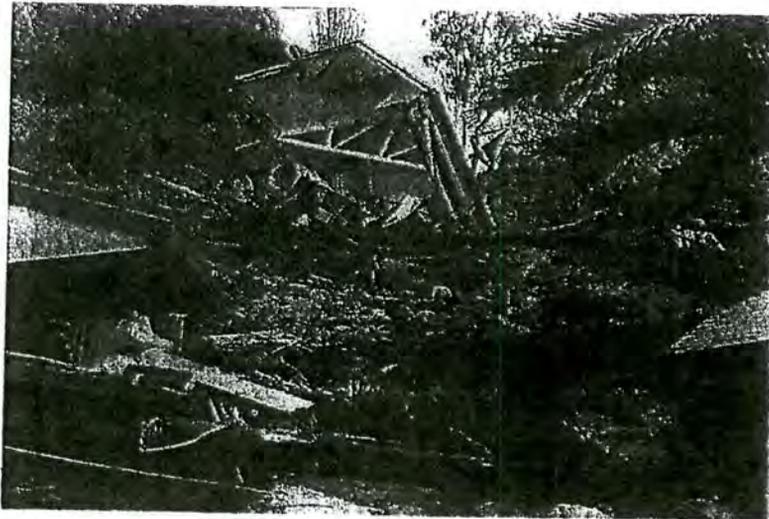
Fig.4 Debris flow damage, Matata, Bay of Plenty NZ May 2005

Since debris flows are potentially extremely destructive (Fig. 4), any situation in which human development – particularly dwellings and infrastructure – is exposed to their impact is a fatal disaster waiting to happen. It was very lucky that no lives were lost at Matata.

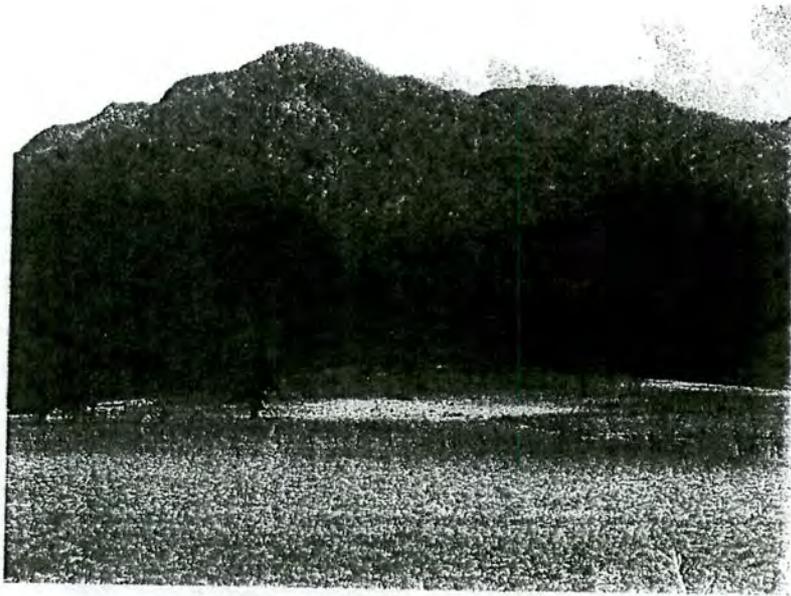
Fig. 6 Westland. The gully feeding debris to the fan is formed on the Alpine fault.

The number of developed debris-flow vulnerable fans in New Zealand is unknown. There are however many examples visible throughout the mountainous and hilly parts of the country; Figs 3, 6 and 7 are unfortunately typical.

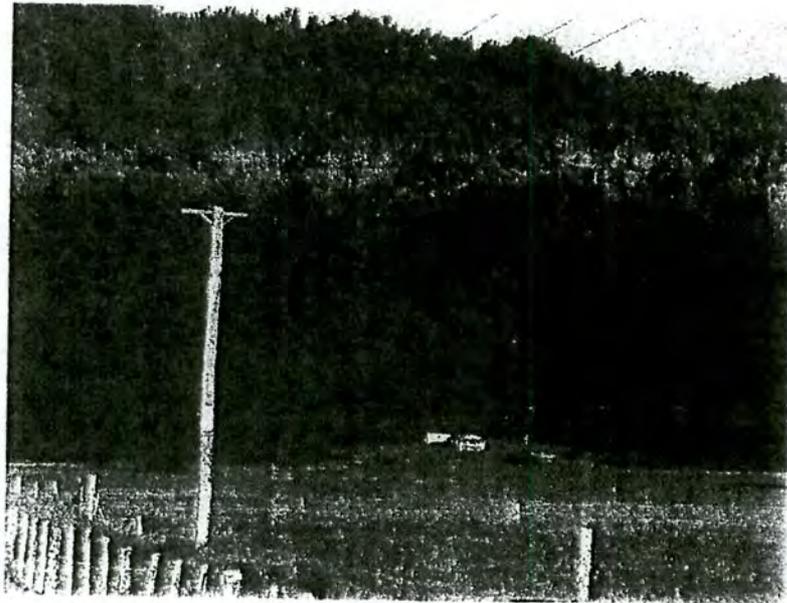
Fig. 7 South Westland. The gully above the house is formed in moraine.

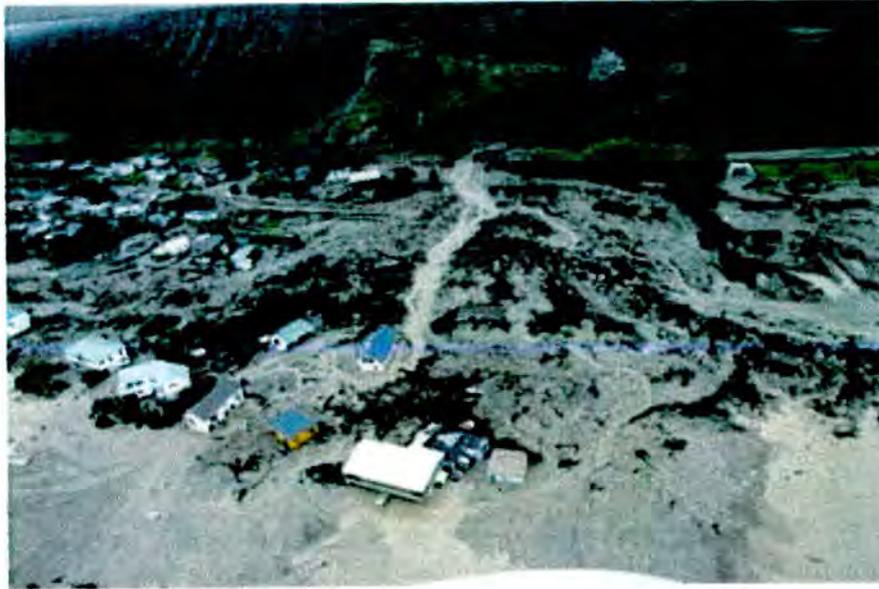
Figure 1. View of western Matata in the immediate aftermath of the 2005 debris-flows. The Awatarariki Stream flows across recently deposited debris on the fanhead. The permanent stream channel is located in the left middle distance. In the right distance, State Highway 2 crosses beneath the East Coast Main Trunk railway via a narrow underpass.

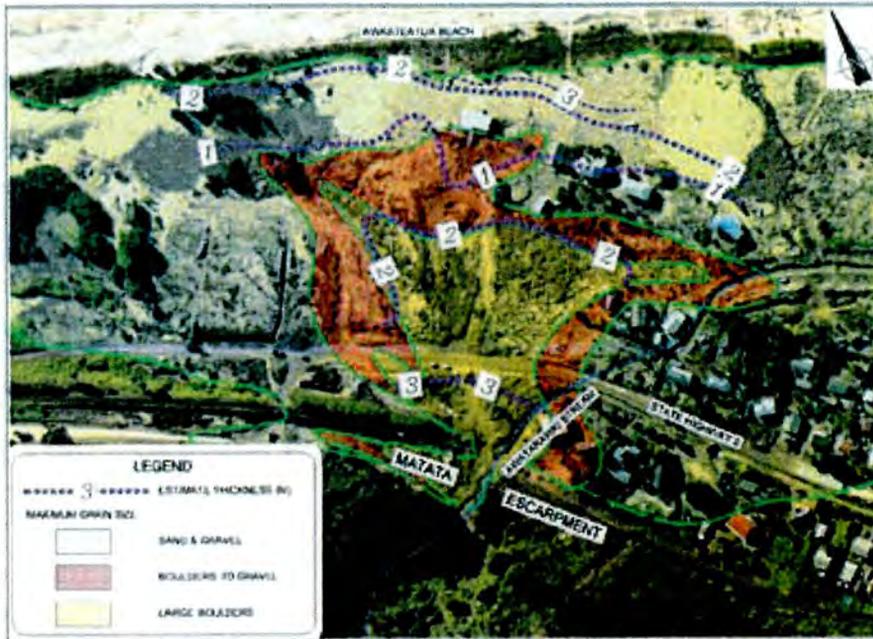
Figure 2. Western Matata immediately after the 2005 event. The estimated fanhead deposit distribution is shown.

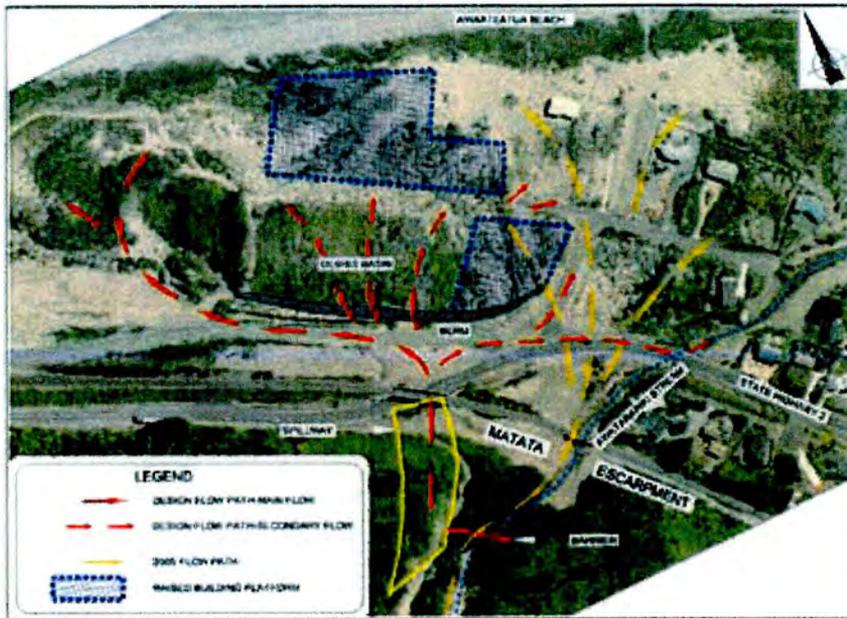
Figure 4. Aerial photo of western Matata indicating the location of the proposed debris-flow control system and dominant flow paths. Debris from the 2005 event is still clearly evident in this 2007 photo.

Although the barrier could structurally survive being overtopped, it is intended to maintain a nominal freeboard of 1 m. With a retained debris height at the barrier of 14 m, the stream valley would have an estimated maximum retainable volume of some 110,000 to 130,000 m<sup>3</sup>. This is significantly less than the design deposit volume of 250,000 m<sup>3</sup>. It is therefore proposed to direct excess material out of the Awatarariki Stream via a spillway located within the abandoned quarry. The diverted debris material would flow down the spillway, passing through the State Highway 2 underpass onto the fanhead west of the Awatarariki Stream. Determining the configuration of the spillway and the extent of diversion structures on the fanhead were two of the most important factors to be assessed by the modelling. Estimated flow directions are shown on Figure 4.

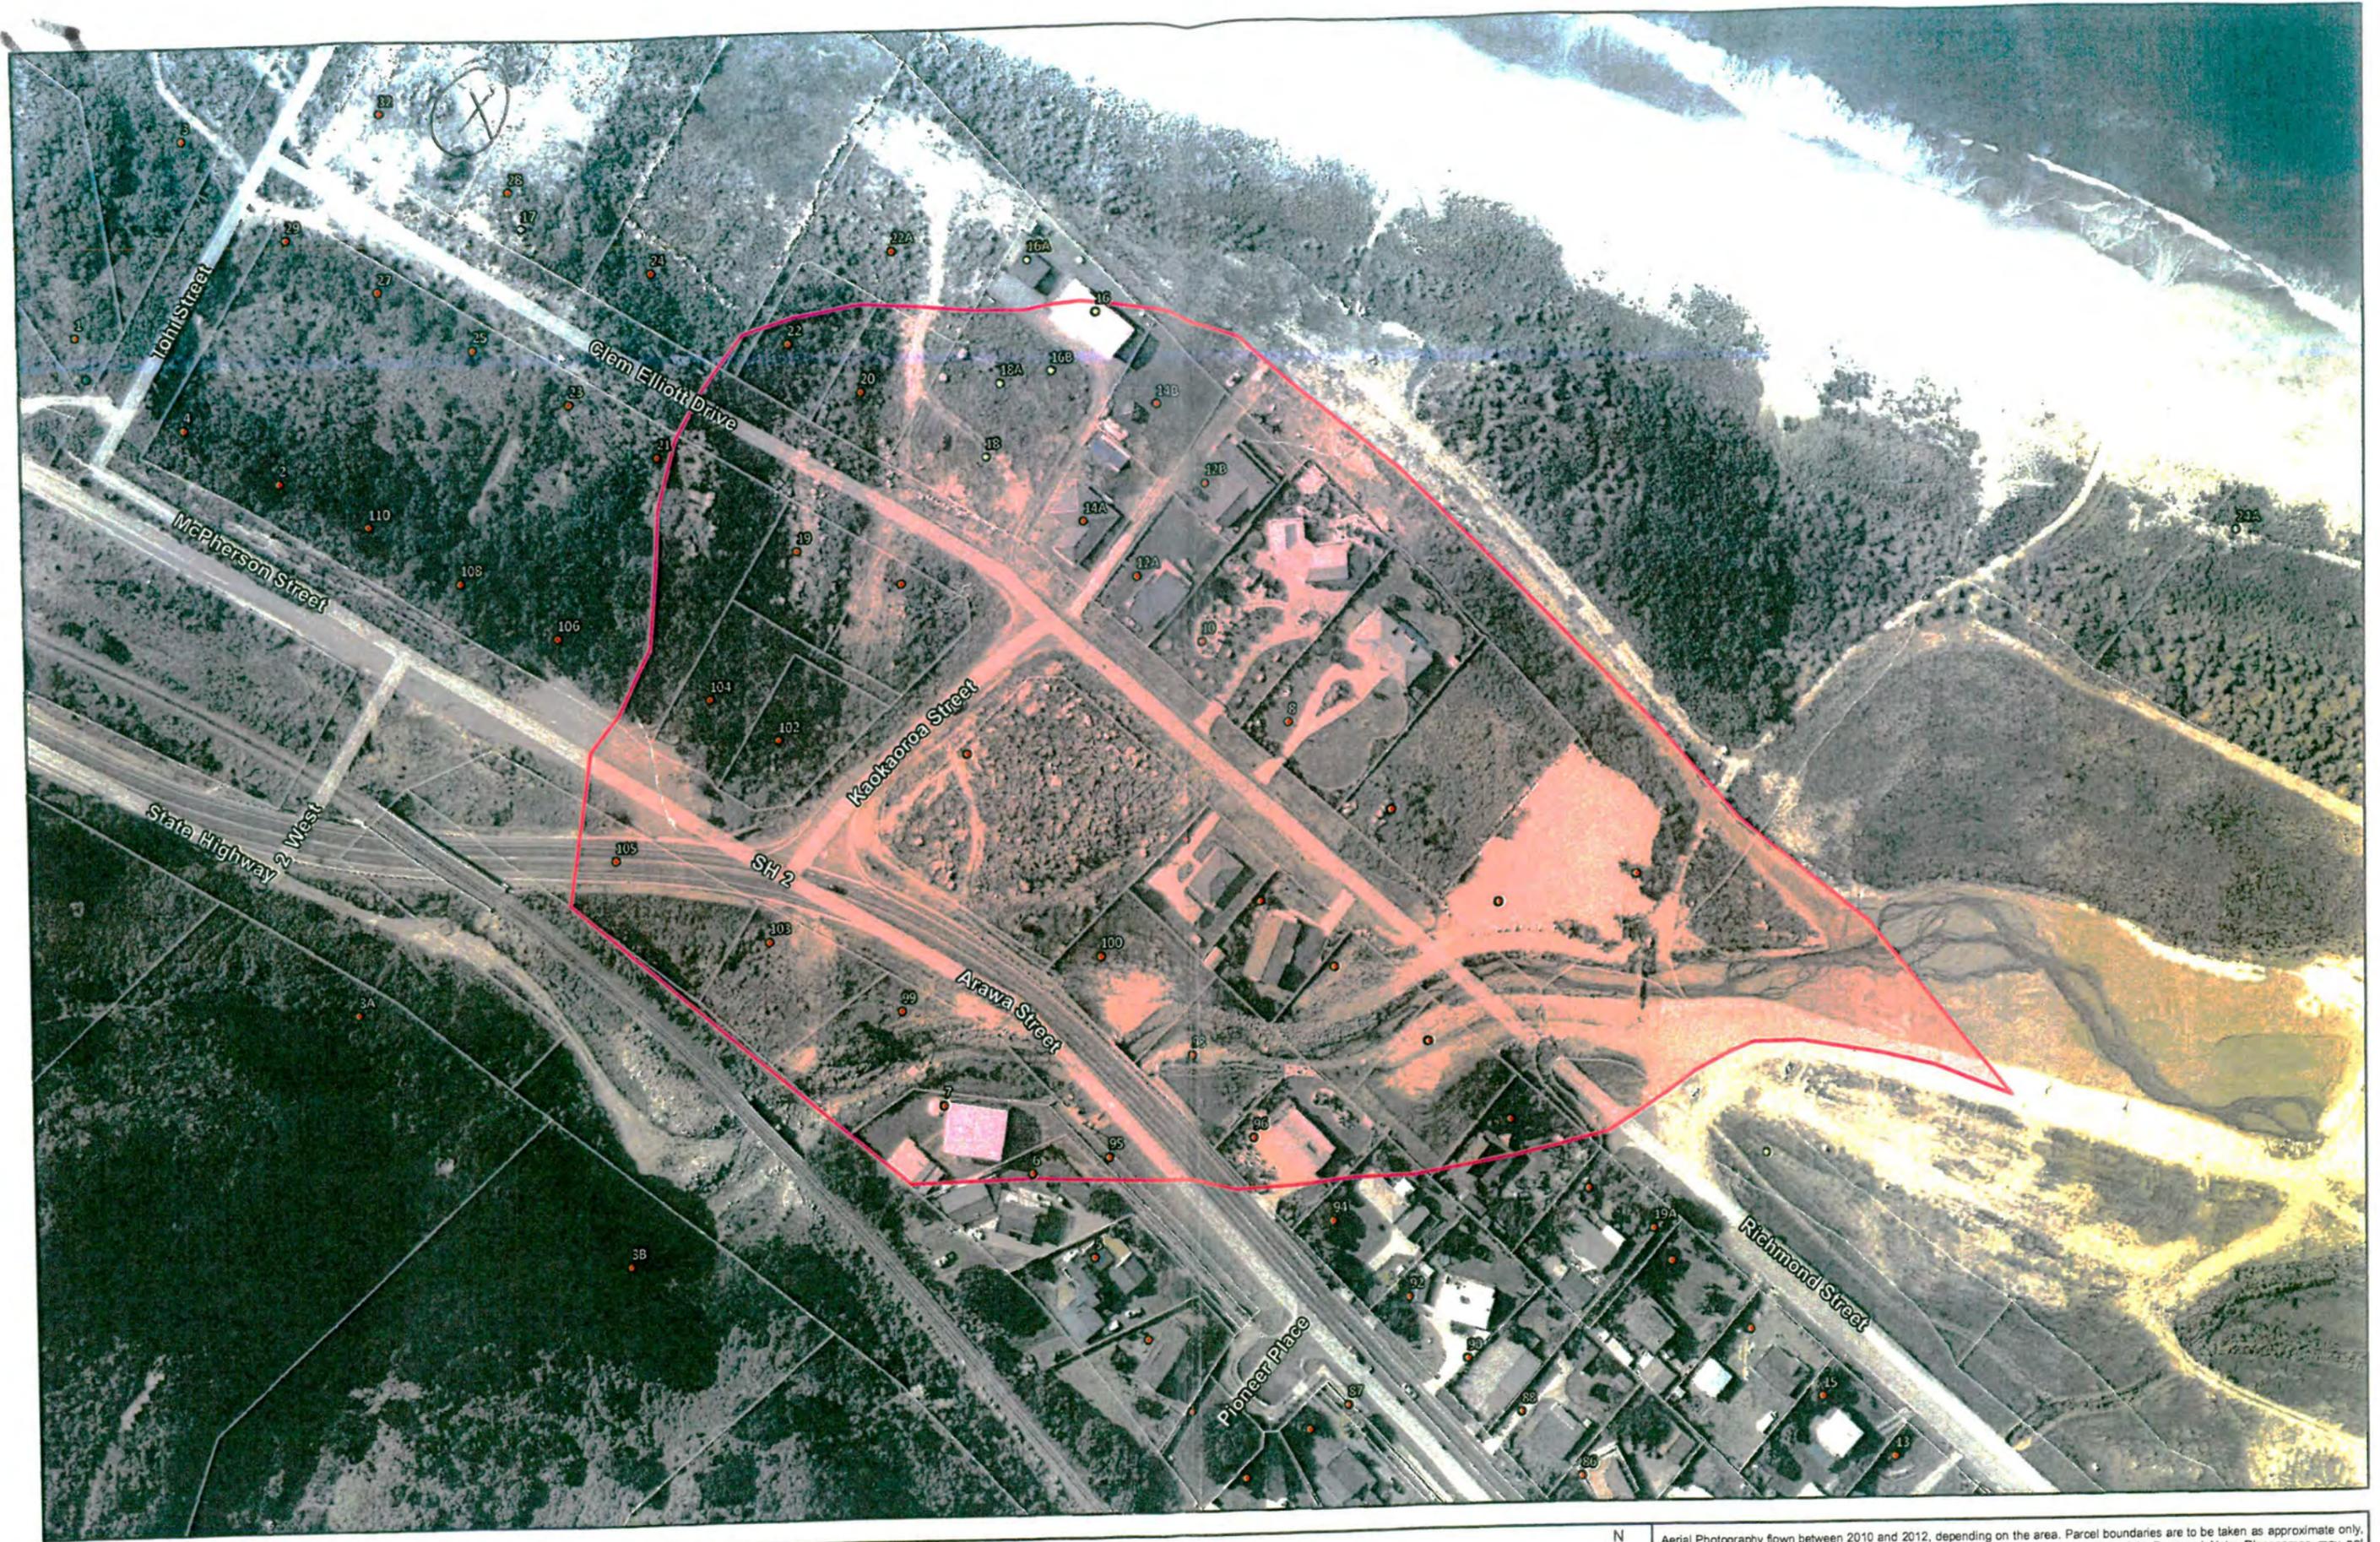
Awatarariki Fanhead Intolerable Risk Area

reference - Supplementary Risk Assessment Debris Flow Hazard Matatā Report, Tonkin and Taylor Ltd, November 2013, Figure 15.
