# Waimapu

## Sub-Catchment Action Plan 2012

The Waimapu Sub-Catchment Action Plan is one of a series about the sub-catchments surrounding Tauranga Harbour. This action plan provides an analysis of the current land management issues, a summary of the available physical resources in the Waimapu sub-catchment, and planned action for land and resource use in the sub-catchment.

Published September 2012

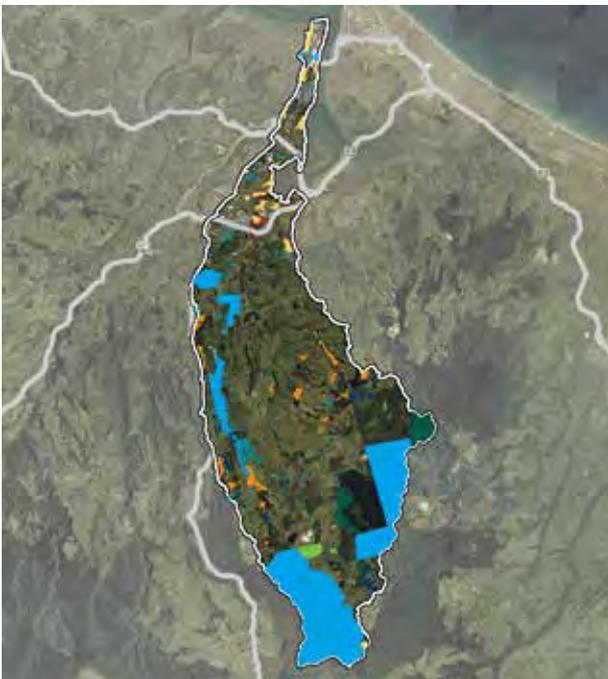
Existing protection status in the Waimapu sub-catchment

Class	Percent
DOC	6
BOPRC Covenant	5
Māori	0.2
Nga Whenua Rāhui	2
QEII	2
District Reserve	5
WBOPDC Covenant	4
TCC Water Reserve	76
