Welcome Bay

Sub-Catchment Action Plan 2012

The Welcome Bay Sub-Catchment Action Plan is one of a series produced for the sub-catchments surrounding Tauranga Harbour. The aim of this action plan is to provide an analysis of the current land management issues, a summary of the available physical resources in the Welcome Bay sub-catchment, and action for land and resource use of the sub-catchment.

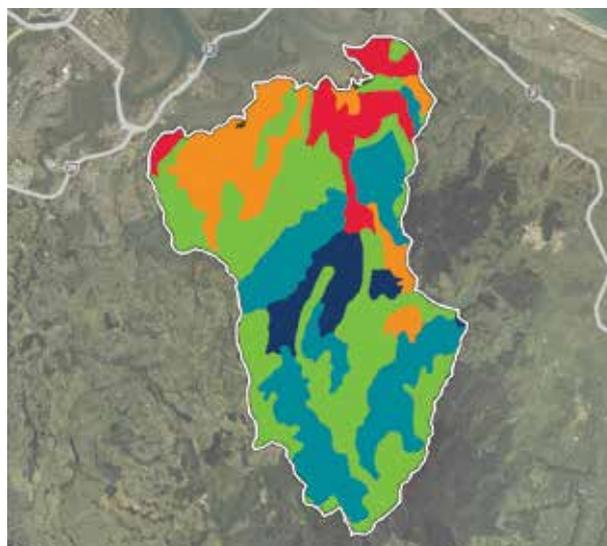
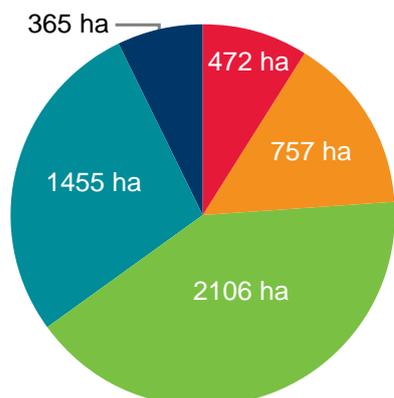
Land use capability classification in the Welcome Bay sub-catchment

The majority of land in this sub-catchment is Land Use Capability (LUC) Classes 6 and 7; rolling, steep and very steep landscapes respectively. Both LUC Classes 6 and 7 land are located in the middle and upper catchment. Highly productive LUC Classes 2, 3 and 4 land are primarily restricted to the lower catchment.

LUC Class	LUC Units	Percent
3	3e 1, 3e 2, 3w 1	9
4	4e 1, 4e 2, 4w 1	15
6	6e 1, 6e 3, 6e 4, 6e 7, 6w 1	41
7	7e 1, 7e 2, 7e 11	28
8	8e 4	7

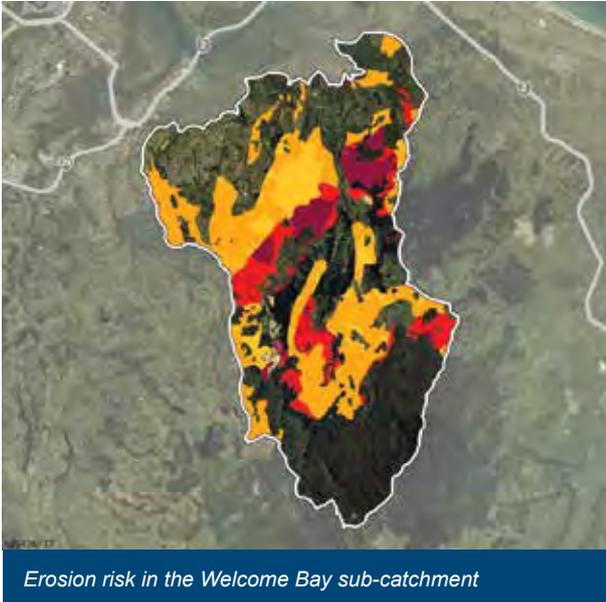
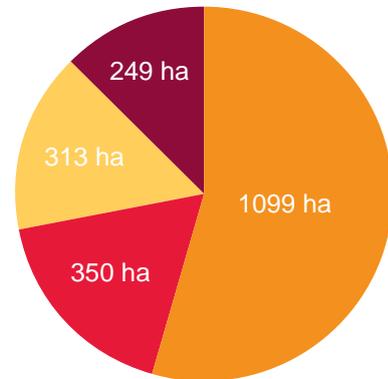
Erosion risk in the Welcome Bay sub-catchment

A high proportion of Land Use Capability Classes 6 and 7 land in the Welcome Bay sub-catchment are medium to high risk erosion prone land due to pastoral land use.

Land Use	Risk	Percent
Pasture	Medium	21
Pasture	High	7
Exotic forest	Medium	6
Exotic forest	High	5

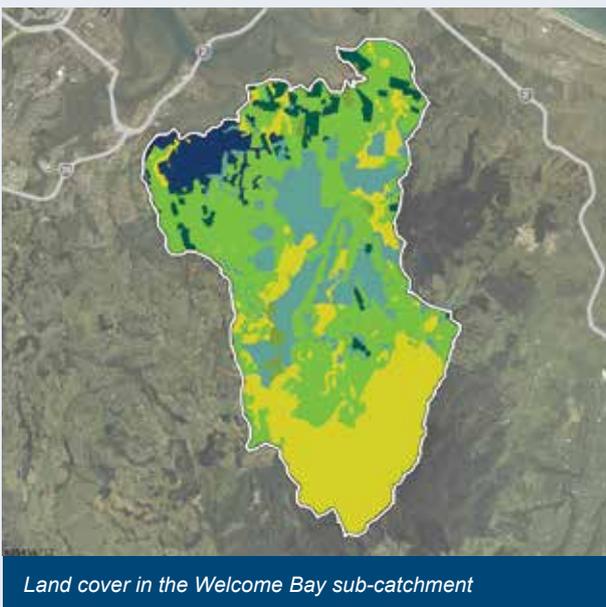
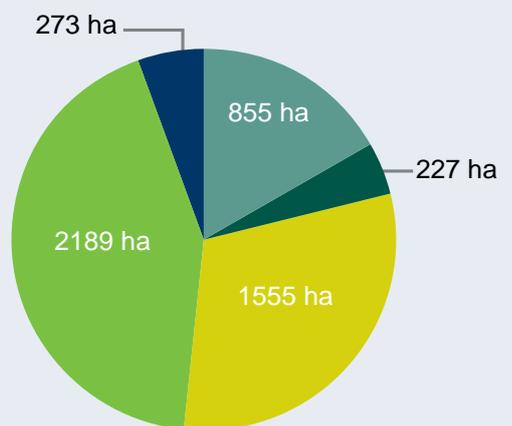
Land cover in the Welcome Bay sub-catchment

Vegetation	Percent
Exotic	17
Horticulture	4
Indigenous	30
Pasture	42
Urban	5

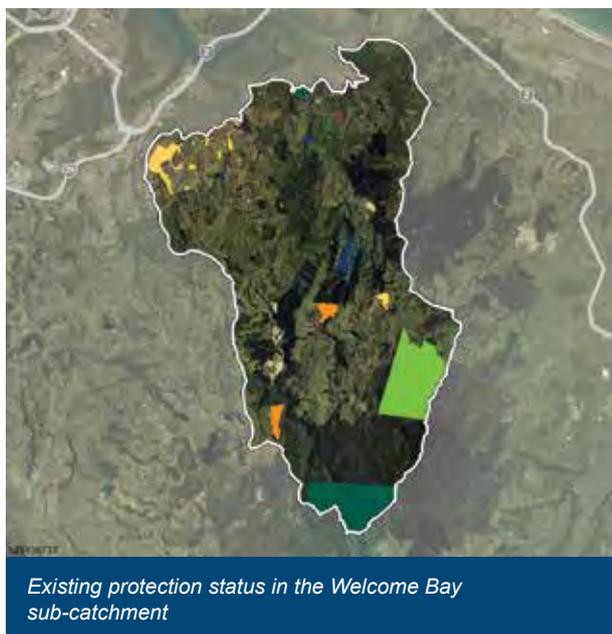
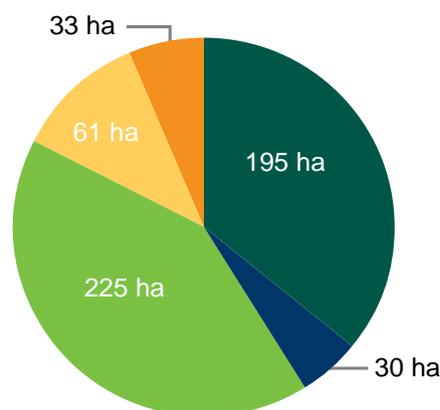
Existing protection status in the Welcome Bay sub-catchment

Class	Percent
DOC Reserve	4
BOPRC Covenant	1
Nga Whenua Rāhui	4
District Reserve	1
WBOPDC Covenant	1
