Monitoring impacts of on-site wastewater treatment systems - Bay of Plenty

Bay of Plenty Regional Council
Environmental Publication 2011/05
May 2011

Monitoring the impacts of on-site wastewater treatment systems, Bay of Plenty

Environmental Publication 2011/05

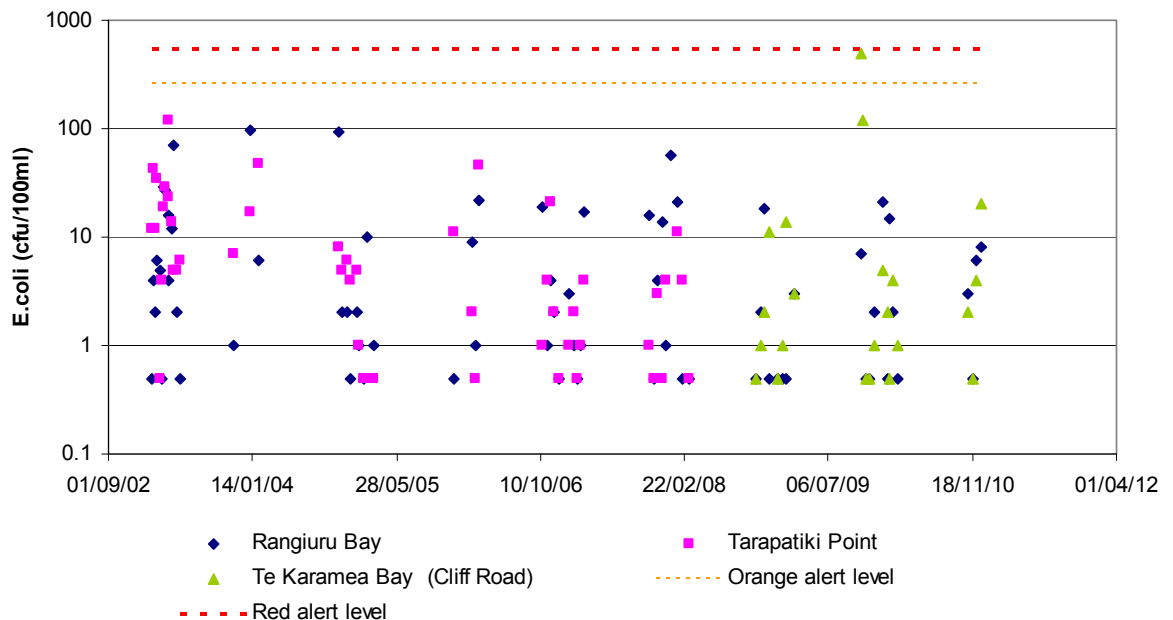
Figure 3.3 Bathing surveillance monitoring results, 2003 to 2011, Lake Tarawera.

Bathing surveillance results indicate good water quality with only low level of contamination well below recommended contact recreation guidelines (Figure 3.3). Only one result has been above the orange alert level at Te Karamea Bay in 2009 which occurred during rainfall and high wave action in the lake.

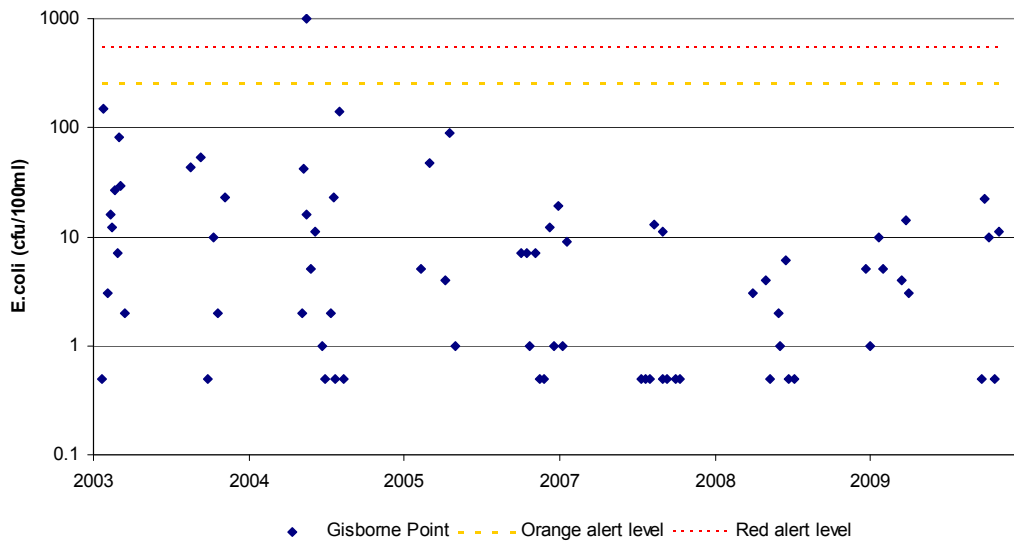
Figure 3.7 Bathing surveillance monitoring results, 2003 to 2011. Gisborne Point, Lake Rotoiti.

The Gisborne Point boat ramp is the site for bathing beach and shellfish monitoring. Figure 3.7 shows the bathing water quality results from 2003 to 2010. Bathing water quality is generally good with almost no exceedances. Analyses of freshwater mussels show relatively high concentration of faecal coliform, above safe consumption guidelines. Enterococci, another indicator organism of faecal contamination, are generally low (Figure 3.8).

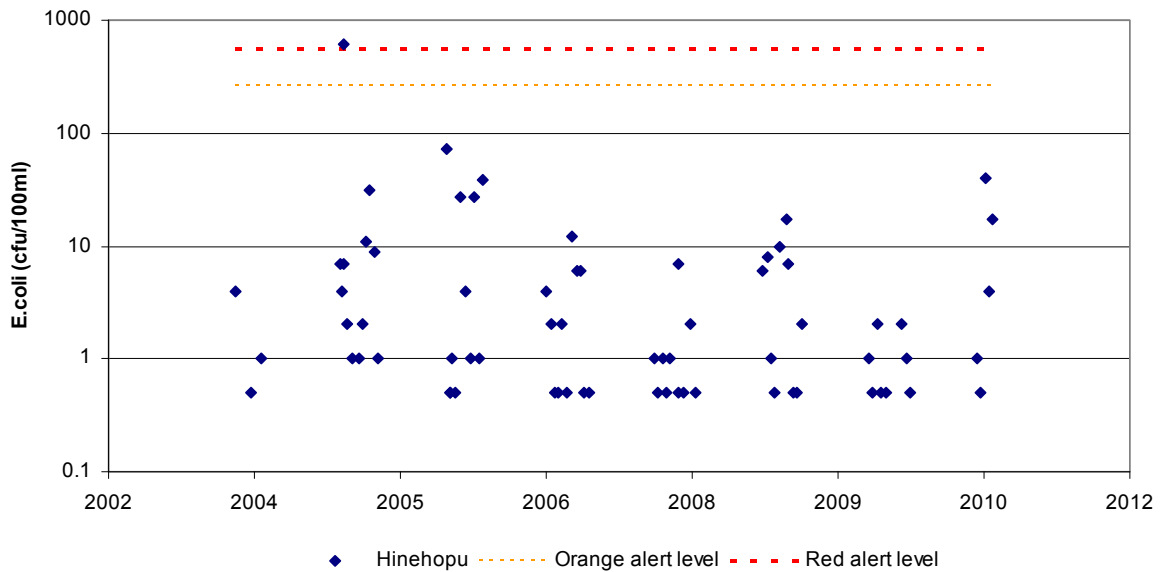
Figure 3.10 Bathing surveillance monitoring results, 2003 to 2011. Hinehopu.

Even with sporadic elevated indicator bacteria levels coming from the Tamatea drain the bathing water quality of the Hinehopu area remains excellent (Figure 3.10). Surface water inflows to the area are of small volume so faecal loading from these sources is likely to be low.

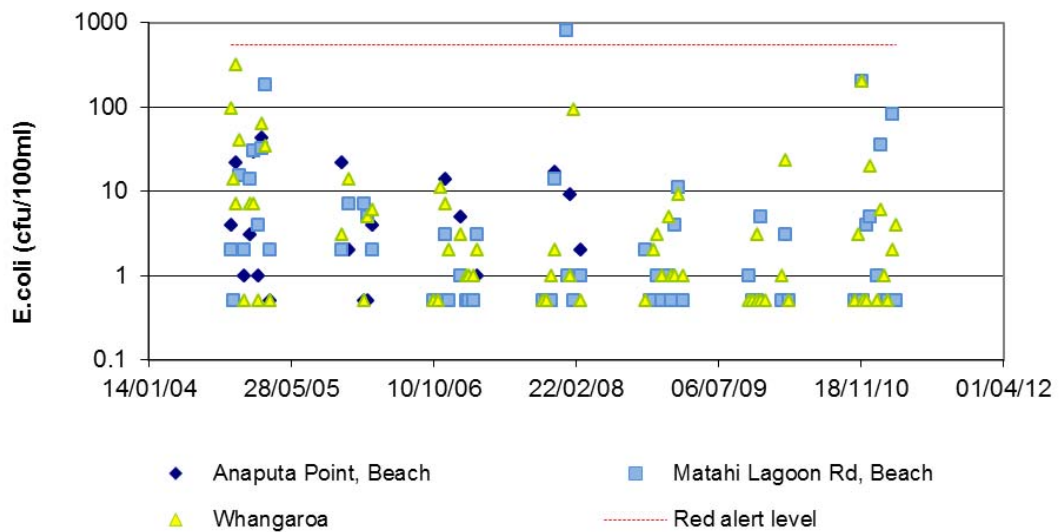
Figure 3.15 Bathing surveillance monitoring, Lake Rotomā.

Bathing surveillance monitoring of the Lake Rotomā waters adjacent to the built up communities reveals the lake to be in excellent condition for recreational pursuits. In the last seven seasons only one sample has exceeded the microbiological guideline red alert mode, and this may be an anomaly (e.g. sample potentially contained water fowl faeces). Although only a few freshwater mussel samples have been analysed from near Matahī Beach in the past few years, there were no results to indicate any contamination issues.

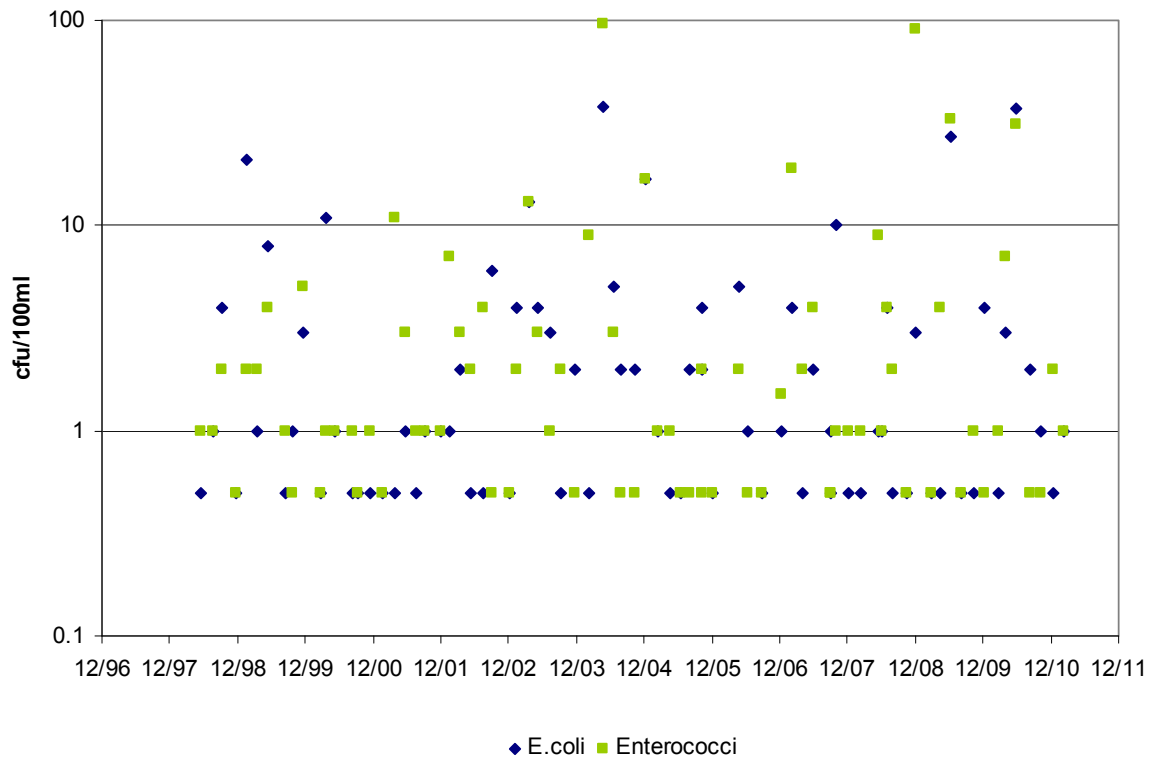
Figure 3.19 Indicator bacteria concentrations, Tanners Point Jetty.

Indicator bacteria results taken from the jetty near the boat ramp at Tanners Point are at consistently low levels (Figure 3.19). Similarly bathing surveillance monitoring undertaken at the boat ramp in summer has only recorded one value over the microbiological water quality guidelines (2003) in eight seasons. This exceedance may have been the result of an illegal boat discharge, flow from the Tuapiro River or water fowl rather than a land based discharge from Tanner Point.

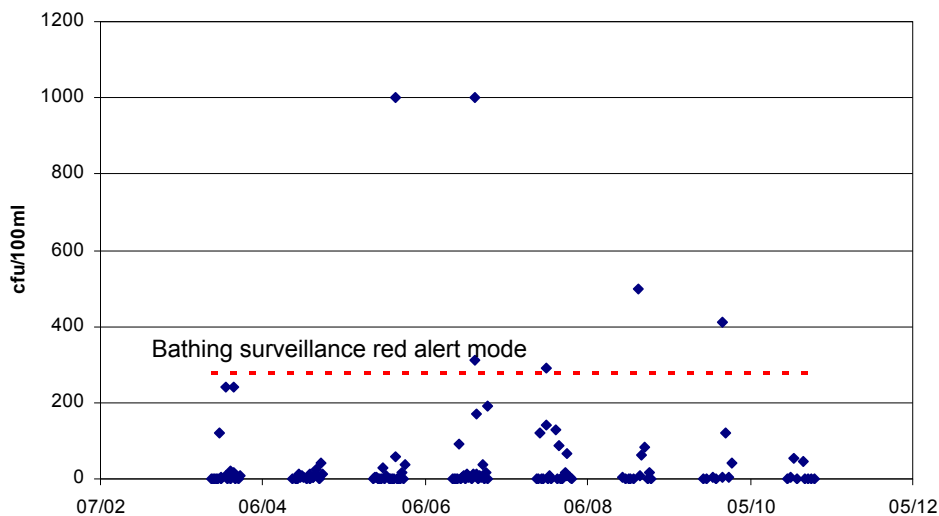
Figure 3.25 Bathing surveillance monitoring results, Enterococci, Ongare Point.

Bathing water quality around Ongare Point is generally good with only ten samples exceeding the Microbiological Water Quality Guidelines (2003) orange alert mode of 140 enterococci per 100ml. Results of 1000 enterococci per 100ml occurred in 2006 and 2007. Both samples were taken after substantial rain had fallen

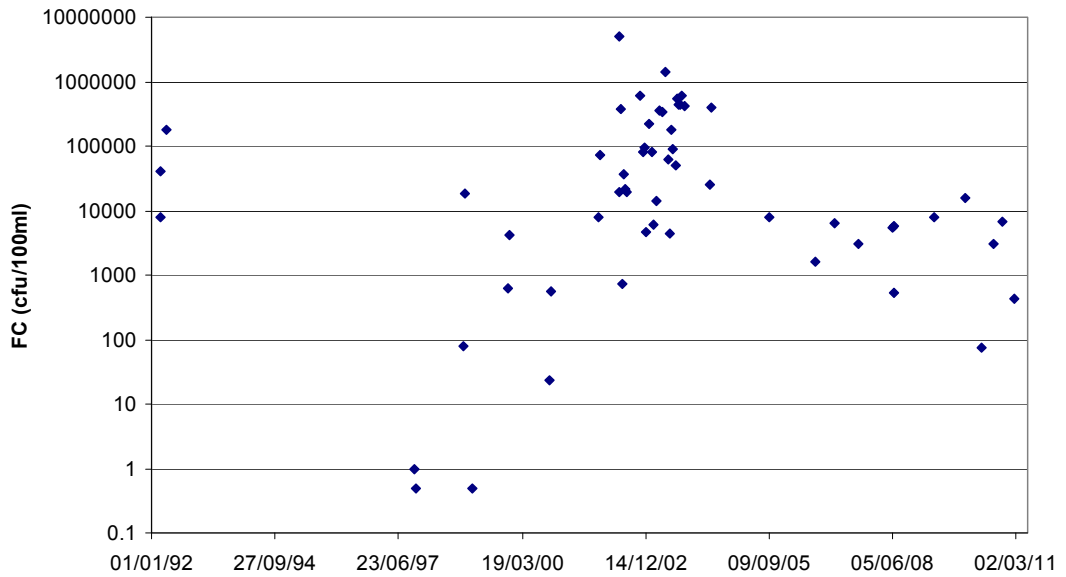
Figure 3.32 Waitui drain faecal coliform concentrations.

One of the main stormwater drains, the Waitui drain, has not only high indicator bacterial levels but also elevated nutrient levels, indicating contamination from on-site effluent treatment systems. Figure 3.32 indicates that faecal contamination is high in 1992 but showed low results in 1997 elevating to extremely high results in 2002, 2003. This has returned to a more moderate contamination level in recent times possibly due to septic system servicing.

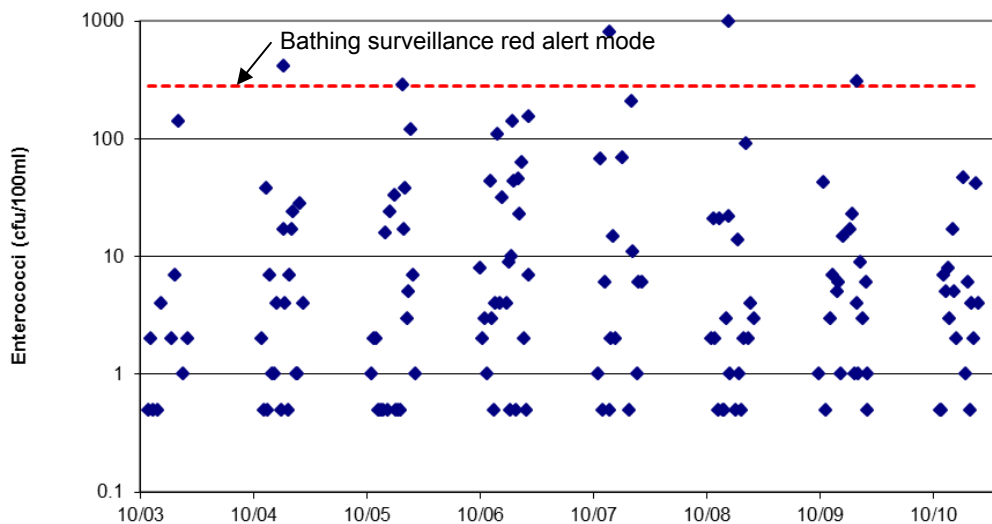
Figure 3.33 Bathing surveillance monitoring results, Enterococci, Te Puna.

The microbiological swimming water quality of the Te Puna estuary is good based on monitoring of the indicator bacteria enterococci (Figure 3.33). Only four results have been above the bathing surveillance red alert threshold (280 cfu/100ml) over the past eight seasons.

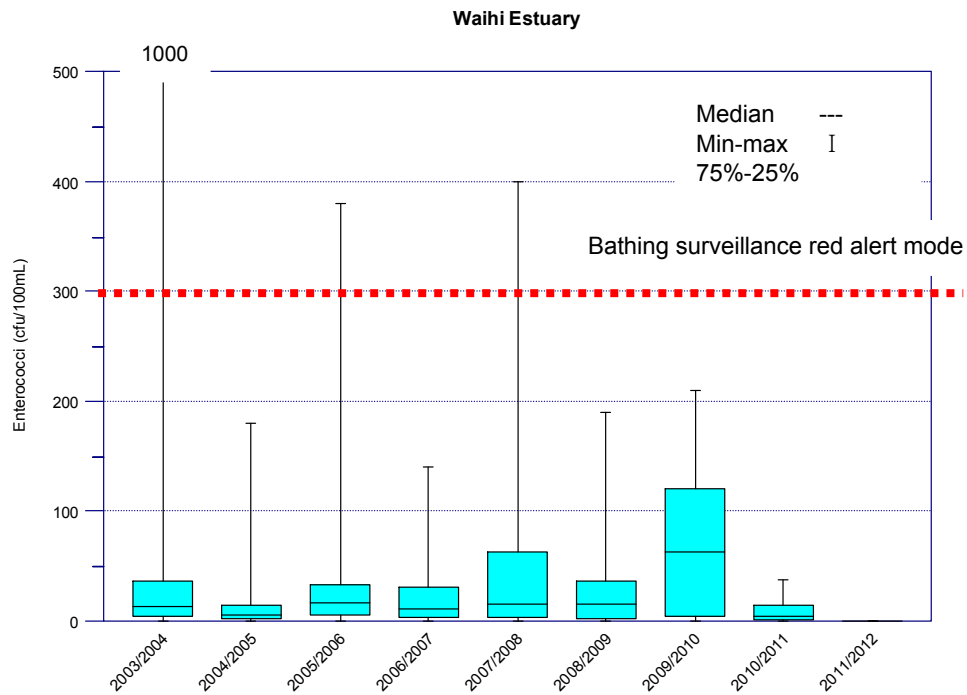
Figure 3.38 Bathing surveillance results, Waihi Estuary.

Bathing surveillance monitoring at Pukehina beach shows these waters to be excellent for contact recreation purposes. Waihi Estuary has lower water quality due to rural freshwater inputs, local contamination from the Little Waihi community and potentially from Pukehina. Figure 3.38 shows monitoring results for the lower estuary from 2003 to 2011. Apart from the 2009/2010 season results have been under 50 enterococci/100ml, well below the bathing surveillance alert levels for marine waters. Only three seasons in the last eight have had occasional results above the bathing surveillance red alert level.

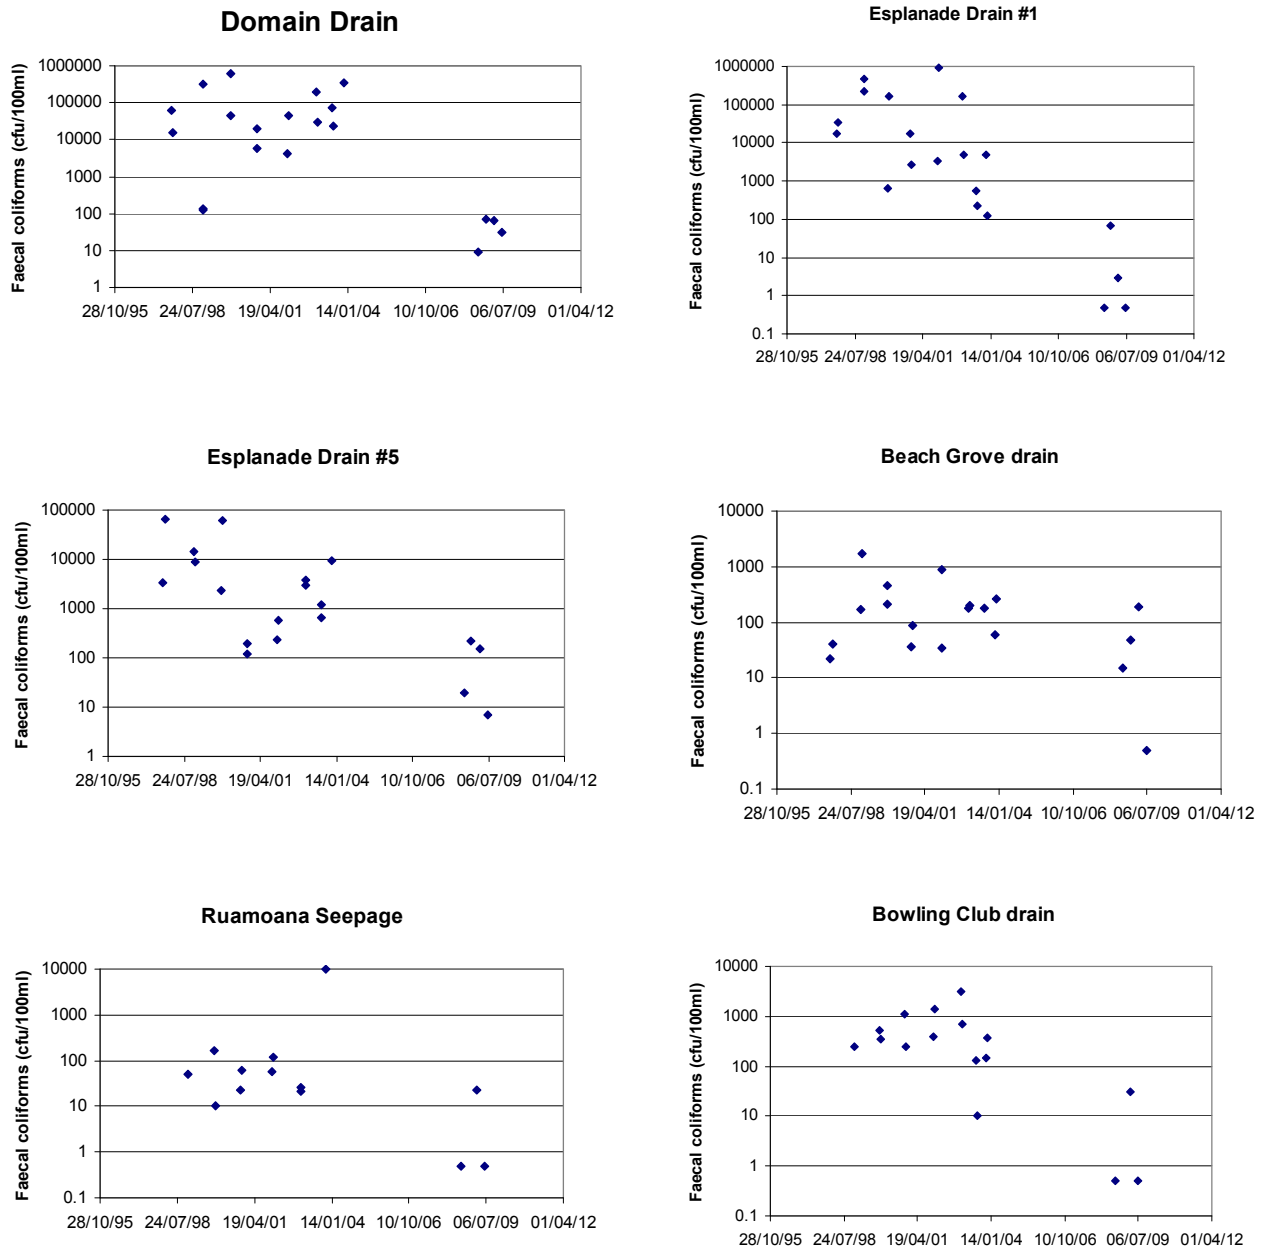
Figure 3.45 Faecal coliform concentrations in drains and seeps, Ōmokoroa. Note: the Log scale in the graphs de-emphasises the significant reductions that occurred post-reticulation.

Drains and seeps show an overall improvement in indicator bacteria concentrations since reticulation. The most dramatic improvements appear in the faecal coliform results (Figure 3.45). The highly contaminated drains (Domain and Esplanade #1) have shown around a 3 log order reduction (1,000 to 10,000-fold) in faecal coliform levels. Other drains and seeps are displaying a 2 or 1 log (10 to 100-fold) reduction, but these were generally not as highly contaminated as the Domain and Esplanade No. 1 drains.

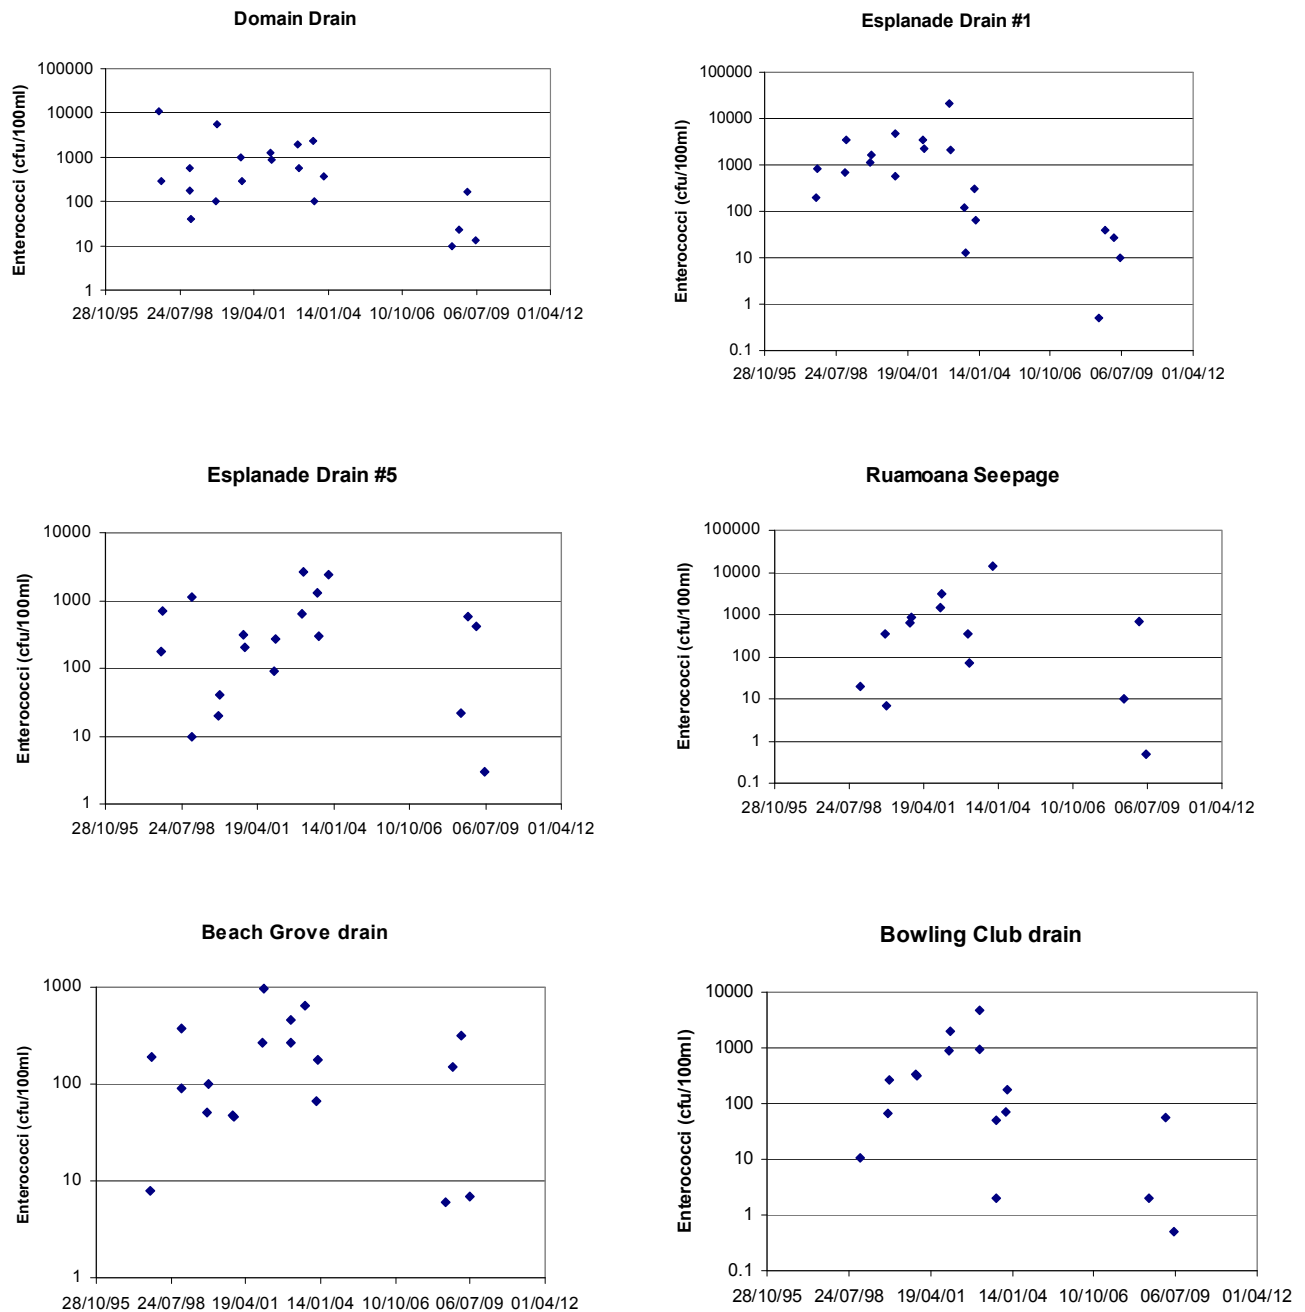
Figure 3.46 Enterococci concentrations in drains and seeps, Omokoroa. Note: the Log scale in the graphs de-emphasises the significant reductions that occurred post-reticulation.

The enterococci results are not as conclusive as the faecal coliform results, with a one to two log order improvement in concentrations in the Domain and Esplanade #1 drains. However, results from other communities tend to show faecal coliform or *E.coli* as the better indicator of contamination from on-site wastewater treatment sources (see Scholes, 2007). Enterococcus species also come from a variety of vegetative sources and may not be exclusively from a faecal source.

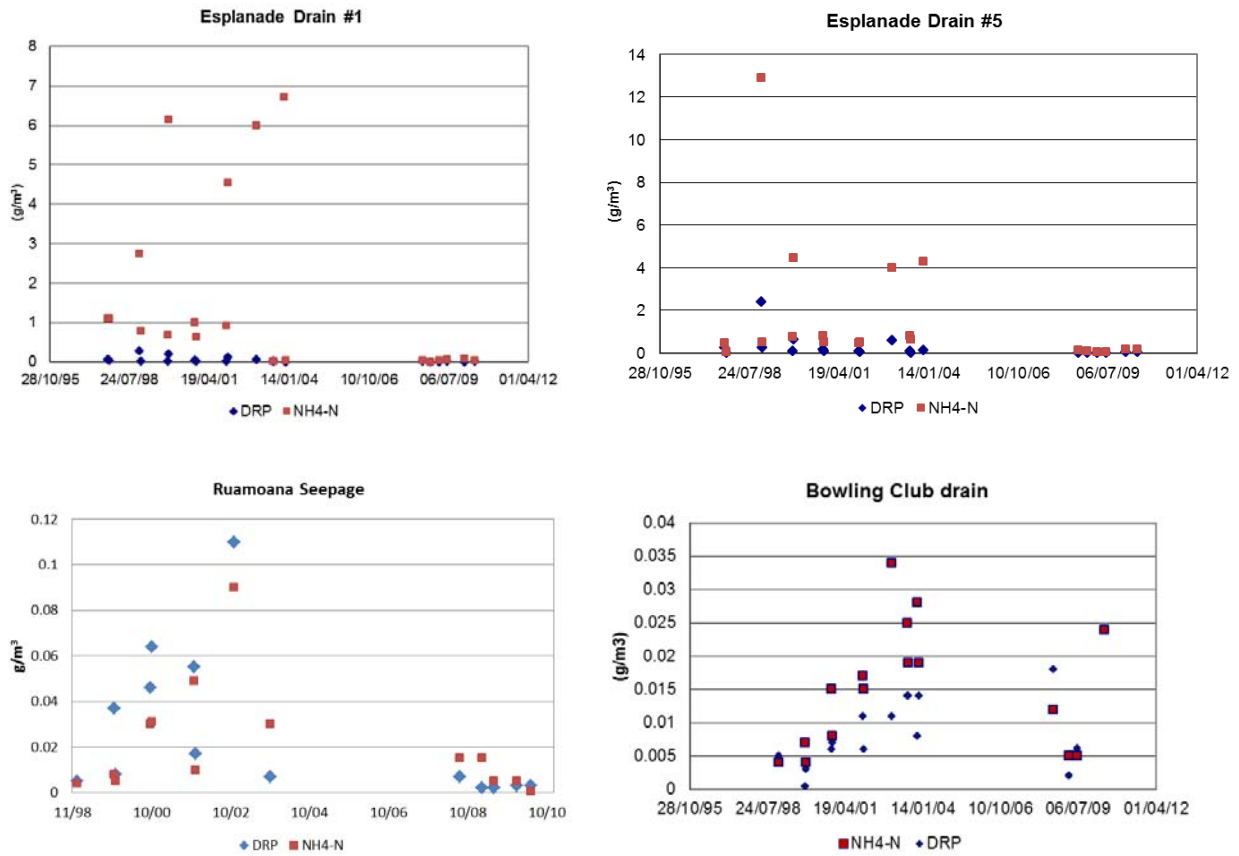
Figure 3.47 DRP and NH₄-N concentrations in drains and seeps, Omokoroa.

The nutrient results indicate an improvement in ammonium (NH₄-N) and dissolved reactive phosphorus (DRP) concentrations in discharges to the foreshore. Oxides of nitrogen show

little change since reticulation indicating a pool of organic nitrogen that is continuing to oxidise and leach into groundwater. These concentrations may also be due to high background concentrations and/or slow leakage of existing on-site wastewater treatment tanks through anaerobic soils.
