The Mt Maunganui terminal site³

Incident

Cause of the discharge

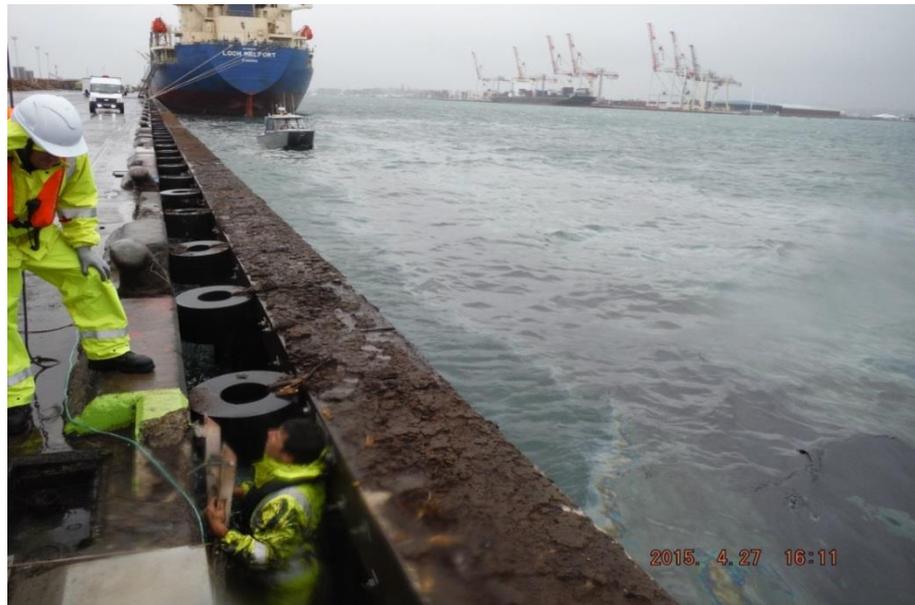
27. At 11:55am, the Council's Regional On-Scene Commander, Adrian Heays arrived at berth 7 at the Port of Tauranga. At that time there was a strong northerly wind and an incoming tidal flow. Mobil's Mt Maunganui Terminal Manager arrived at 12pm and initiated Mobil's Emergency Response Plan. At 1:00pm Mobil's contractors inspected lateral 1340 and confirmed the discharge had stopped. The Council's Regional On-Scene Commander declared a Tier 2 oil spill response at 1:45pm. The following photograph shows oil spreading south from under the wharf at lateral 1340 at 4.11pm.

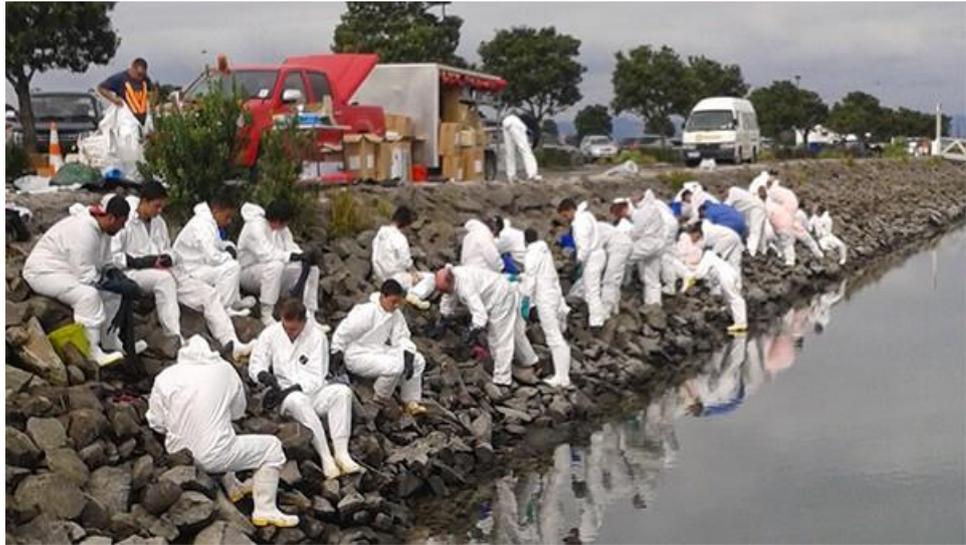
69. The following photograph shows clean-up work near TBM.¹³

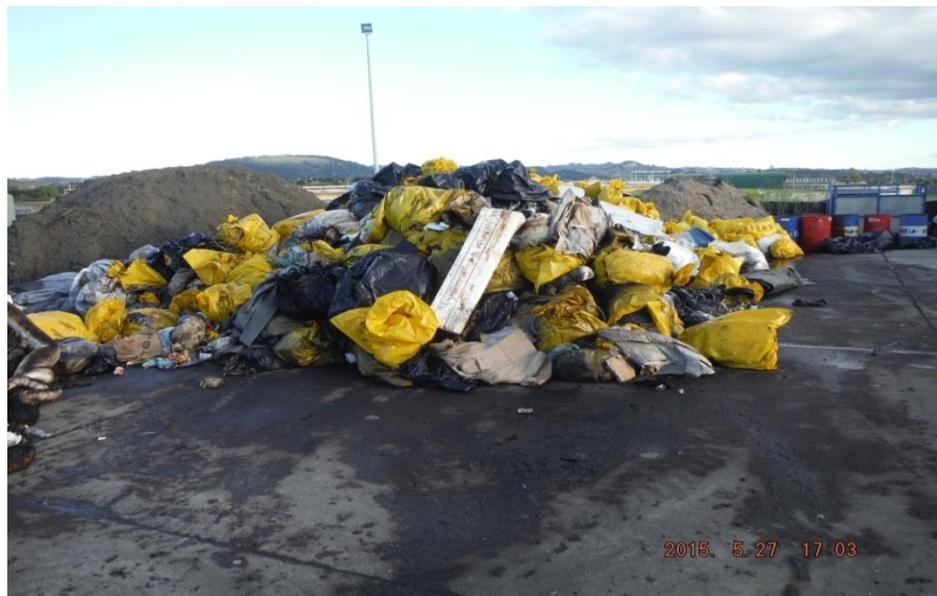
70. The oiled waste was stored in sealed skips before being assessed at Tauranga's transfer station at Te Maunga (as shown below) and disposed of at the specialist Hampton Downs facility in the Waikato.

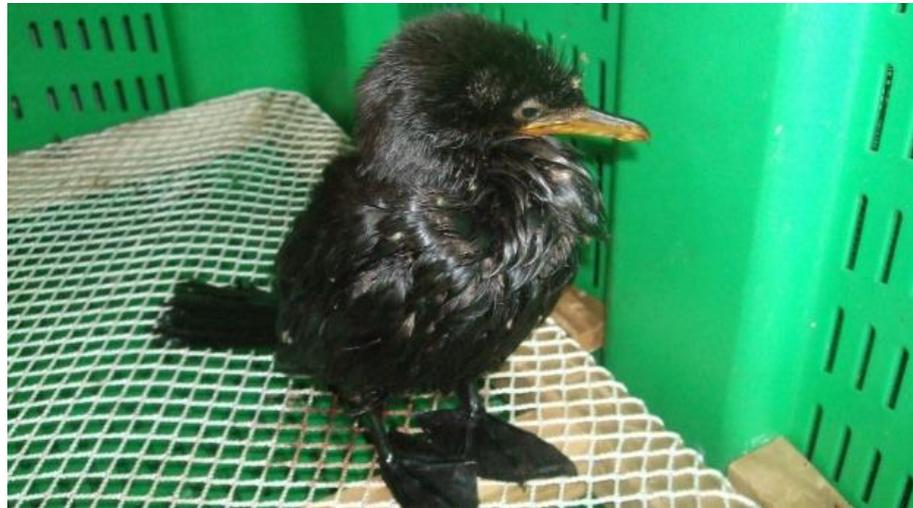
84. Maungatapu Bay was the area most significantly impacted by oil in the inner harbour. The impacted area extended over approximately 1.2 km and included 350 metres of fringing upper tidal natural saltmarsh and sandy/muddy shore habitat, 530 metres of artificial rip rap rock wall along Turret Road causeway and 90 metres of artificial wooden and concrete seawall adjacent to Moiri Place. Two birds in this area died as a result of becoming oiled, one of which is shown in the following photograph shortly after it was found. The one penguin that was affected by the spill was cleaned off, rehabilitated and released.
