# Bay of Plenty Regional Council

## Koapeopeo Canal Remediation

### CLG Monthly Update Report

March 2019

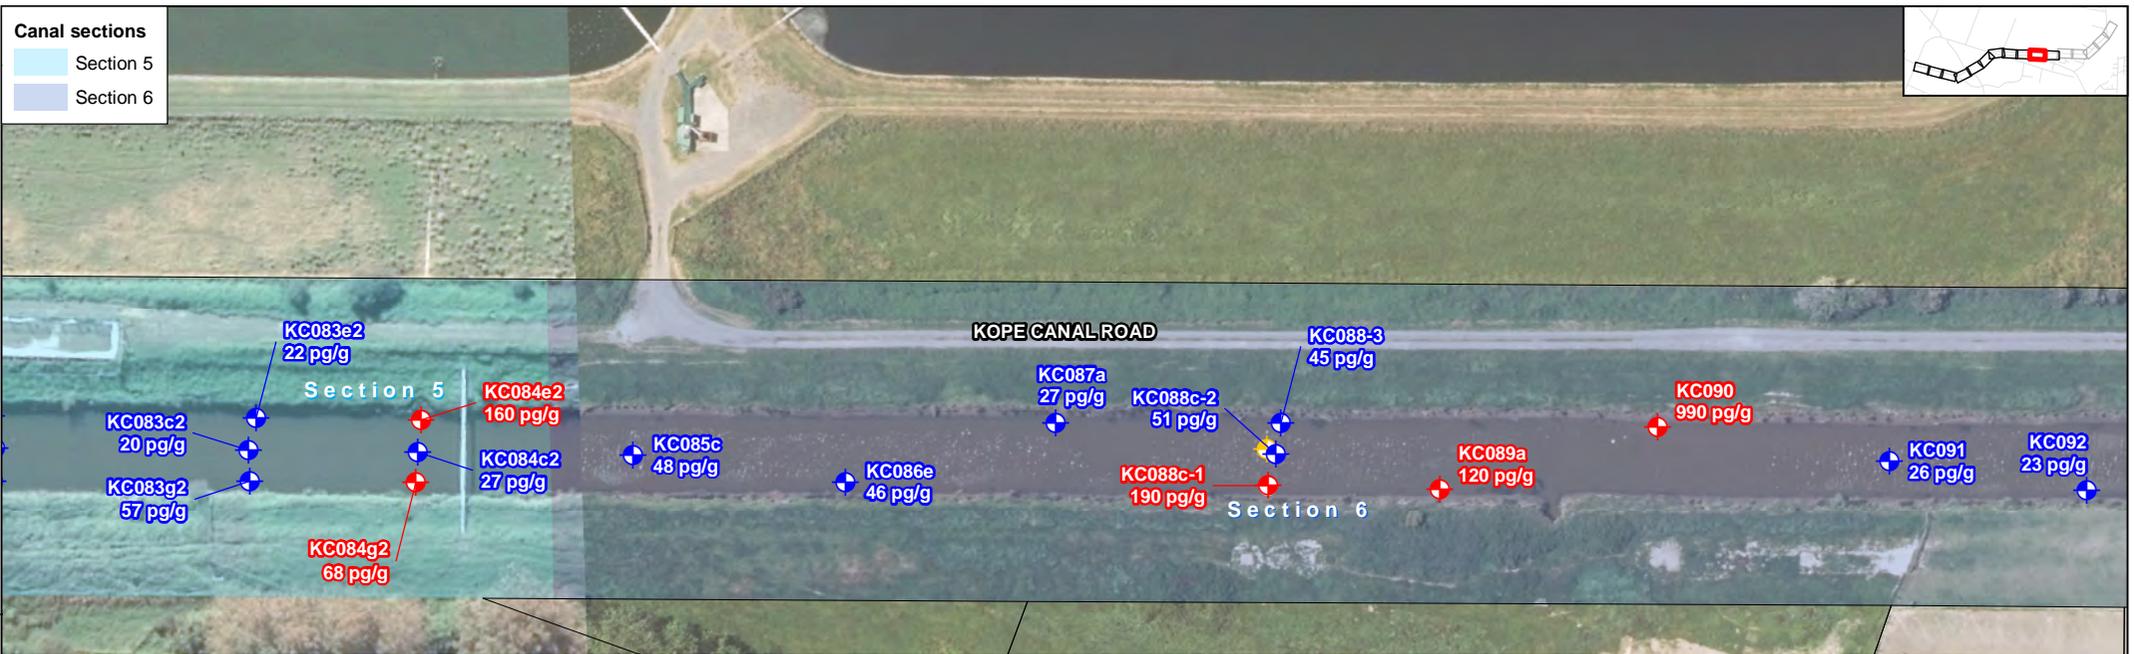
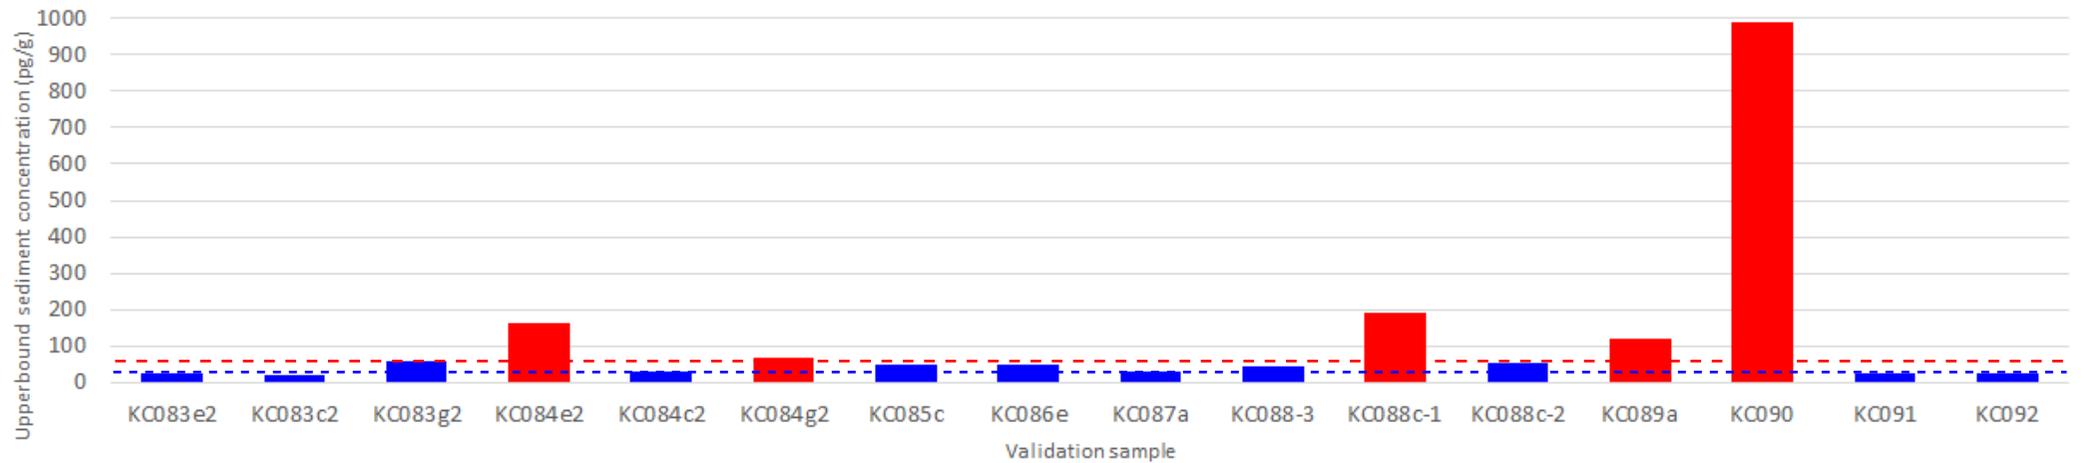
Eleven validation samples were collected from behind the dredge within Section 6 (See Figure 10 and 11 in the Validation Plan in Appendix B). The Total PCDD/F (dioxin) I-TEQ Upperbound results ranged from 21 and 990 pg/g. Of the 11 samples analysed, three dioxin results of 120, 190, and 990 pg/g triggered the need for redredging in accordance with the EMVP. The remaining samples had dioxin results between 21 and 51 pg/g, which is below the remedial target. The 95% UCL was calculated as being 40.19 pg/g for the approximately 3200 m length of the canal chemically validated as at 31 March 2019 (excluding the three dioxin results over 120 pg/g).
