# Karaponga Stream Hydro Dam

For Karaponga Hydro Limited

Assessment of Effects Ecological Report December 2015

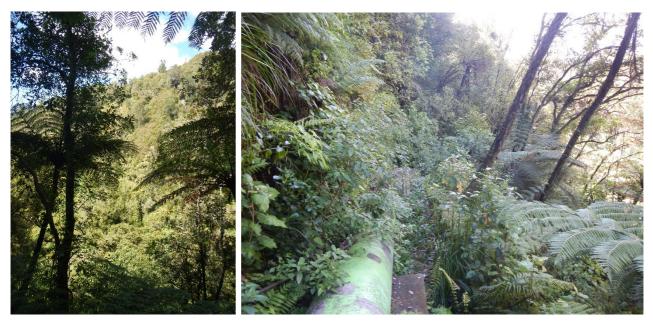
Figure 2: Native vegetation of the gully (left), which the penstock passes through along a narrow section of track on the true left bank (right).

The vast majority of the vegetation within the forested gully central to the site can be classified as mature native podocarp/broadleaf forest. Throughout most of this area the land slopes sharply down to the Karaponga Stream mainstem at the gully floor (Figure 2, left). Rewarewa (*Knightia excelsa*), tawa (*Beilschmiedia tawa*), kohekohe (*Dysoxylum spectabile*) and kanuka (*Kunzea robusta*) are the dominant canopy species, with an understory comprising a diverse range of common native trees and shrubs. Species recorded included putaputaweta (*Carpodetus serratus*), mamaku (*Cyathea medullaris*), kawakawa (*Piper excelsum* subsp. *excelsum*), ponga (*Cyathea dealbata*), hangehange (*Geniostoma ligustrifolium* var. *ligustrifolium*), pate (*Schefflera digitata*), fivefinger (*Pseudopanax arboreus*), karamu (*Coprosma robusta*), red matipou (*Myrsine australis*), rangiora (*Brachyglottis repanda*), gully tree fern (*Cyathea cunninghamii*), wheki (*Dicksonia squarrosa*), pigeonwood (*Hedycarya arborea*), shining karamu (*Coprosma lucida*), soft tree fern (*Cyathea smithii*), wheki-ponga (*Dicksonia fibrosa*), wineberry (*Aristotelia serrata*) and seedling tawa. Juvenile white rata (*Metrosideros perforata*) was also sighted growing on the trunks of several large trees. Occasional emergent individuals of mahoe (*Melicytus ramiflorus*) occur on the upper gully slopes, with native climbing species such as kiekie (*Freycinetia banksii*) and supplejack (*Ripogonum scandens*) commonly growing down steep rock faces. Rasp fern (*Blechnum parrisiae*) and kiokio (*Blechnum novae-zelandiae*), frequently occur in dense stands amongst the climbers and native seedlings established on the steeper banks where larger trees are unable to persist.

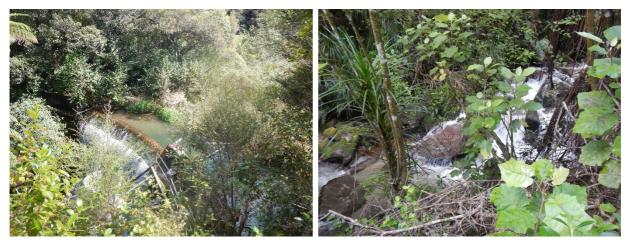
Figure 5: View of the dam spilling water, with the remnant flow spilling over the structure face (left). Rapid flows of the reaches below the dam (right).

Whilst the reservoir has a bed substrate dominated by pumice sands, the directed flow channelled by the dam and associated infrastructure in conjunction with a higher gradient below the dam has facilitated downstream reaches with rapid flows and bed substrate comprising large volcanic boulders and exposed bedrock (Figure 5, right). The overhanging vegetation and stable boulders provide some instream habitats and occasional refuge pools for aquatic fauna, especially at the channel margins and bank edges. The dense riparian vegetation of these reaches additionally provides a high degree of channel shading, contributing significant benefits to water quality through temperature control. Despite this, the habitat provided is likely to be challenging for long-term occupation by instream fauna, with the rapid flows essentially creating a series of falls and cascades regularly scoured by the mobile suspended pumice transported from upstream. At the time of this survey, it was evident the mobile pumice sands infilled any protected crevices and gaps beneath/between boulders and woody debris. Most aquatic biota require some form of stable instream retreat/habitat – including migrating fishes. Earlier surveys conducted within these reaches indicate flows are likely to fluctuate seasonally (Charles Mitchell & Associates, 2013; Tiney & Donovan, 2009), further limiting the availability of stable habitat for aquatic biota. Further downstream, the mainstem flow descends into the gully, and a waterfall of considerable height (approximately 30m) is present, providing a natural barrier to non-climbing fish

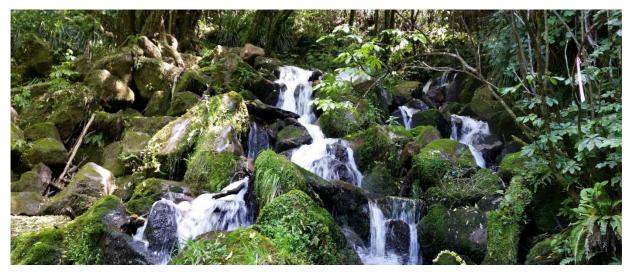
Figure 6: Small falls section downstream of the main waterfall (which was inaccessible at the time of survey for health and safety reasons).

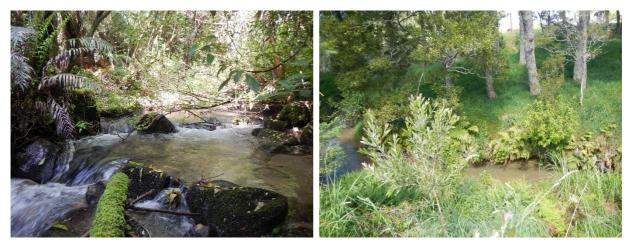
Figure 7: Lower in the gully the channel widens (left), and flows become gentler past the powerhouse (right).

cutting deeper into this easily eroded material and creating shelved banks. Undercutting of these banks have formed a degree of stable habitat for aquatic fauna not present further upstream of the Karaponga, and these environments therefore provide habitats more suitable for long-term occupation by native fish. Whilst in these lower study reaches the stream flows through farmland and pastures where stock is grazed, fencing of the channel was consistent. Despite the riparian vegetation of these reaches lacking the ecological and botanical diversity of the upstream gully environment, continued fencing has facilitated lush pasture growth, encouraged the growth of overhanging bankside vegetation, and allowed for occasional patches of natural regeneration to occur (Figure 7, right).

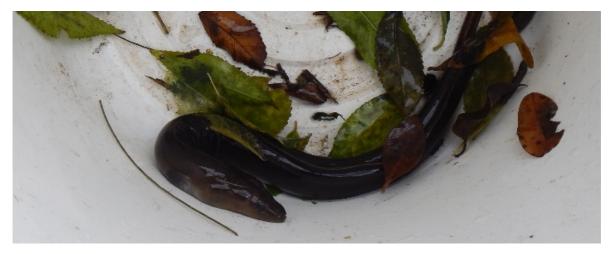
Figure 8: Longfin eel captured during the freshwater survey.

The fish surveys conducted at the four study locations during this investigation recorded only two species, with longfin eel of size range 450mm-550mm identified both at Site 4 downstream of the powerhouse, and near Site 2 upstream of the falls but downstream of the dam. A rainbow trout of size approximately 200mm was incidentally observed near the powerhouse discharge outlet.
